What causes joint filler protrusion?

Basic Concept of the Process Which Leads to Semi-Rigid Filler Protrusion

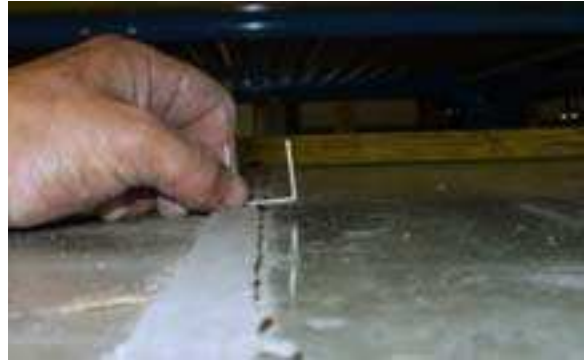
Periodically we receive calls from joint filler installers or facility owners reporting that the joint filler is “bulging” out of the joints or protruding above the floor’s surface. Depending upon the degree to which the filler protrudes and the traffic exposure, filler protrusion ranges from a temporary condition requiring little or no correction to a potential repair issue which should be addressed to ensure the long term protection of the floor joints. This technical bulletin explores the potential causes and corrective actions for joint filler protrusion/bulging.

In basic terms, joint filler protrusion generally results from a narrowing of the joint dimension after the filler has been installed. As joint dimension (width) narrows, installed semi-rigid joint filler is forced into compression. Because semi-rigid fillers are composed of 100% solids and have minimal expansive or contractive movement abilities, filler put into compression “elongates” either downward or upward within the joint. Because semi-rigid fillers are designed to be placed at the full depth of the saw cut, structurally the path of least resistance is at the top of the joint.

Correcting the protrusion condition is normally as simple as razoring off the protrusion to a flush profile, but depending upon the extent of the protrusion, this may later lead to a concave filler profile (exposing edges) which may also require correction. Corrective action may also be best performed during certain periods of the year (i.e. winter months, when joint dimension is at its widest).

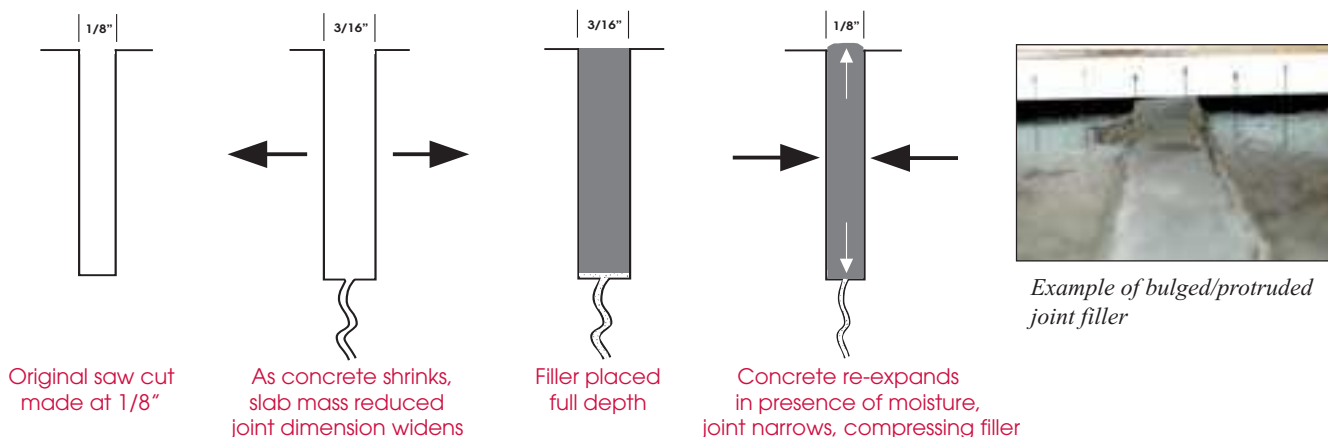
But just as concrete slab panel mass can shrink with a loss of moisture, slab panel mass can also expand in the presence of an increase in moisture absorption (through the base or the surface) or through an “equalization” or redistribution of moisture throughout the slab panel. There are multiple factors that can cause or contribute to slab panel mass increase (and subsequent joint dimension reduction), including:

1. Higher temperatures or humidity in a non-temperature controlled building or floor area
2. Increased moisture migration from below grade and absence of vapor retarder (barrier)
3. Reduced ability for moisture migration through surface (coating, densifier or higher ambient humidity) or filled joints in the presence of a vapor retarder (i.e. moisture has no place to go)
4. Wide joint spacing/larger panel dimensions (exaggerated dimension change at each joint)
5. Slab panel warping/curl relaxation (discussed in detail later)
6. Higher shrinkage concrete mixes (high cement content/smaller aggregate)
7. Joint filler installation at time of maximum joint contraction (mature floor, cold temperatures)
8. Changes in scrubbing operations which lead to reduced or increased moisture availability
