Technical Bulletin No. 007

LP® SmartSide® Trim and Siding Explanation of High and Low Point Overlay Fissures

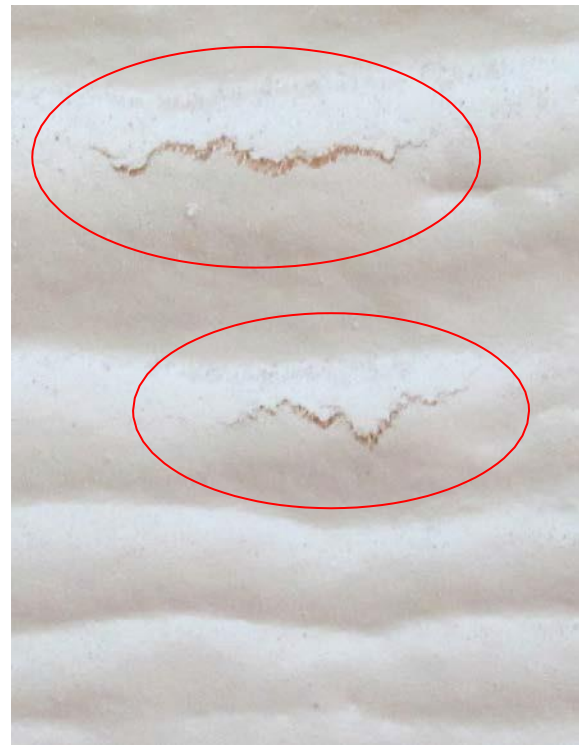
Small surface fissures may be evident in the overlay face and are inherent to the SmartSide production process. Figure 1 provides an example of a surface fissure. The primed overlay is stretched up to eighteen inches when the texture is pressed into the surface. Small surface fissures will occur at the peaks and valleys of the texture where the texture is highly defined. These very small cracks do not reduce the performance or durability of our siding.

Once the product is finished, these fissures become less evident and are difficult to locate unless someone is intentionally seeking them out. Viewing them from any distance is nearly impossible. The fissures tend to be an amber color and contrast somewhat with the factory primer. When finishing SmartSide trim and siding, white and lighter color paints will require enough film thickness to avoid any paint transparency.
