# Notice of Non-Code Compliant Head-of-Wall Joint Assembly

## Use of Wallboard “Rip” to Create Offset

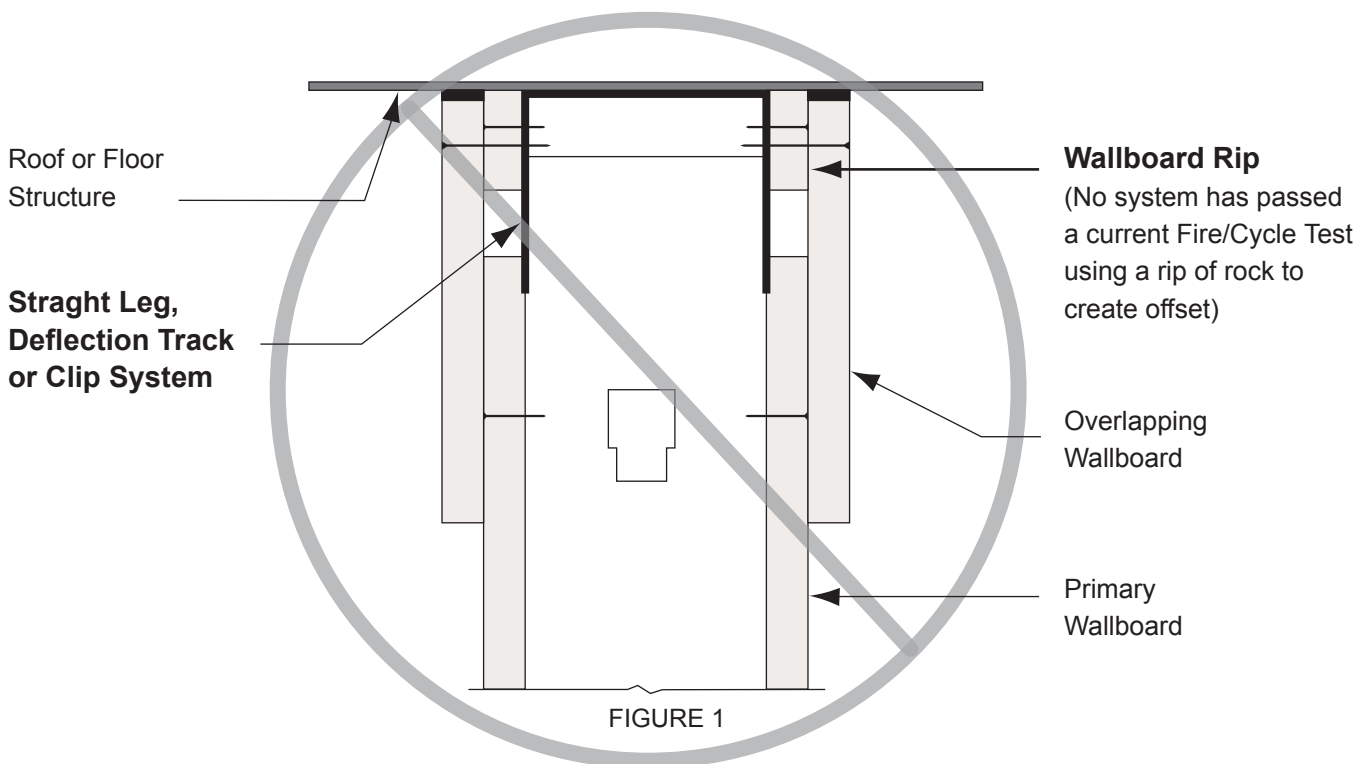
**Figure 1** below depicts a straight leg deflection track with a small rip of wallboard creating an offset in a Head-of-Wall design. This design is problematic in several different ways.

- This design has not passed a current ASTM E 1966 or UL 2079 cycling/fire test and therefore does not meet current building code requirements.
- In fire rated walls, third party tested and listed assemblies must be used when available.

- The small rip of wallboard, after being pierced by two sets of screws and being subjected to cycling, does not have the structural integrity to support the overlapping wallboard in the subsequent fire test.

- The Head-of-Wall joint is where heat and smoke are concentrated and where the fire is most likely to spread from room to room.
- In a typical building, there are more square feet of opening at the Head-of-Wall joints than there are square feet of through penetrations.

Only the Fire Trak system has passed current fire/cycle tests using the overlap board design where the overlap is attached to the track. The Fire Trak system is protected by U.S. Patent No.’s 5,471,805 and 5,755,066.
