# Troubleshooting Guide

Causes, Repair & Prevention

March 2020

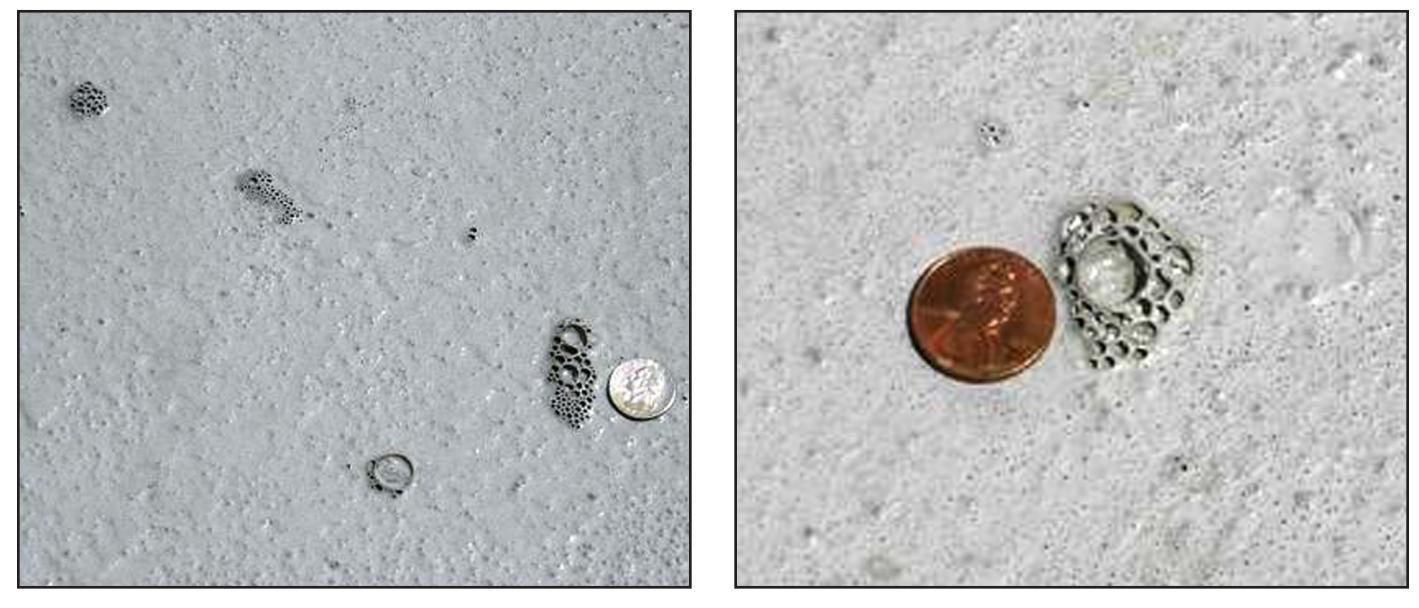
### **Craters Due To Moisture Contamination**

Craters due to moisture will typically occur in clusters.

Moisture from relative humidity or moisture contaminated aggregate will react with the coating material and cause a bubbling effect as shown above. This is caused by a chemical reaction between moisture and the urethane coating material.

- Ensure that the deck is completely dry before coating. Moisture may not be readily apparent, particularly if aggregate has been introduced into the system. Conduct a moisture test before coating application to ensure that there is no contamination.
- Keep aggregate dry as it can be a source of moisture contamination.
- Ambient surface temperature should be more than 5°F above dew point. See Dew Point of Moist Air in the Support Information section of this manual for ambient temperature and relative humidity guidelines.

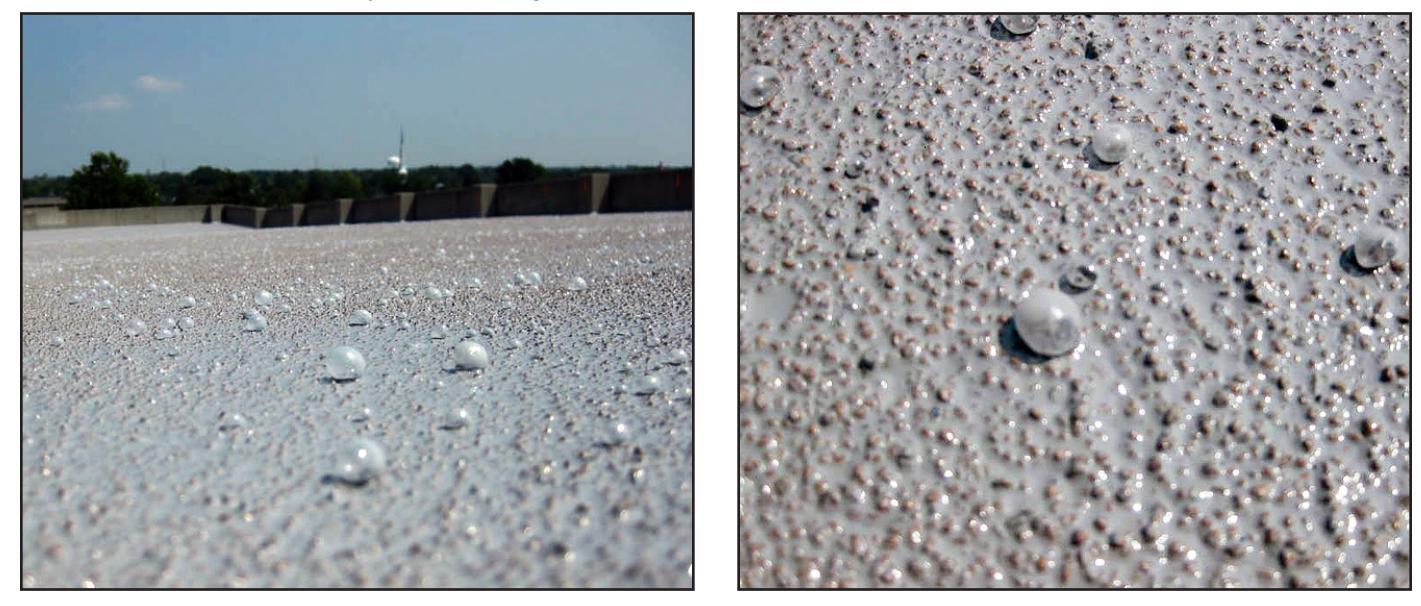
## Pinholes

Pinholes appear as tiny blisters or bubbles. When these blisters pop they usually leave a round crater and the pinhole should be easily seen through the film.

- Porous Concrete: Concrete releases air and moisture vapor that expands as temperatures rise. Also, aggressive shot-blasting or scarifying can open concrete pores and bug holes.
- Excessive Aggregate: Air entrapped in wear coat when aggregate is applied too heavily, leaving air pockets.
- Excessive Additives: When over accelerated, coating rapidly forms a film, trapping air from the substrate, preventing escape during the curing process. Adding solvents can result in surface pinhole blisters if the solvent is not allowed to escape prior to gel.

- Porous Concrete:
  - Begin application as temperatures are dropping and continuing to drop. Rising temperatures result in expansion of the moisture and air in the concrete. Falling temperatures cause the air and moisture to contract within the concrete.

- Excessive Aggregate: Apply wear coat at specified rates, taking care to prevent aggregate from leaving entrapped air pockets.
- Excessive additives: Avoid using accelerators during hot temperatures. See Weather Impact on Coating Materials in the Support Information section of this guide.

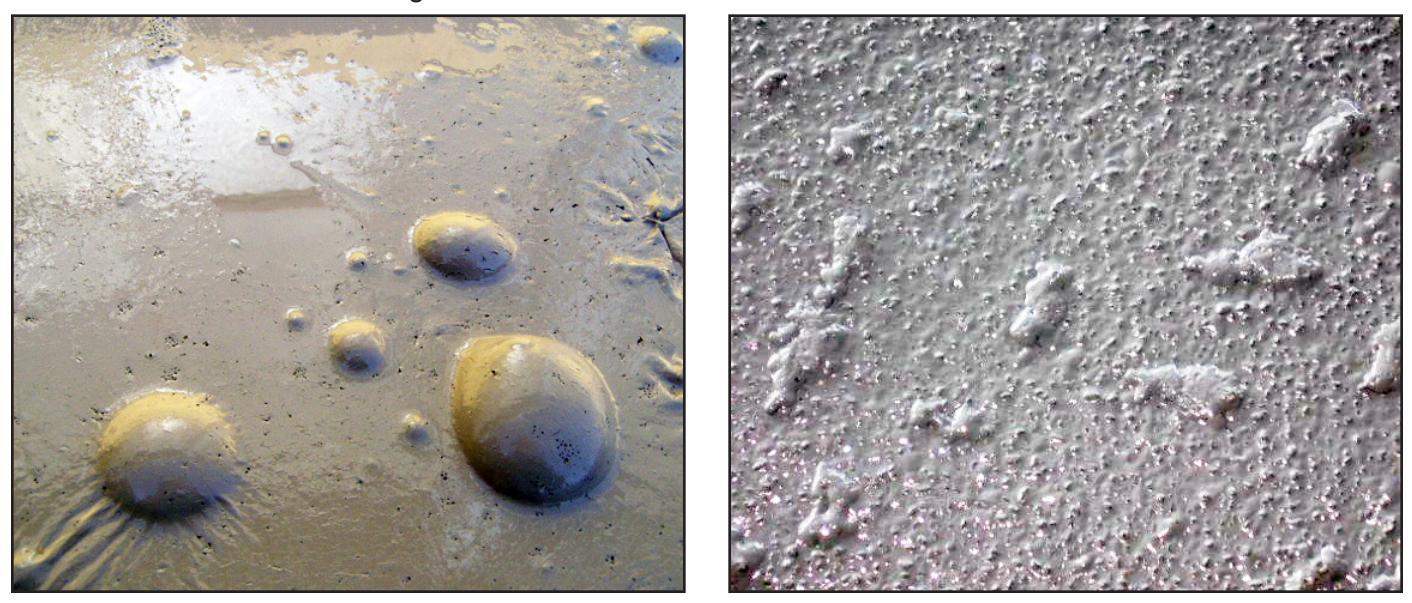
Blisters look like bubbles in the coating surface. The blisters will have a trace of water or moisture trapped inside them. Moisture between the aggregated wear coat and topcoat leaves an orange peel texture on the backside of the blister, mirroring the sand coat texture.

Water from rain, dew or other sources, mixed or rolled into wet, uncured coating. The urethane coating reacts with the water and attempts to cure on the surface, forming blisters and stress wrinkled areas.

- Do not apply coating if rain is imminent.
- Ensure that sprinkler/lawn systems remain off for the duration of the cure.
- Ambient temperature should be more than 5° above dew point. See Dew Point of Moist Air in the Support Information section of this guide for ambient temperature and relative humidity guidelines.
- Ensure that the deck is completely dry before coating. Moisture may not be readily apparent, particularly if aggregate has been introduced into the system. Conduct a moisture test before application to ensure that there is no water contamination.

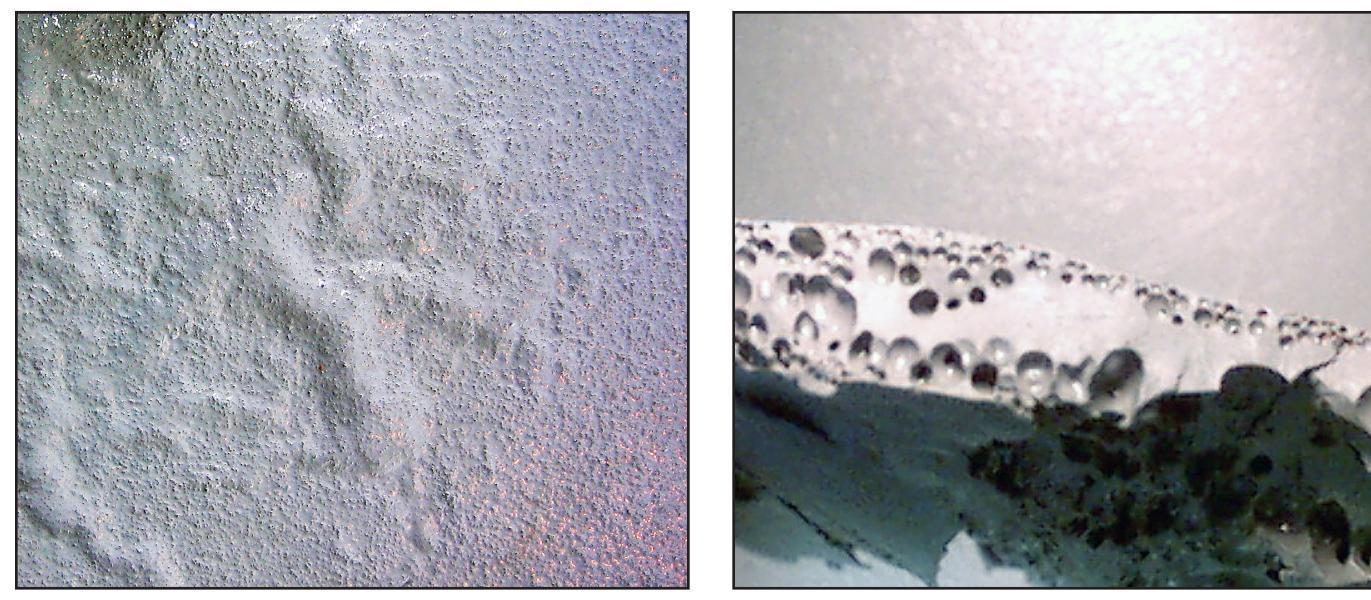
Blisters look like small to large unbroken bubbles in the coating surface and can appear round or oblong. Depending on the state of cure, they can feel spongy or fluid beneath the surface.

Coating was applied at a rate greater than application instructions.

- 1. Completely remove affected areas down to cured coating or substrate.
- 2. Reapply coating system per Neogard specifications and recommendations.

- During installation of coating, frequently check the wet film thickness by use of recommended mil gauges.
- Laying out the job prior to coating by gridding out the area will help to maintain proper and uniform coating thicknesses.
- During application, backroll to eliminate low spot areas where self-leveling coating may pool.

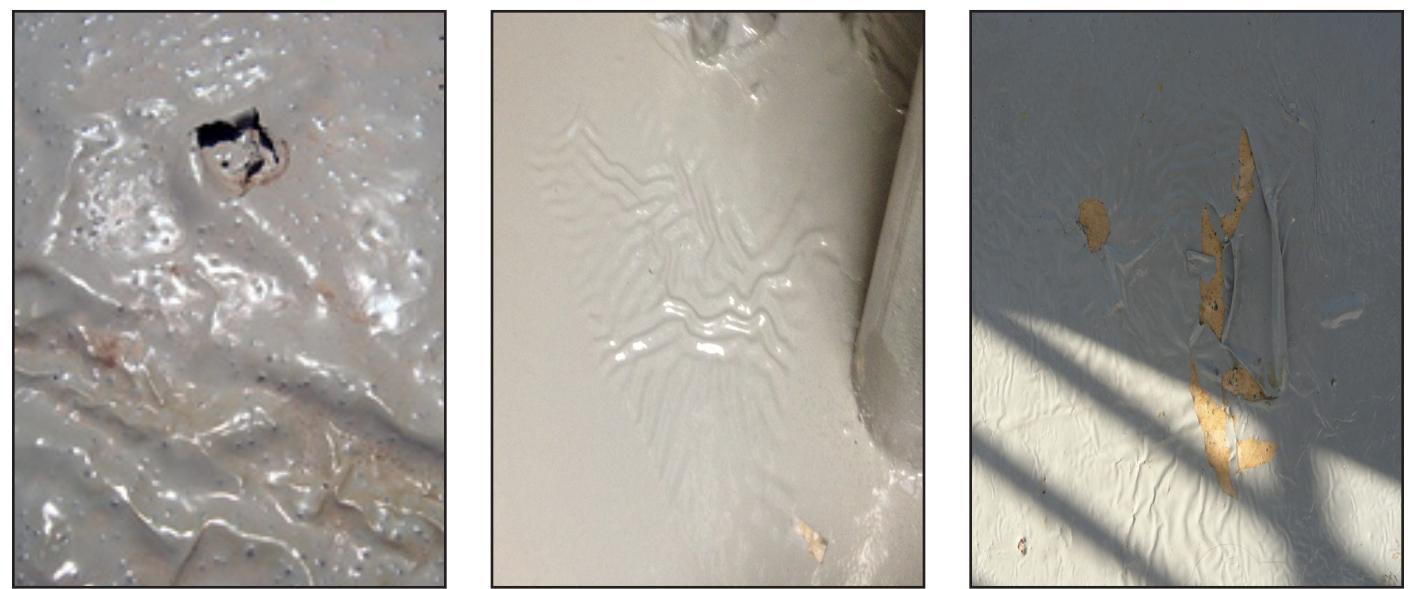
Coating is wrinkled in appearance. Multiple lines of parallel wrinkling may occur.

- Previous Coat is Uncured or Off-Ratio: Material applied over uncured or off-ratio coating, causing stress on topcoat.
- Coating Too Thick: Coating applied at a thickness that exceeds application instructions.

- Previous Coat is Uncured: Ensure that coatings are completely cured before applying additional coats.
- Previous Coat is Off-Ratio: Mix all materials thoroughly, following mix ratios printed on product labels or the Product Data Sheet. See Product Mixing Instructions in the Support Information section of this guide.
- Coating Too Thick: Apply coatings at recommended coverage rates.

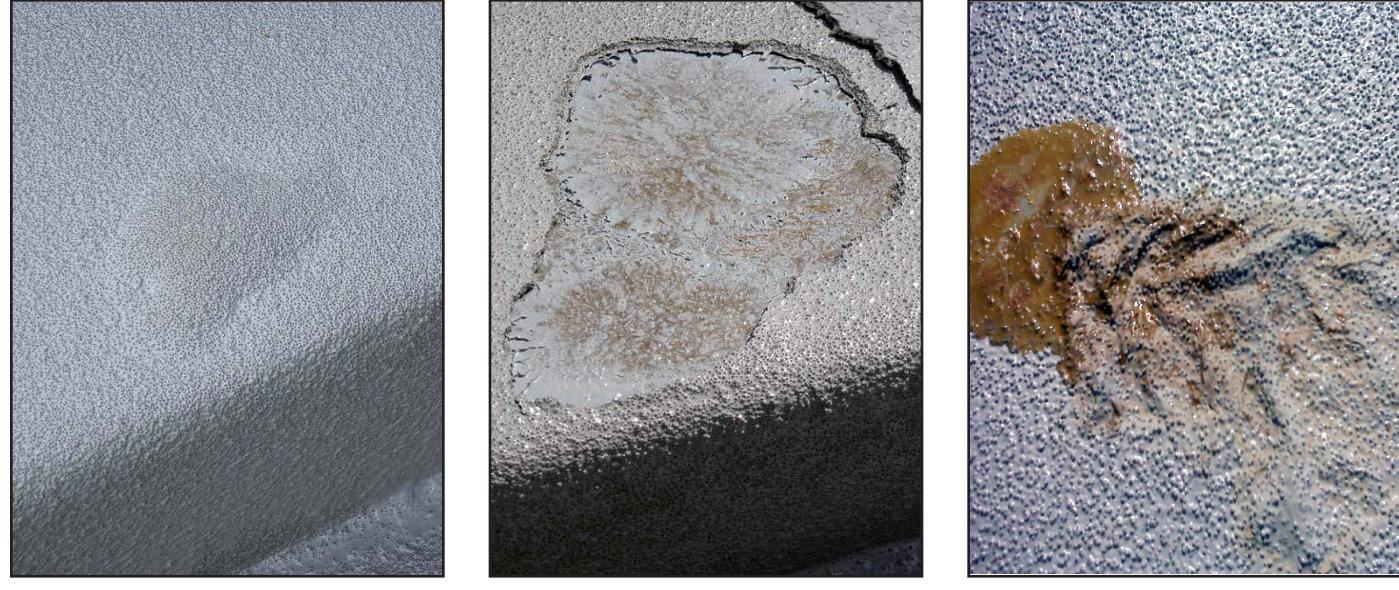
Coating is soft and may transfer when touched. Coating may also delaminate.

**Typical blister**

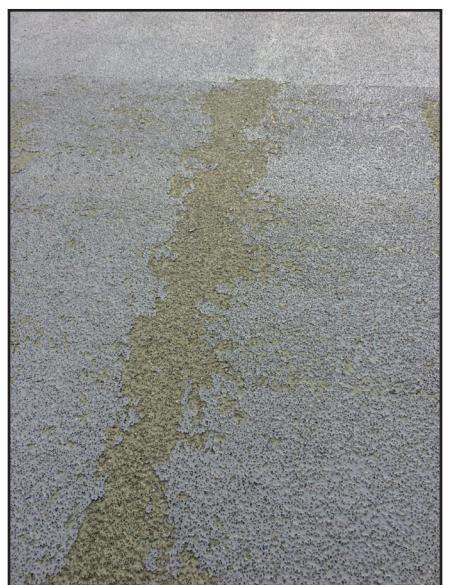
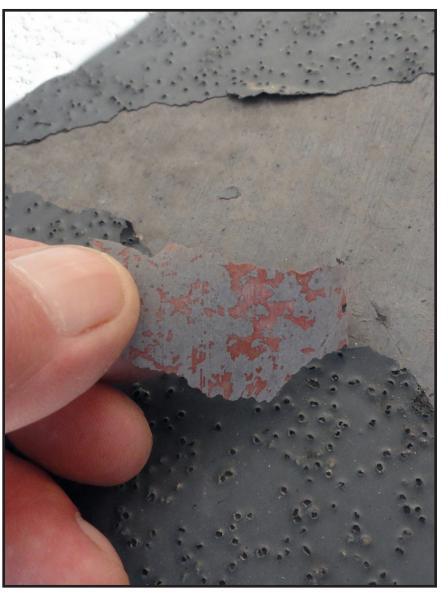
Delamination due to moisture

Delamination due to incompatible materials

Delamination due to improper surface preparation

- Improper Surface Profile: Surface was not shot-blasted or abraded prior to applying membrane, or the base coat was applied over epoxy primer after the 24-hour window.
- Contamination from Moisture: There was dew or other moisture on the surface that was coated.
- Contamination from Dust, Dirt, Etc.: Coating over contaminated surfaces will lead to coating failures such as loss of bond.
- Incompatible Materials: Materials that are incompatible with the coating will cause many issues including delamination.
- Thin Topcoat Application: A final topcoat applied too thin may delaminate and peel from the coating system.

- 1. Remove all loosely bonded material.
- 2. If substrate is exposed, abrasion may be necessary.
- 3. Clean repair area.
- 4. Re-apply material as specified and per Neogard recommendations.

- Improper Surface Profile: Substrate should be shot-blasted or abraded and cleaned prior to application
  of primer. Shot-blast surface ICRI CSP3 to CSP4 to remove contamination or laitance, and for optimal
  bonding. Base coat must be applied within 24 hours of primer application. If base coat cannot be
  applied within 24 hours, clean and re-apply primer.
- Contamination: Ensure deck is clean and dry prior to application of material.
- Incompatible Materials: Perform field adhesion test prior to application of the coating when installing coating over existing coating system. See the Field Adhesion Testing section of this guide.
- Apply coating at specified rates and per Neogard recommendations.

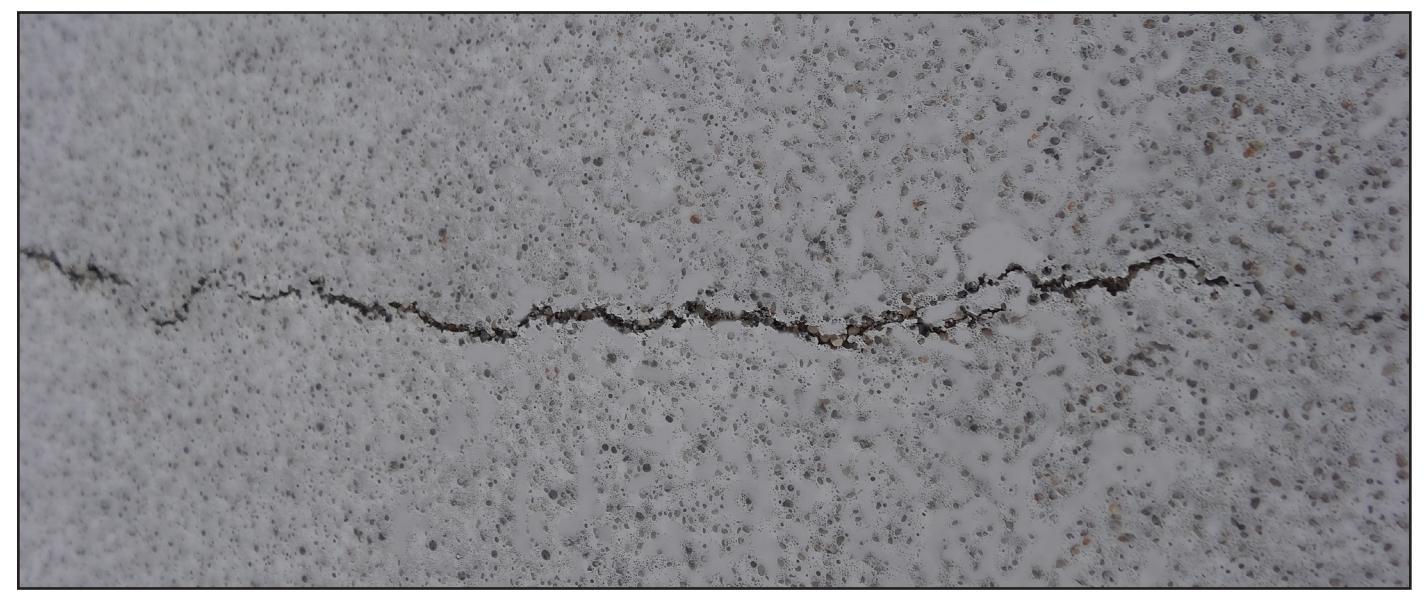
### Cracks

Cracks in concrete substrate may telegraph through the coating and become clearly visible. Over time, these cracks may increase in number as well as in size.

- Settling: Substrate cracks are caused by shifting and settling of the structure after original construction.
- Expansion/Contraction: Concrete structures continually experience expansion and contraction driven by temperature, moisture and load. All cracks should receive detail treatment prior to application of the base coat.

- 1. Route cracks.
- 2. Fill with Neogard 70991 polyurethane sealant and strike flush. Allow sealant to fully cure.
- 3. Clean repair area with Neogard 8500 BioDegradable Cleaner or solvent wipe. Extend cleaning 6"–8" beyond the affected area.
- 4. Prime any exposed concrete.
- 5. Install a detail coat of base coat material extended to a minimum of 2" on either side of the crack to yield a thickness of 30 dry mils. Allow to cure and then apply required system.
  - Optional: Apply base coat material extended to a minimum of 3" on either side of the crack at 30 dry mils and embed reinforcing fabric into wet coating. Center fabric over urethane sealant and allow to fully cure. Apply additional base coat material as necessary to fully encapsulate reinforcing fabric. Allow detail coats to cure, then apply required system.

- Prior to application of the coating system, perform proper surface preparation including crack detail:
- Hairline cracks below 1/16" should receive a 30 mil detail coat utilizing base coat material, a minimum of 2" on either side of crack.
- Large cracks above 1/16" should be routed and filled with Neogard 70991 polyurethane sealant. After sealant is fully cured, apply a 30 mil detail coat utilizing base coat material extended to a minimum of 2" on either side of the crack. Reinforcing fabric is optional.

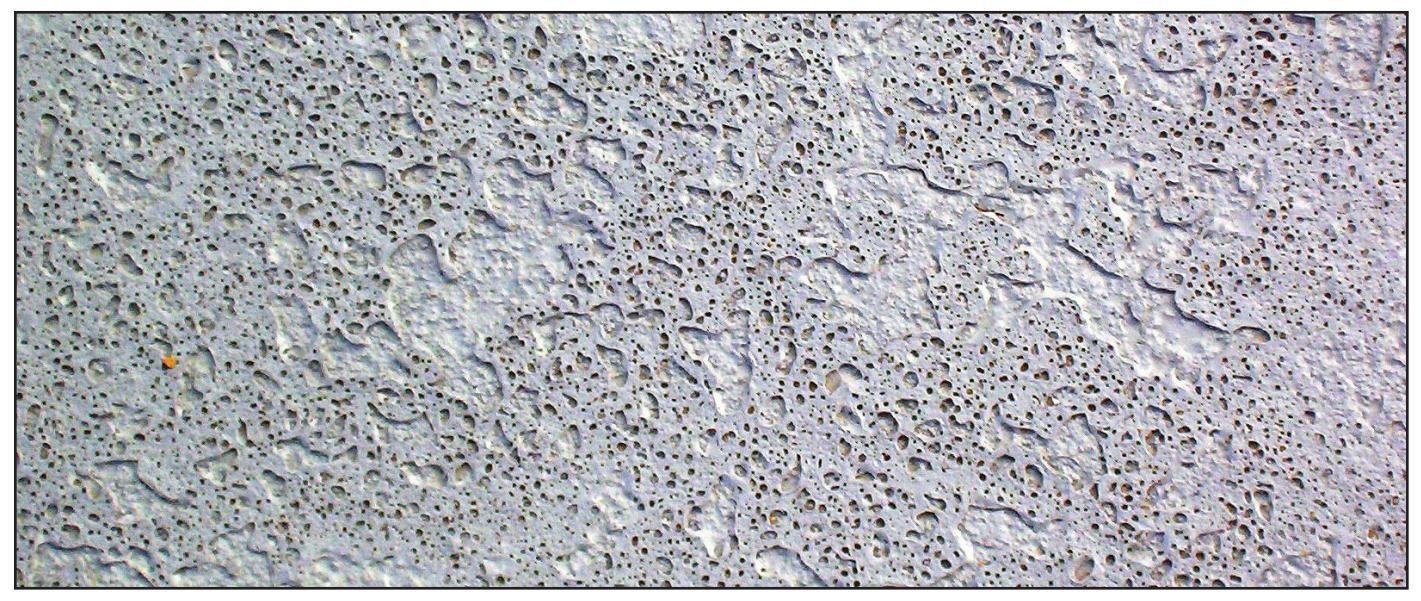
### Water Damage To Uncured Coating

Surface has areas of sponge-like, cratered patterns where water has come in contact with uncured coating.

Heavy rain, sprinklers or other water source caused damage to uncured coating.

- 1. Grind all affected areas to eliminate ridges in the cratered areas.
- 2. Clean and allow to completely dry.
- 3. Re-apply coating as specified and according to Neogard recommendations.
- 4. In severe situations, the coating may have to be totally removed prior to re-coating.

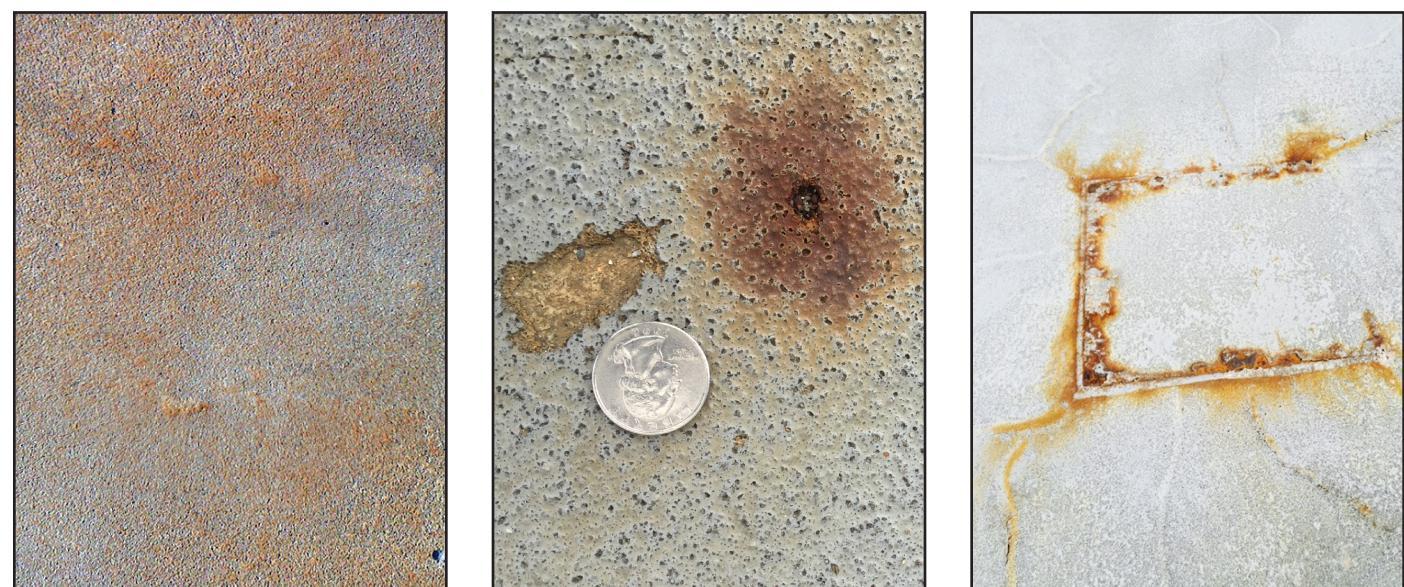
# **Rust/Metal Contamination**

There are rusty, reddish-brown stains in the coating. The presence of rust can be purely aesthetic, or it may indicate a condition which affects the integrity of the coating system.

- Shotblast Beads: Rust stains develop when shot-blast beads utilized during surface preparation are not properly removed. Rust stains will bleed through the entire system if metal is not removed prior to applying the coating system.
- Metal in Aggregate: Rust may also develop from metal fines contained in the aggregate.
- Rebar or Mesh: Rust from rebar or mesh too close to the surface can also appear.

If the contamination source is from the surface, power washing along with the use of a rust neutralizer may remove stained area.

- 1. If the contamination source is located in the substrate, remove the coating down to the substrate and abrade the surface to remove all rust.
- 2. Apply Ureprime HS2 or HS4 at a rate of 300 sf/gal to properly prepared area and allow to cure.
- 3. Apply 70714/70715 Series epoxy at a rate of 100 sf/gal (16 WFT/16 DFT).
- 4. Re-apply coating per specifications and Neogard recommendations in the Waterproofing Application Manual.

- Shotblast Beads: Remove all iron and metal residue from the substrate, including cracks and joints.
- Metal in Aggregate: Use Neogard or Neogard-approved aggregates.
- Rebar or Mesh: After the deck is cleaned and shot-blasting completed, inspect for rebar and/or mesh near the surface. If rebar or mesh is near the surface, it may be necessary for the owner to consult with a structural engineer.

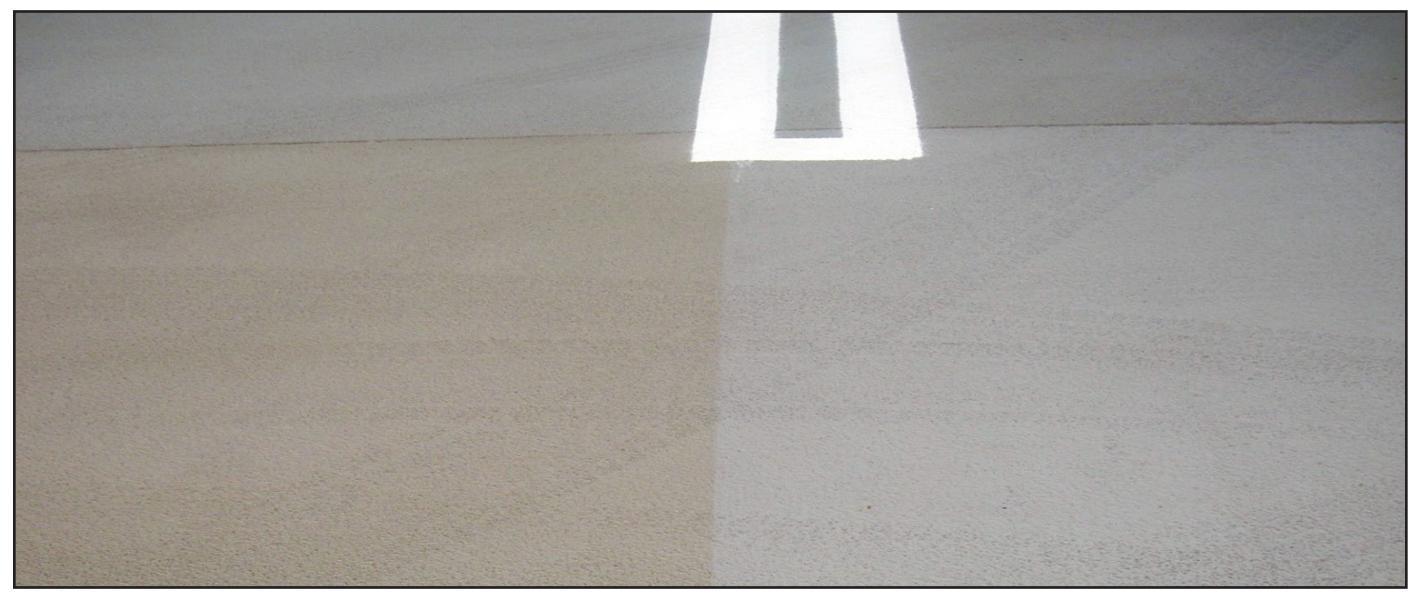
Finished waterproofing surface shows different shades of color. While considered less than aesthetically appealing, this condition does not affect the integrity of the waterproofing system.

- Different Batches of Topcoat: There may be slight shade variation from batch to batch of material.
- Deck Coated at Different Times: Older coating material has weathered and appears different than newer coating material.
- Improper Mixing: Product not mixed sufficiently to disperse pigment. See Product Mixing Instructions in this guide.

- 1. Apply an additional wear coat and topcoat.
- 2. Allow sufficient time for weathering.

- Different Batches of Topcoat: Always purchase or set aside enough topcoat from the same production batch to coat the entire surface area. Use odd batches elsewhere such as in the wear coat if applicable. If there is not enough topcoat of a single batch to complete the project, "boxing" batches is an alternative. Boxing is the process of combining all the coating you will be using as the topcoat into one large container. This is especially important when coating a large surface area or if there is insufficient coating from a single batch, where a color variation from one batch to another is likely.

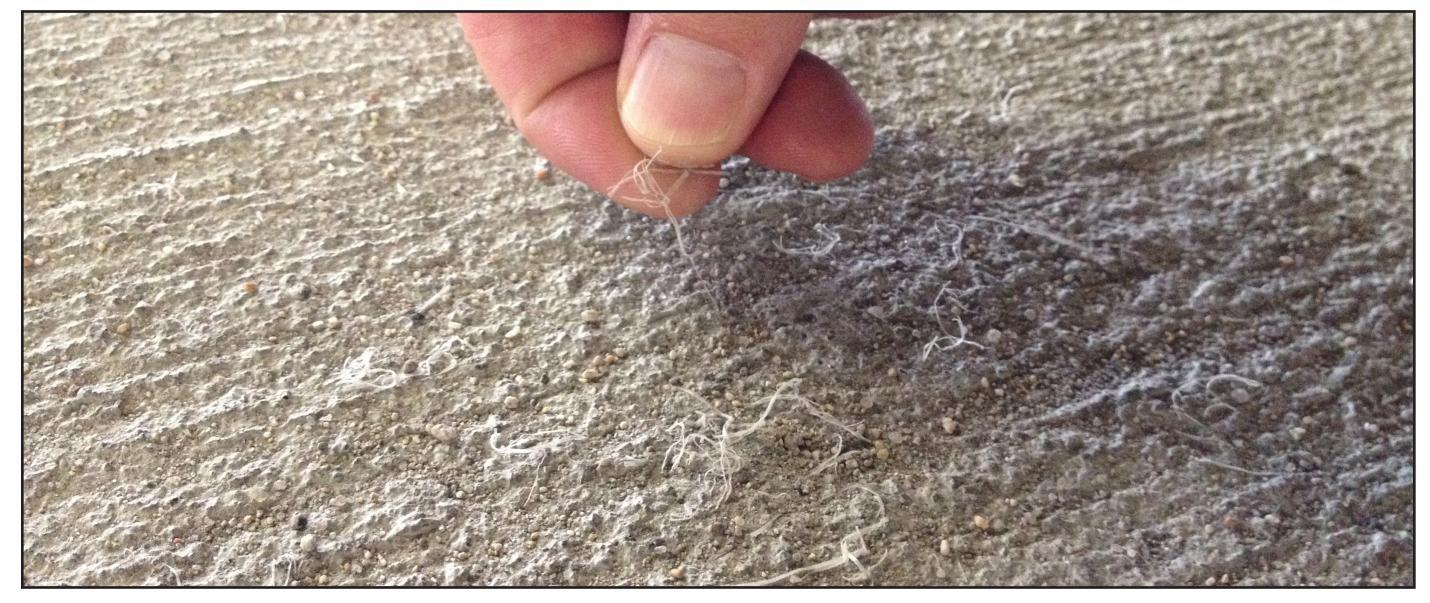
Fibers have been added to the concrete mix to control shrinkage cracks and to improve other physical properties. These fibers will protrude and breach the coating system and may cause future leaks.

Fibers added to the concrete mix will protrude through the concrete surface.

- 1. Mechanically prepare surface by shot-blasting to industry-standard texture (ICRI CSP3–CSP4) without causing defects to substrate.
- 2. Remove fibers by burning with a propane torch.
- 3. Remove any remaining residue prior to coating application.

It is not recommended to use fibers in the concrete mix when a coating is to be applied. If fibers are present, remove them before applying coating.

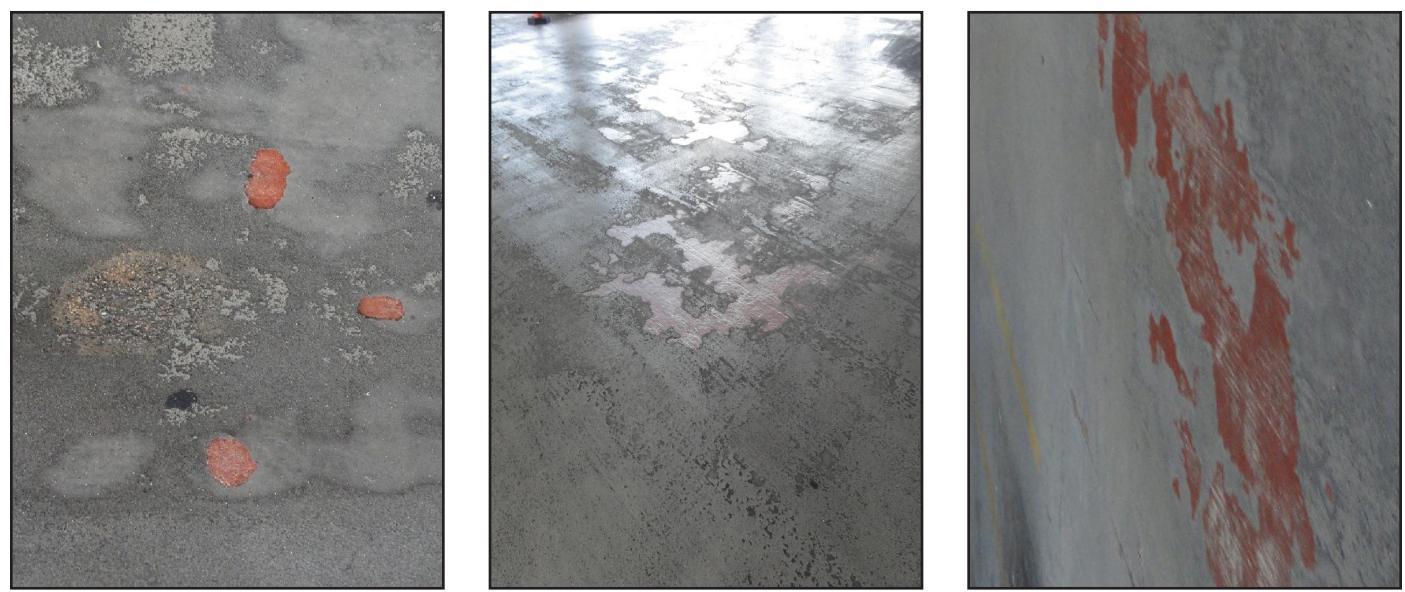
### **Excessive Wear**

Coating is worn, exposing primer and bare concrete.

- Inappropriate Application: Excess aggregate in wear coat and insufficient topcoat material led to premature wear.
- Wrong System Specified: Applied system not designed for heavy duty areas such as drive lanes, turns, ticket splitters, etc.
- Moisture Contamination: Premature wear due to moisture contamination during application.
- Improper Mixing: Failure to mix components properly prior to installation, scraping unmixed material from walls of buckets, insufficient mixing time for proper dispersion, or a contaminated mixing paddle, resulting in off-ratio components and poor physical properties.

- 1. Remove all loosely bonded material. In areas where primer is exposed, grind to expose substrate.
- 2. Clean repair area with Neogard 8500 BioDegradable Cleaner and solvent wipe.
- 3. Reapply coating as specified and according to Neogard recommendations.

- Inappropriate Application: Apply system as recommended by Neogard; include heavy duty application in designated areas.
- Wrong System Specified: Ensure that the appropriate system is specified for existing project conditions and use.

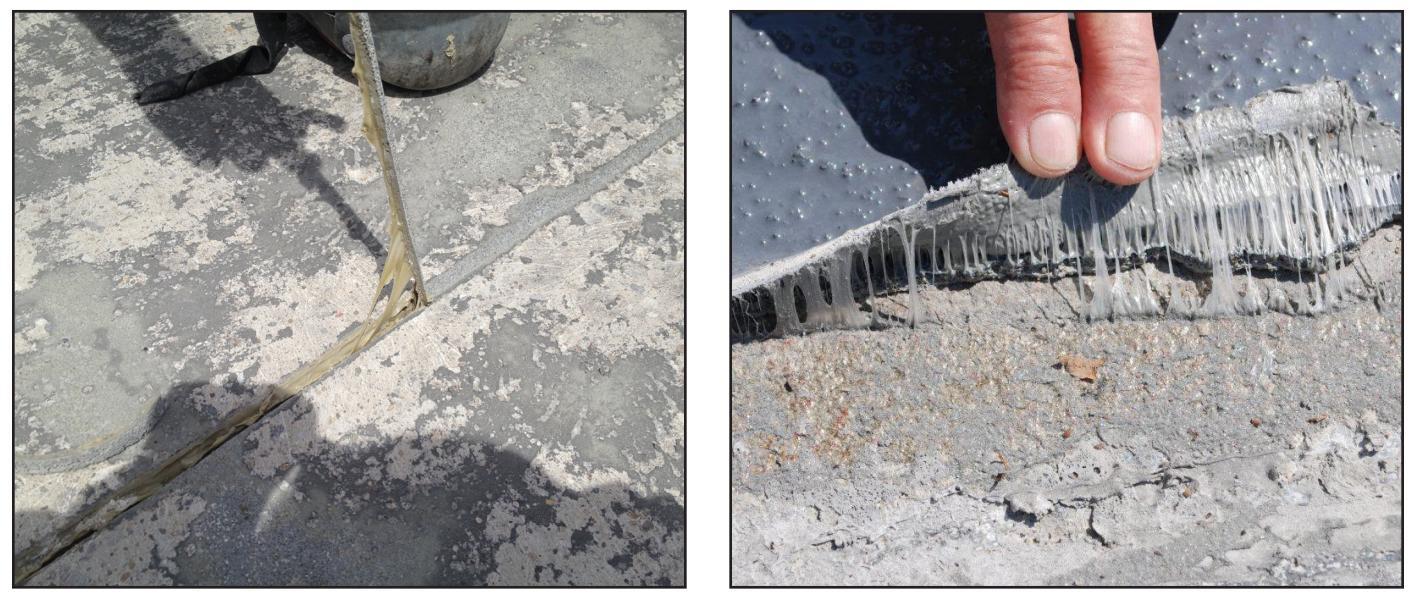
# **Delamination Caused By Sealant**

Coating delamination has occurred due to off-ratio, uncured sealant.

Two-component sealant was improperly mixed or was contaminated.

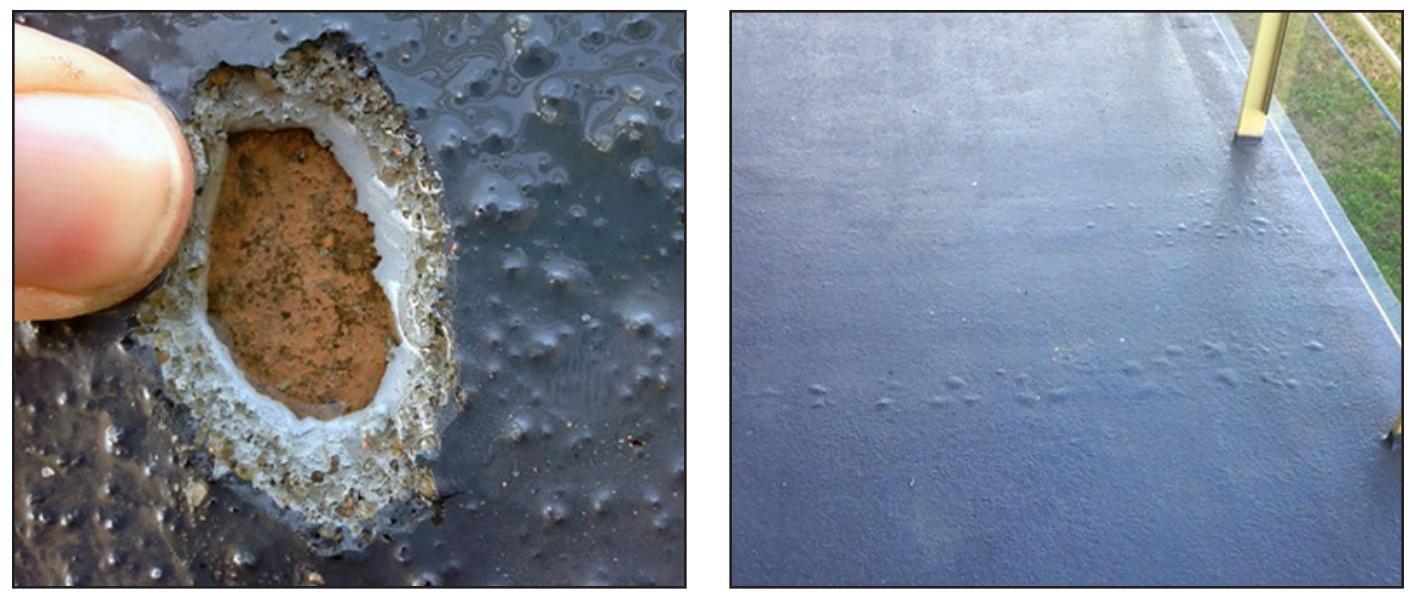
### **Blisters Caused By Trapped Moisture**

The coating system fails due to delamination caused by moisture migration in the concrete substrate.

Trapped excess moisture in or below the concrete substrate.

- 1. Identify the source of the moisture.
- 2. Remove coating in affected areas down to clean substrate.
- 3. Re-apply coating as specified and according to Neogard recommendations.

- Moisture Contamination: Ensure that the deck is completely dry prior to coating. Moisture may not be readily apparent, particularly if aggregate has been introduced into the system. Monitor the ambient surface temperature for the entire duration of the application process. See Dew Point Chart in the Support Information section of this manual for ambient temperature and relative humidity guidelines.
- Moisture Test: Ensure that the deck is completely dry before coating. Moisture may not be readily
  apparent, particularly if aggregate has been introduced into the system. Conduct a moisture test before
  application to ensure that there is no water contamination.

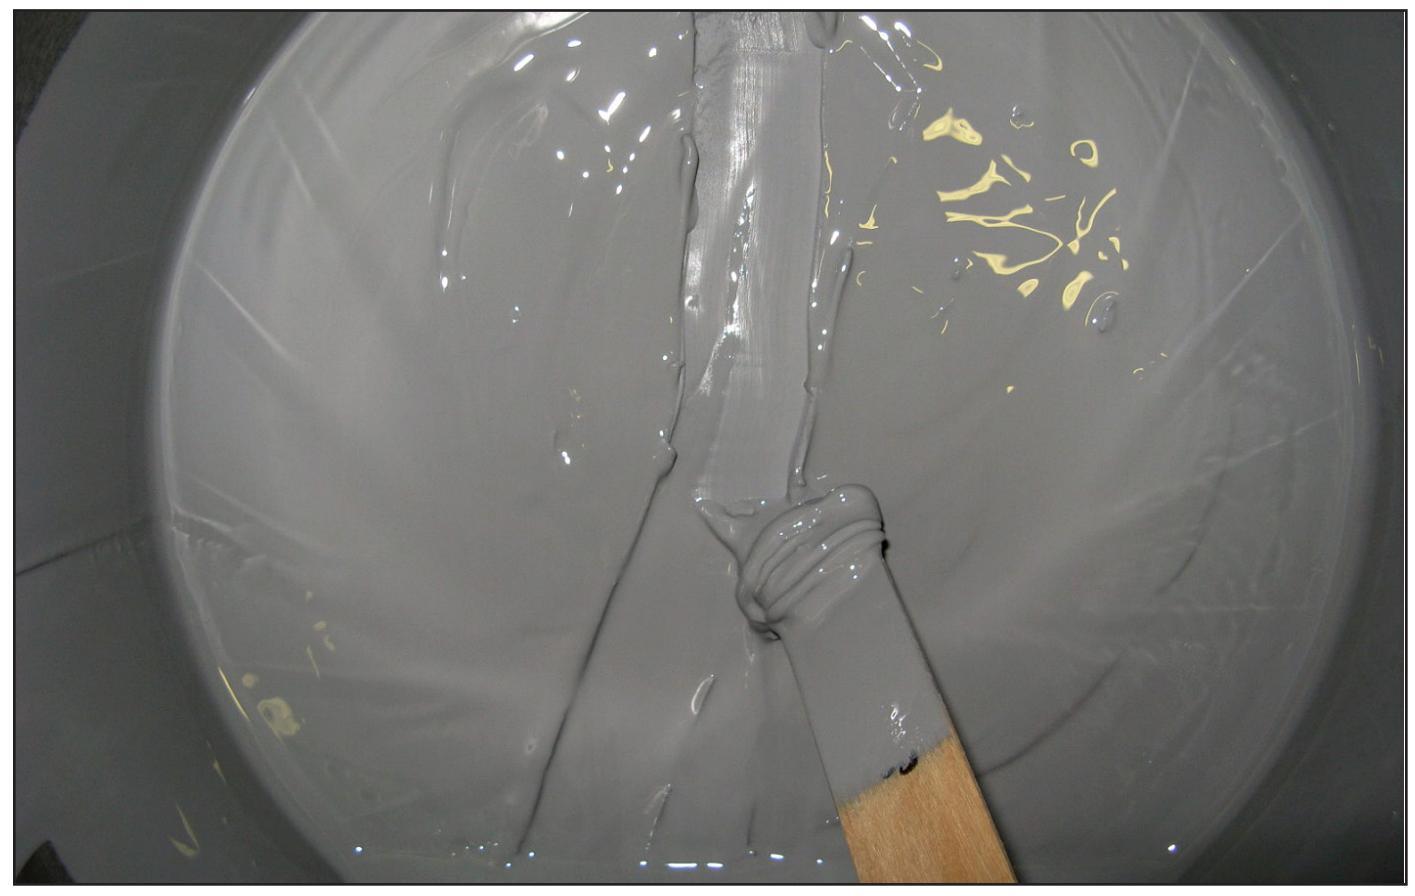
Solid material settles in the bottom of the bucket. This typically occurs in the pigmented/color side of a product.

Some products have a tendency to settle over time.

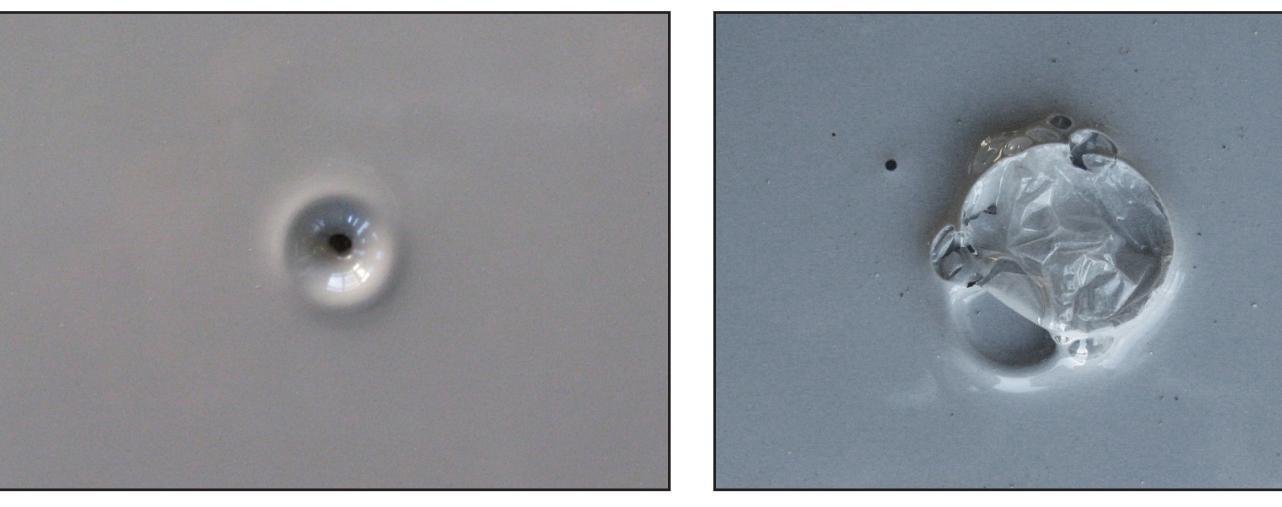
Pinholes appear as tiny blisters or bubbles. When these blisters pop they usually leave a round crater and the pinhole should be easily seen through the film.

- Outgassing: Air escapes from porous concrete and becomes trapped in the coating.
- Air Movement: Excessive air movement from vents, doors, or other sources may cause flash drying and prevent necessary air release from coating.
- Temperature/Humidity: High temperatures or humidity can cause rapid drying, entrapping air in coating.
- Direct Sunlight: Coating exposed to direct sunlight can tack off before releasing air, forming bubbles.
- Improper Mixing: Mixing at high speed and improper mixing procedures may result in entrapped air.
- Roller Covers: Too short or too long of a nap roller can introduce air into the coating.
- Surface Prep: Aggressive shot-blasting or sandblasting will open pores in the concrete, causing air to become trapped when coating is applied.

- Air Movement: Avoid generating fast air movement across the coating. When providing ventilation, always exhaust air rather than blowing with fans.
- Temperature/Humidity: Wait to apply material until temperature and humidity are within the ranges specified in the Product Data Sheets.

- Direct Sunlight: Prevent direct sunlight exposure during initial cure.
- Improper Mixing: Use slow speed mixing equipment with a paddle-type blade. If air is introduced into the material, let stand until air is visibly released.

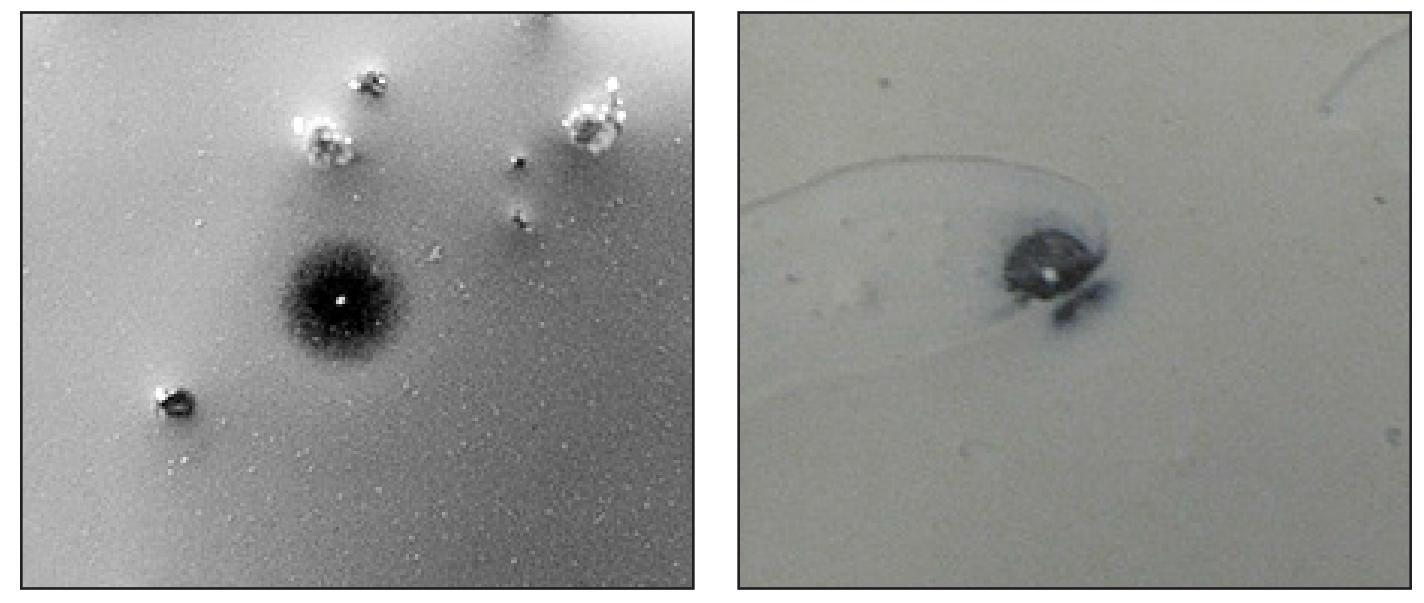
Fish eyes are round indentations or separation in the coating finish. Upon closer examination, they look like a crater with a rim around the perimeter of the defect along with a very small dot in the center.

Silicone Contaminants: Certain manufacturing processes such as welding or spraying can deposit silicones on the floor causing fish eyes to appear.

Oil/Grease Contaminants: Oil or grease contaminants can cause the coating to function improperly and fish eyes to appear.

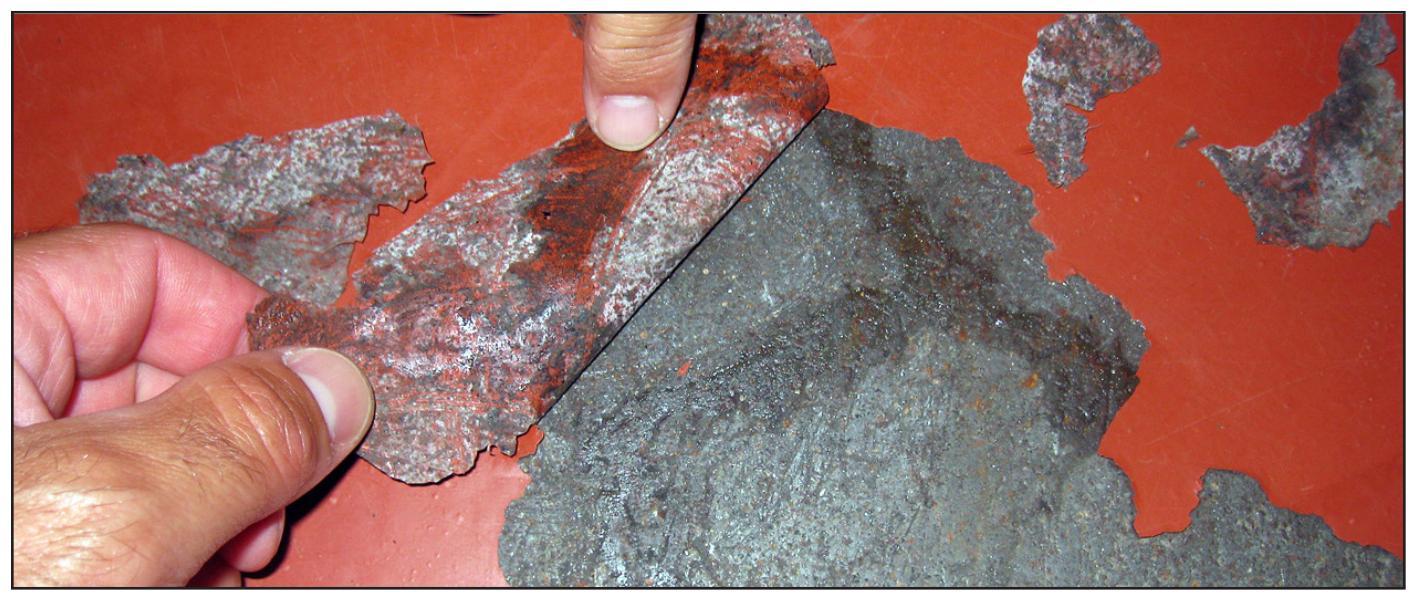
Coating is peeling or de-bonding from the substrate.

- Inadequate Cleaning: Coating will not adhere to oil, grease or other contaminants.
- No Primer Used: Without primer, peeling/delamination may occur.
- Moisture Vapor Transmission: Water vapor penetrating through the substrate can cause peeling/ delamination. After removing delaminated areas, moisture may be visible or the concrete may be dark in appearance.

- 1. Remove any coating that is not tightly bonded by stripping, shot-blasting, or other suitable means.
- 2. Consult Neogard Technical Services if this condition exists.

- Inadequate Cleaning: Properly clean the substrate and provide a suitable profile for adhesion by stripping, shot-blasting, or other suitable means.
- No Primer Used: Use a suitable primer prior to coating the substrate after proper surface preparation.
- Moisture Vapor Transmission:
  - Substrates in contact with ground must have a properly installed, effective vapor barrier to help prevent potential problems resulting from hydrostatic, capillary or moisture vapor pressure.
  - Always perform a calcium chloride test to ASTM standards prior to installation. Test results should yield no more than 3 pounds of moisture per 1,000 square feet per 24 hours.
  - When calcium chloride test results are higher than 3 pounds per 1,000 square feet per 24 hours, consult Neogard Technical Services.

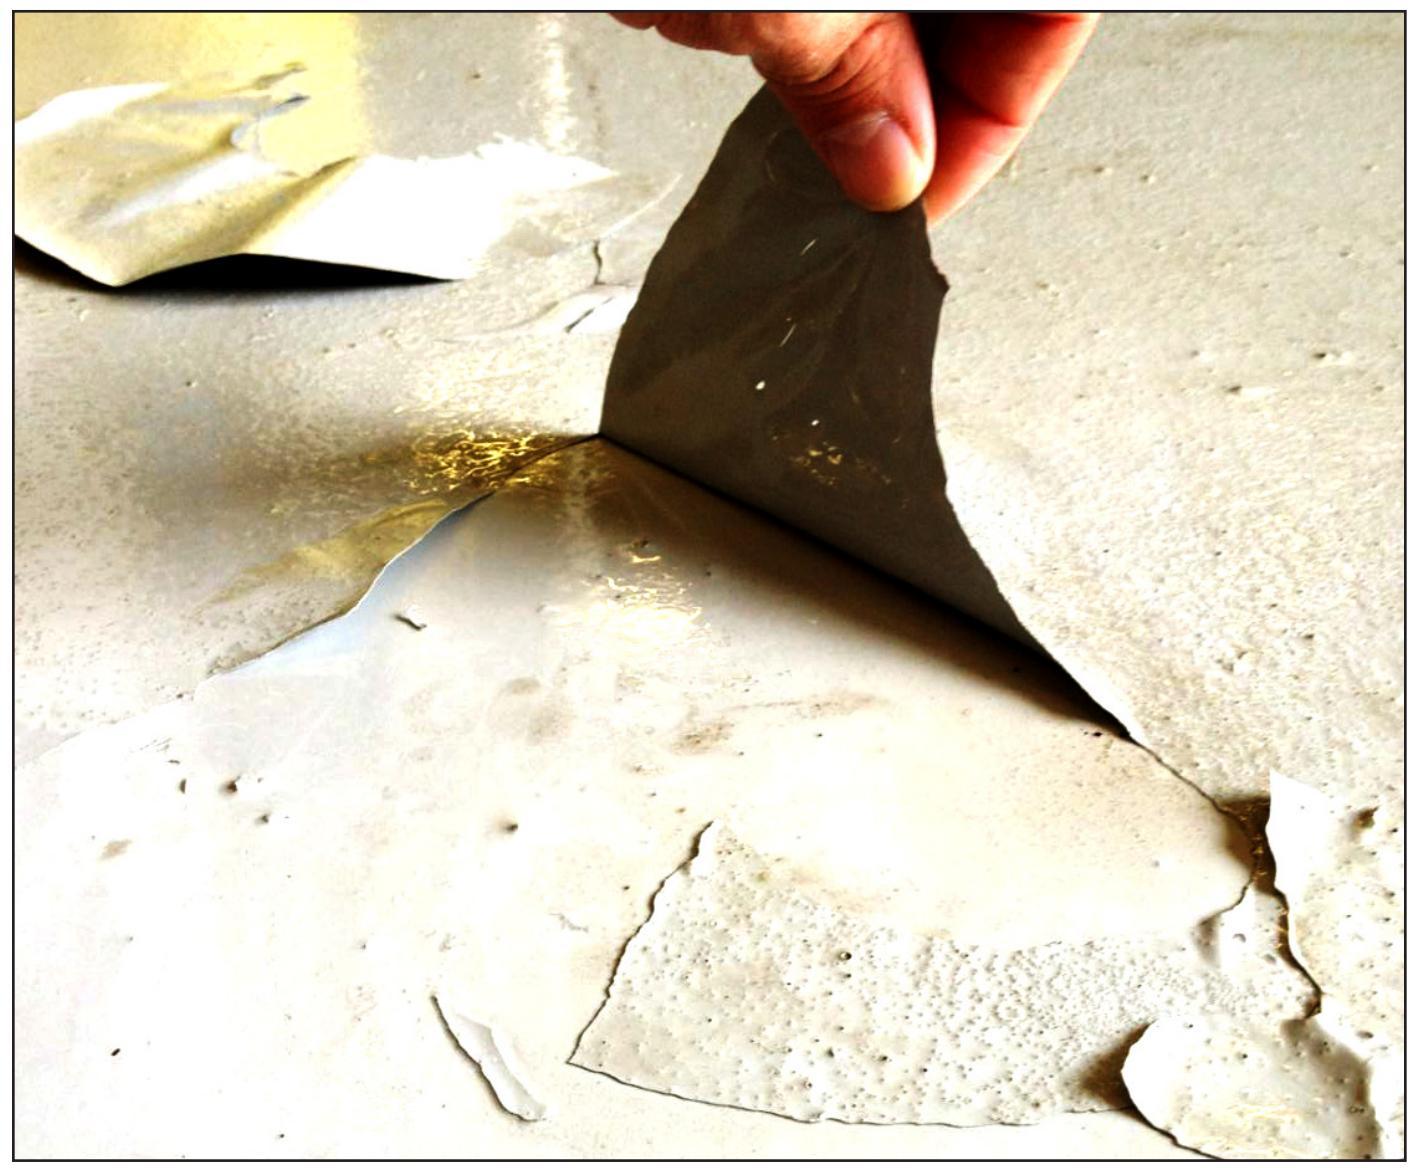
Coating is peeling or de-bonding between layers of coating.

- Beyond Recoat Window: Coating was not applied within 24 hours of previous coat.
- Surface Contamination: Surface was contaminated by water, humidity, oil, grease, or dust.
- Improper Mixing: Coating was not mixed at proper mix ratio, or not mixed for a minimum of 3 minutes.
