# Troubleshooting Guide

Causes, Repair & Prevention

March 2020

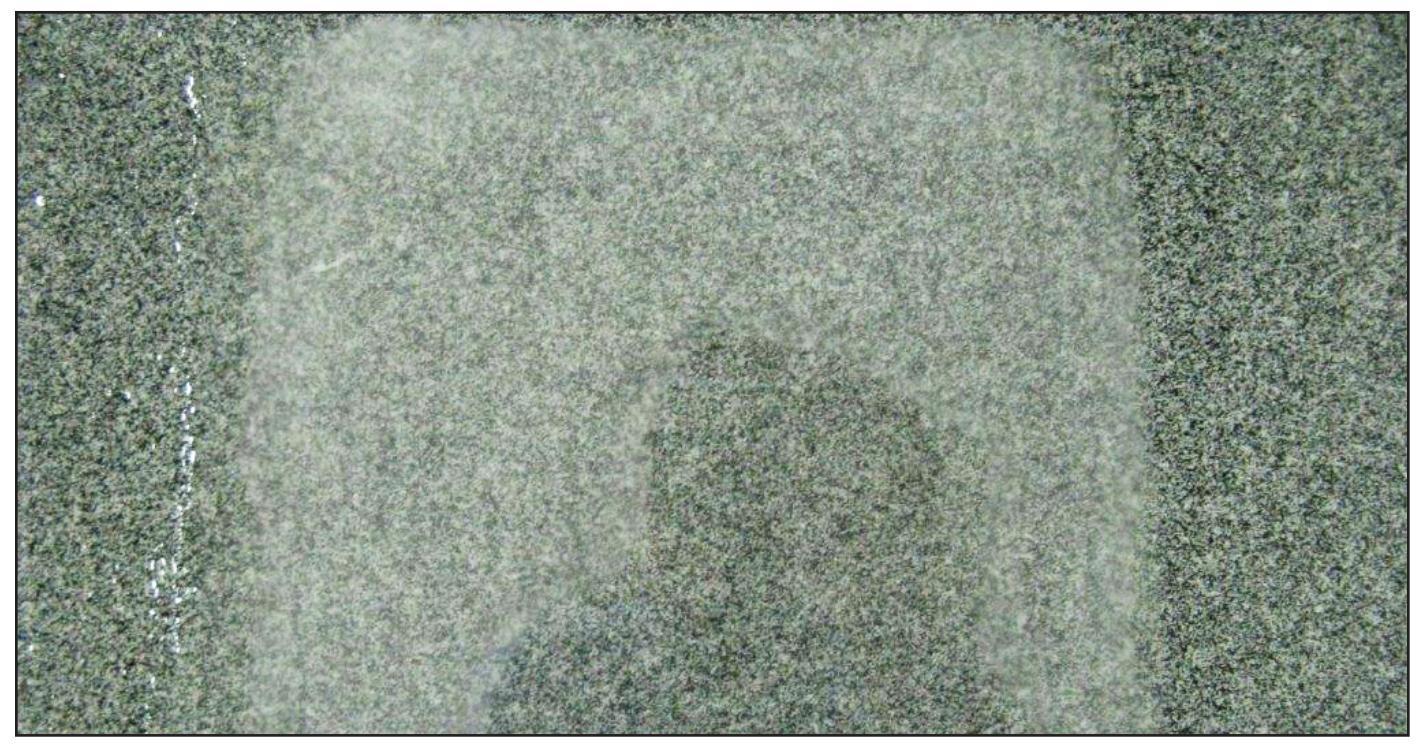
There is a milky or cloudy appearance in wet or cured coating material.

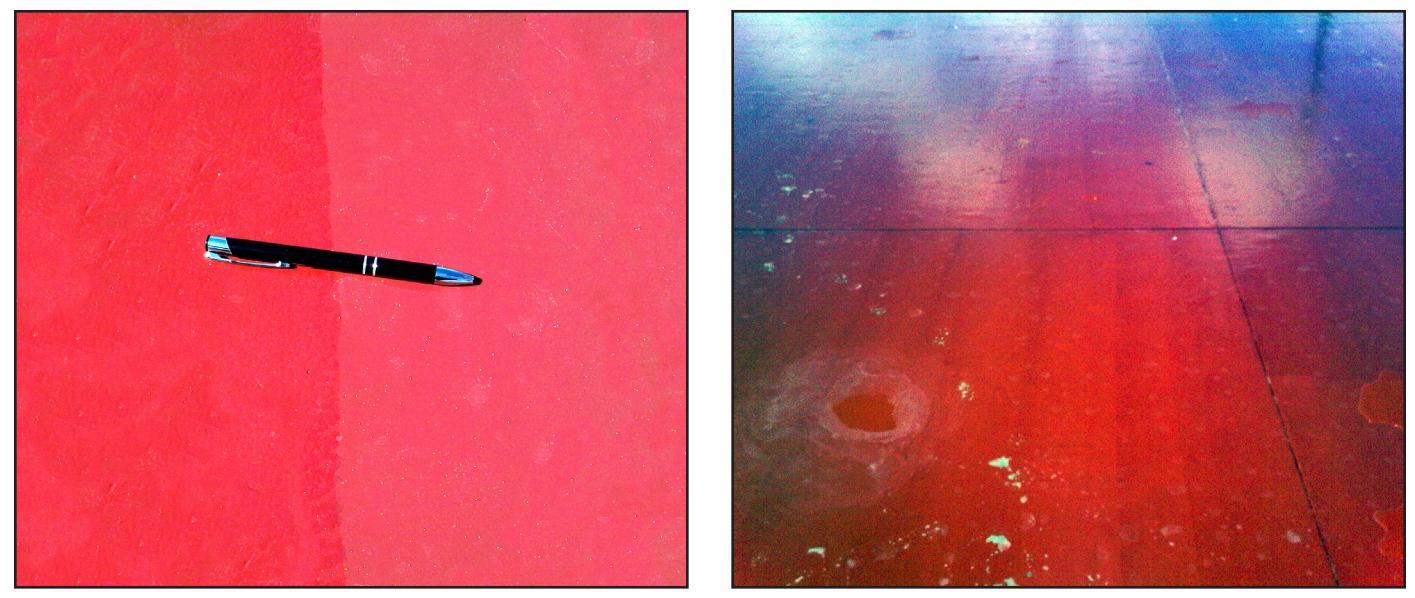
Coated surface has different shades of color.

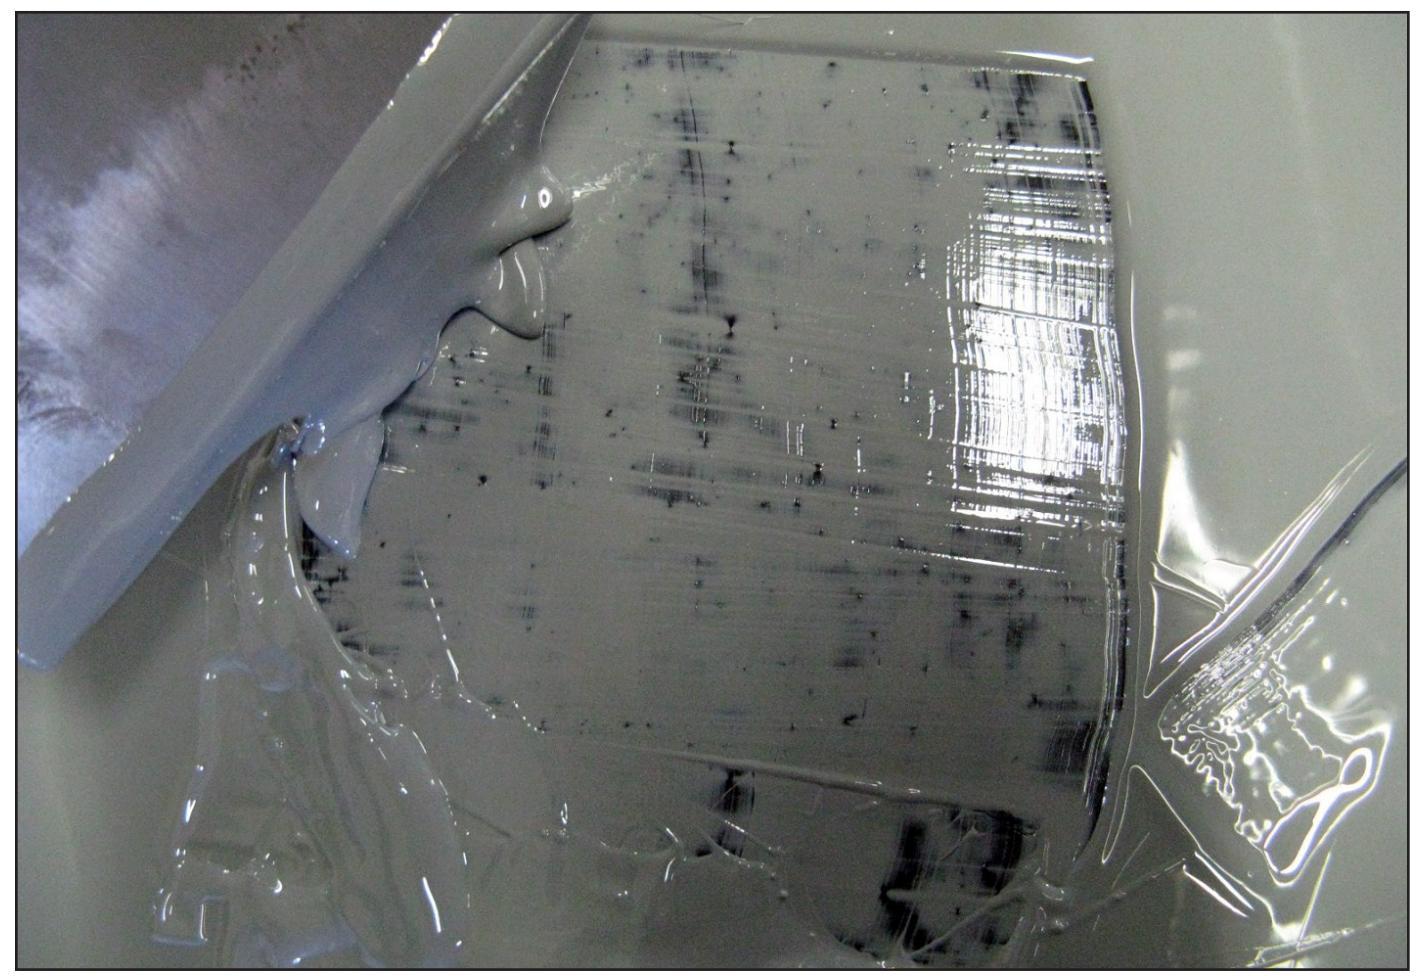
The material does not fully cure or is still soft after 24 hours.

- Improper Mix Ratio
- Improper Mixing
- Cold Materials
- Cold Ambient Temperatures
- Cold Surface Temperatures

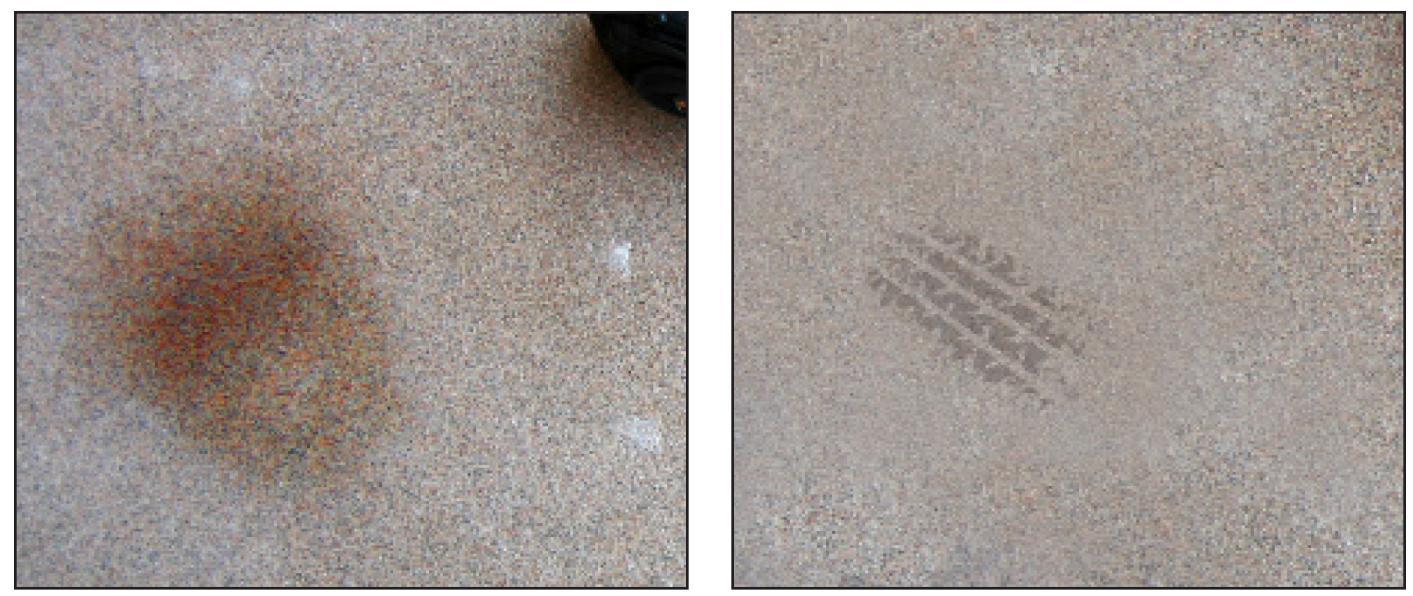
There are dark or discolored spots in the coating system.

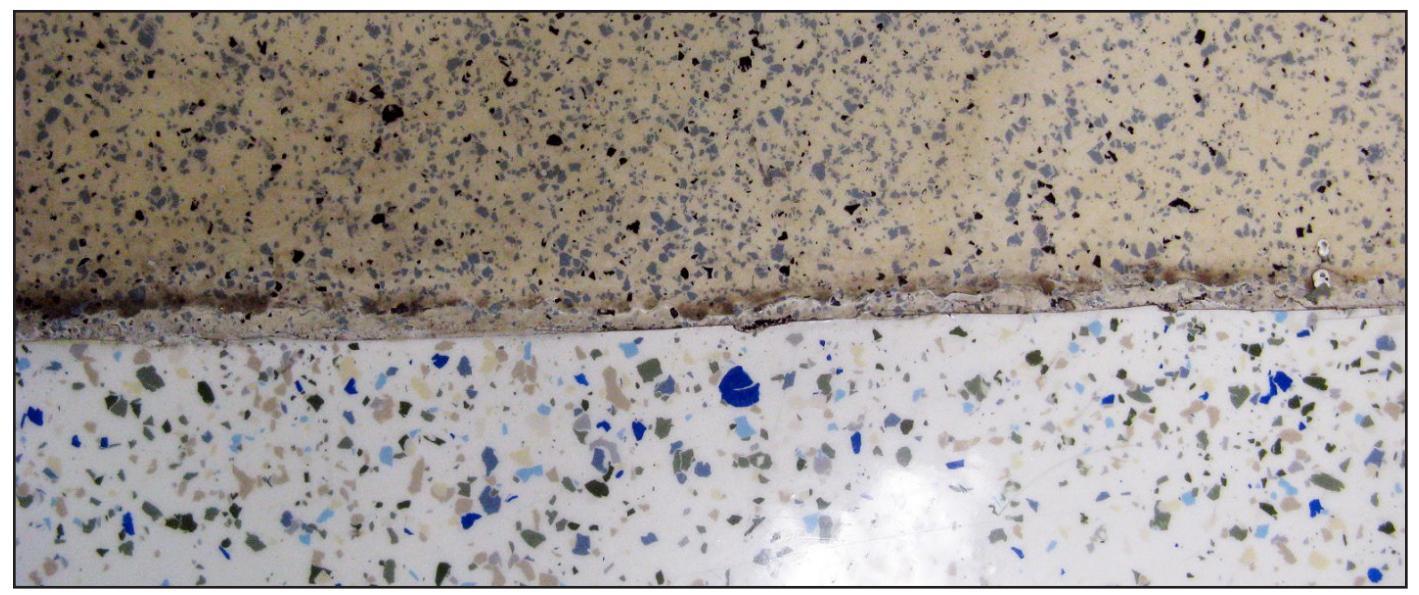
Topcoat has developed a yellow hue. This problem will affect epoxies regardless if the epoxy is clear or not.

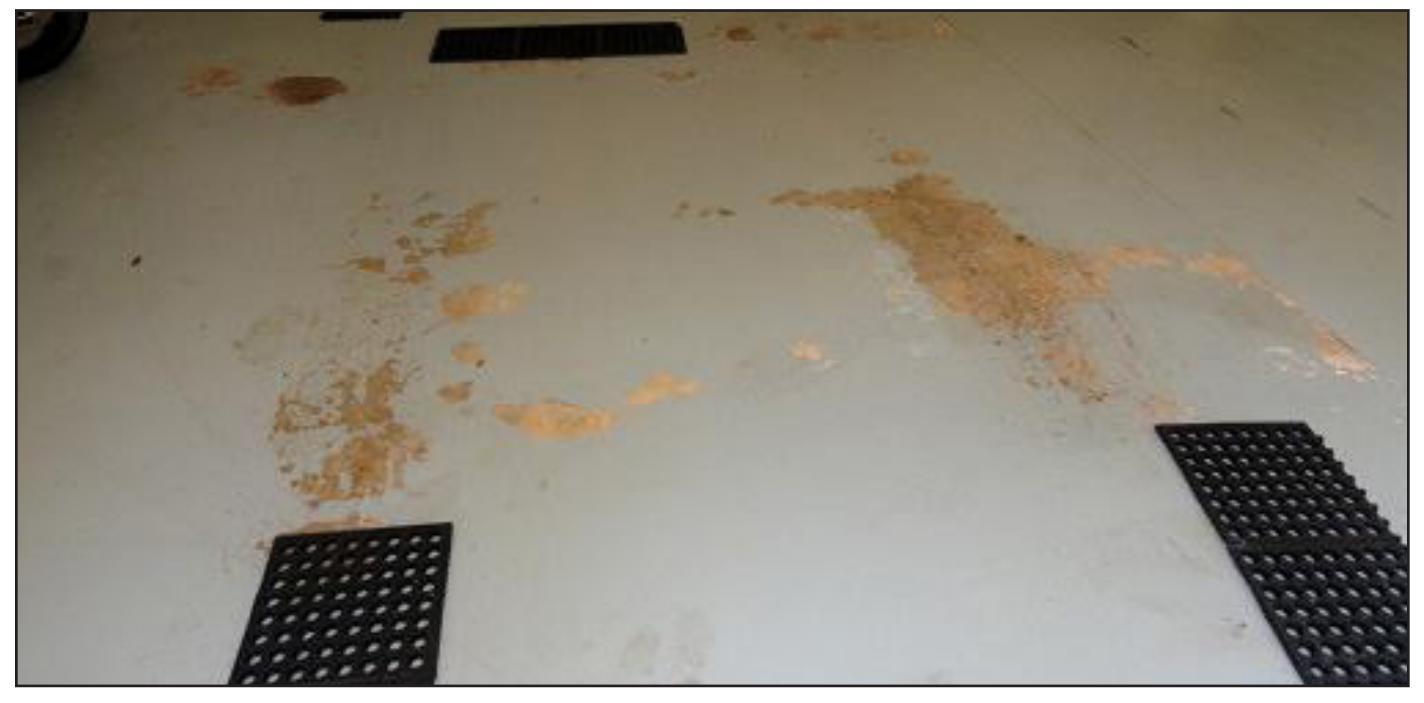
Flooring system is delaminating and peeling in areas where tires are consistently in contact with the coating.

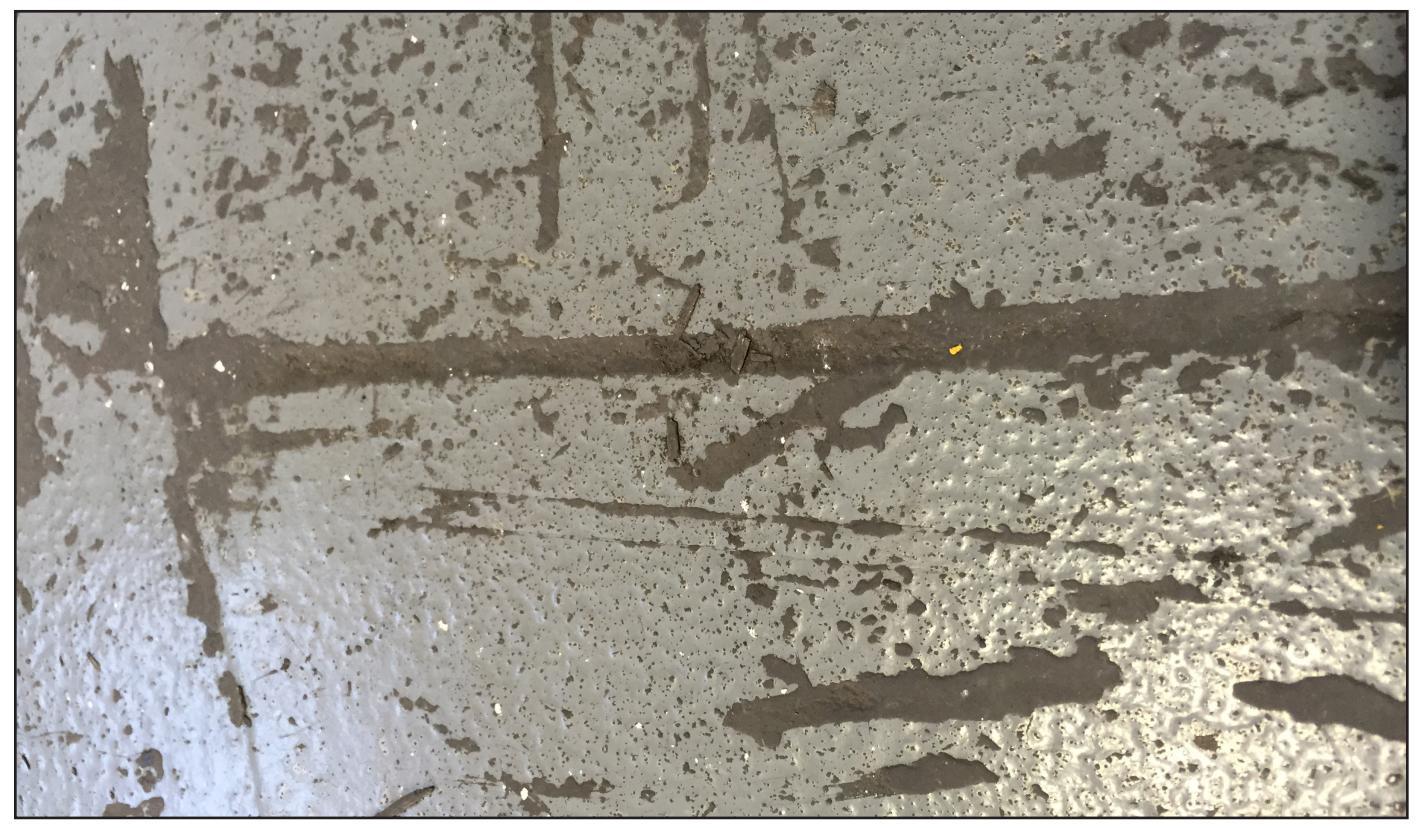
Flooring system has been scratched and/or gouged.

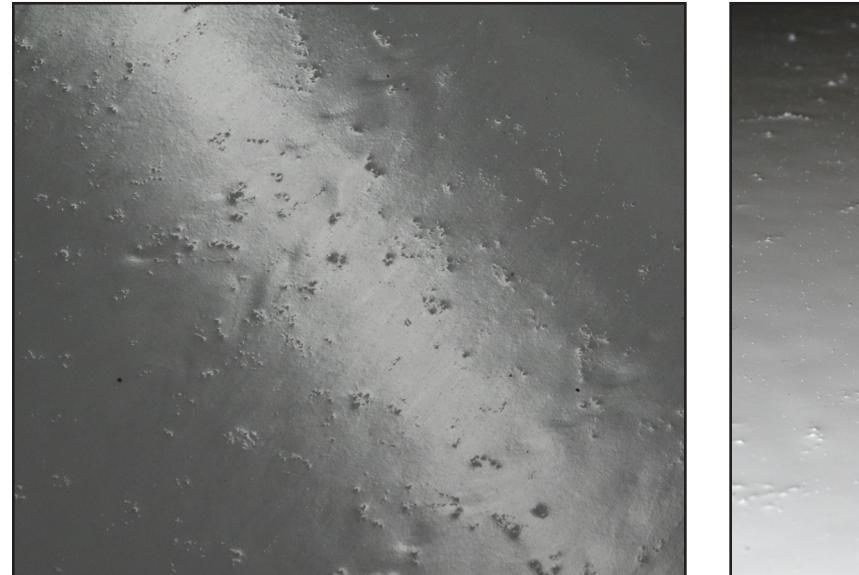
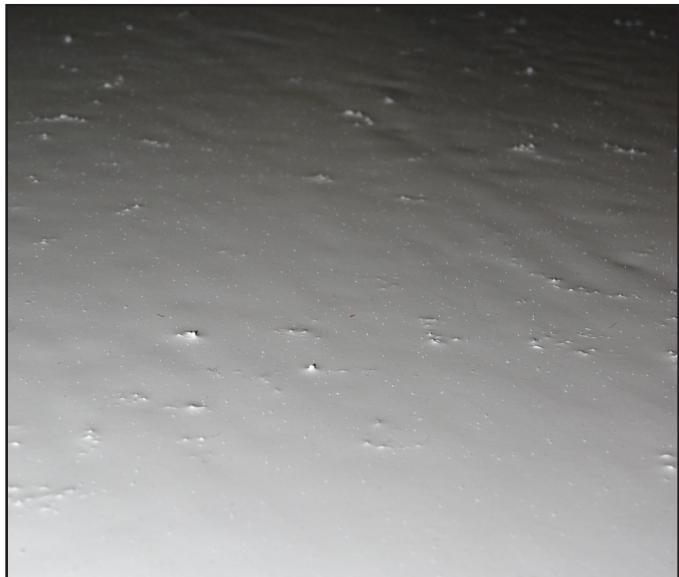
Roller lint is embedded in the coating after application.

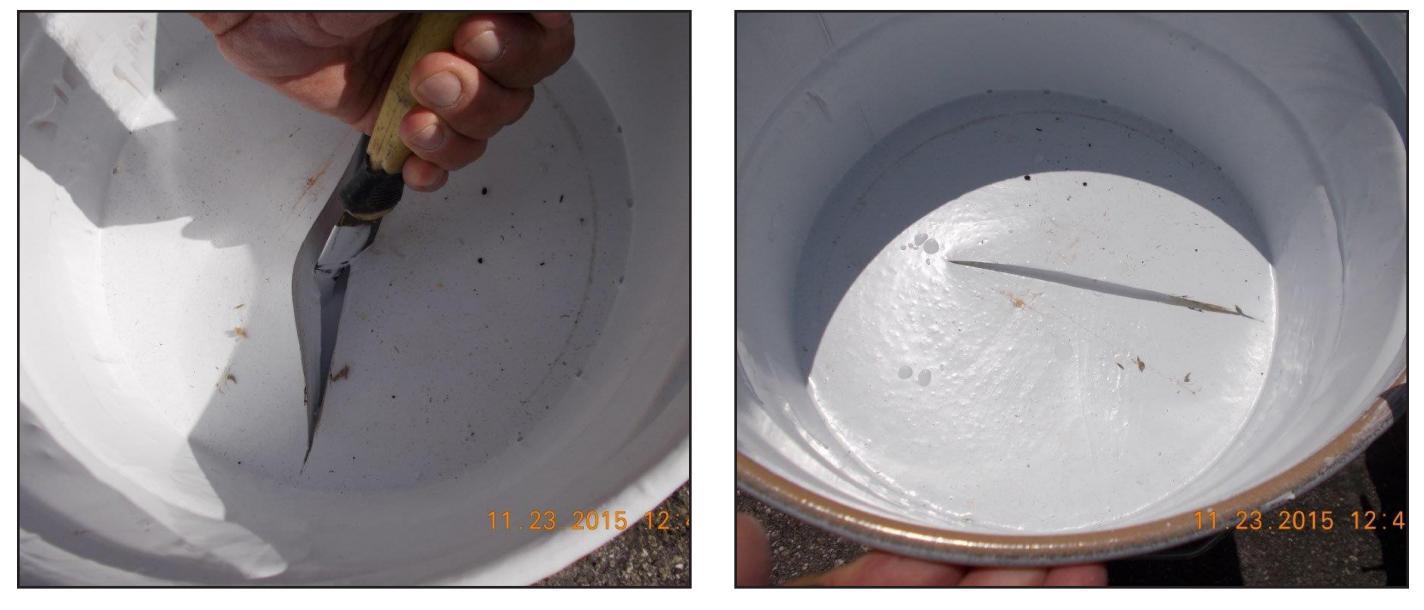
A skin forms on the top of the Material in a pail or barrel.

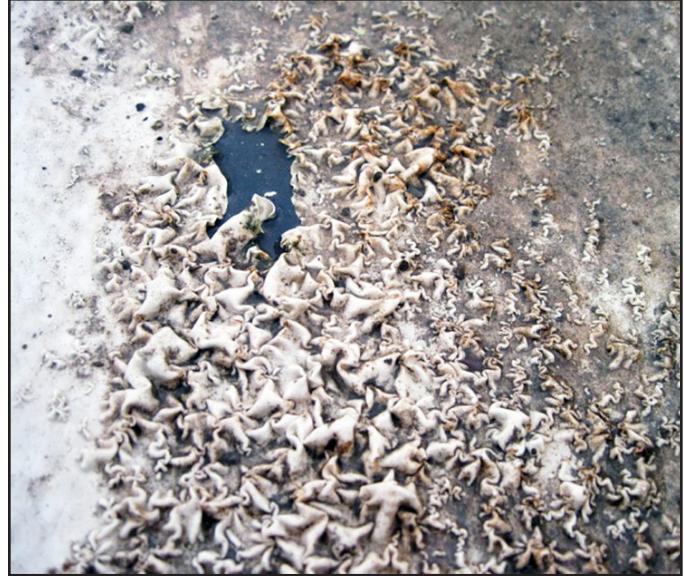
Delamination due to thin topcoat and ponding Delamin

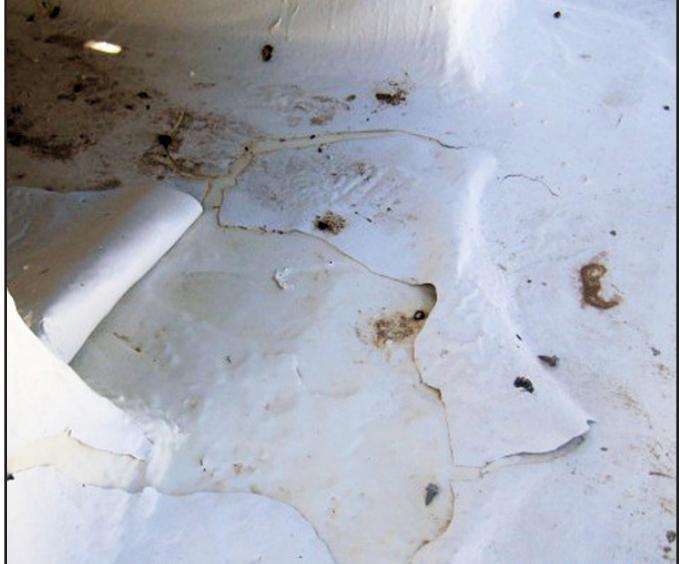
Delamination due to improper cleaning

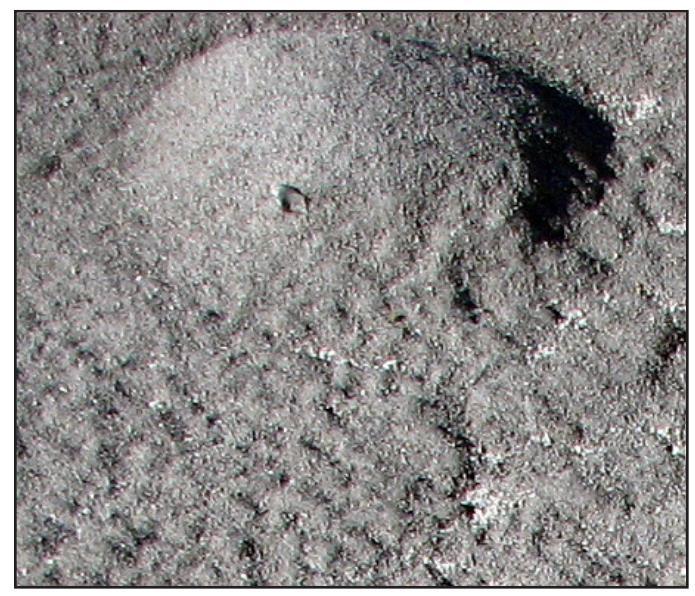
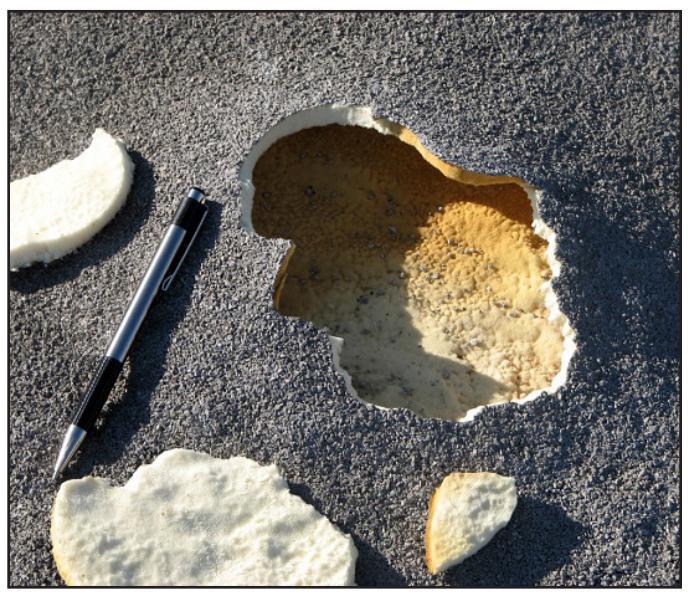
Medium to large bubbles on the surface of the foam. They are typically randomly dispersed.

Typical unopened foam blister

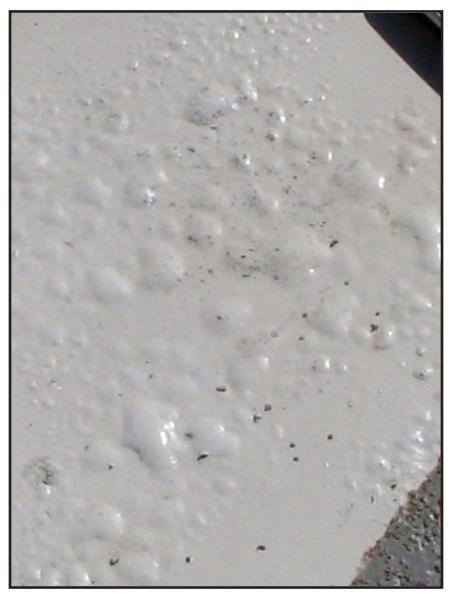
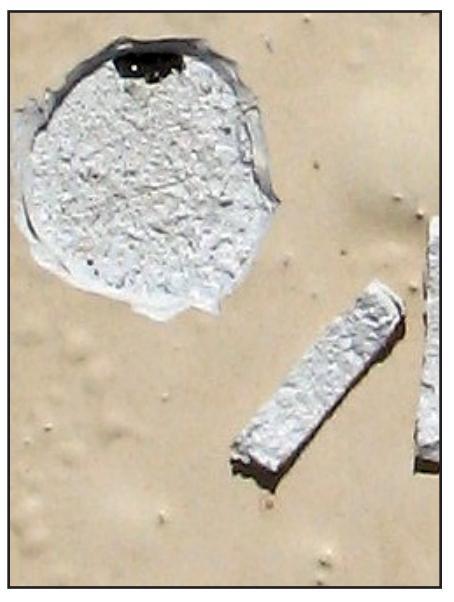
Blister due to contamination

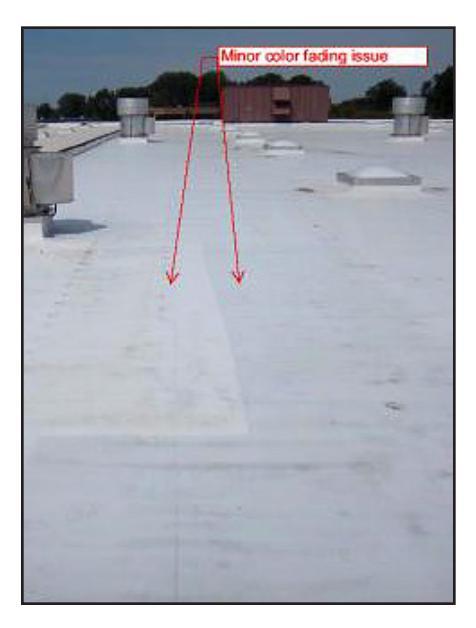
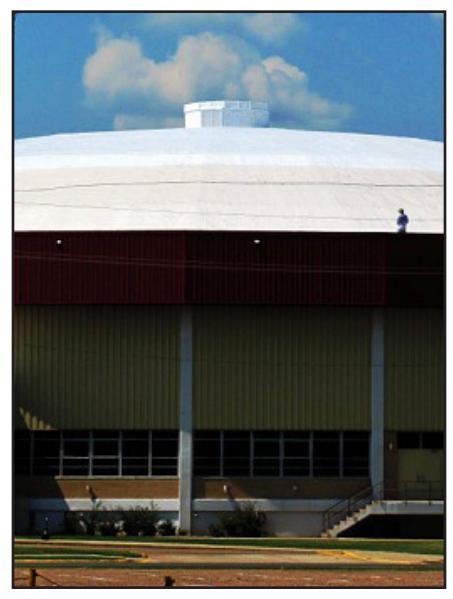
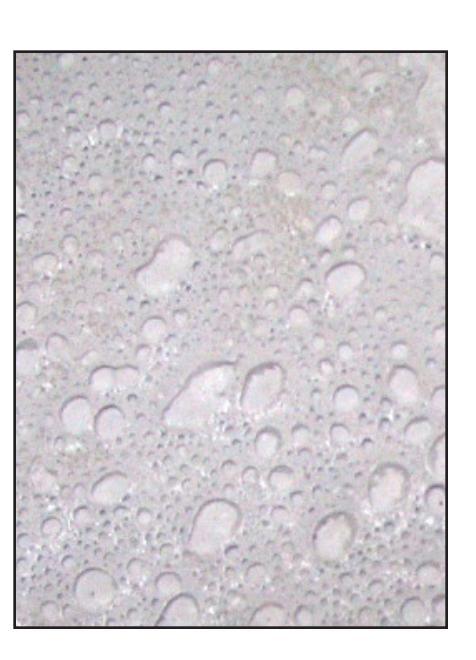
Surface of coating does not cure to a glossy finish and reflect light, which is ideal for a roofing topcoat.

Roof with shade variation

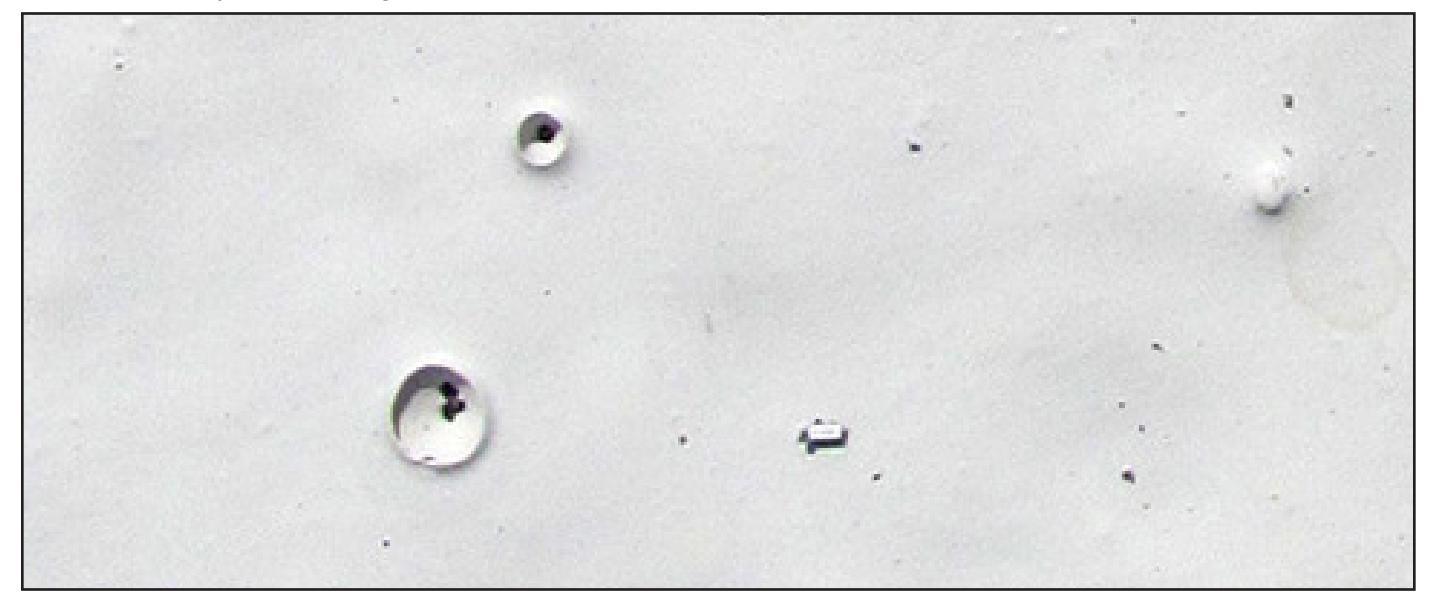
Appear as tiny blisters or bubbles. When these blisters pop they usually leave a round crater. The pinhole should be easily seen through the film. Concrete decks are susceptible to this condition.

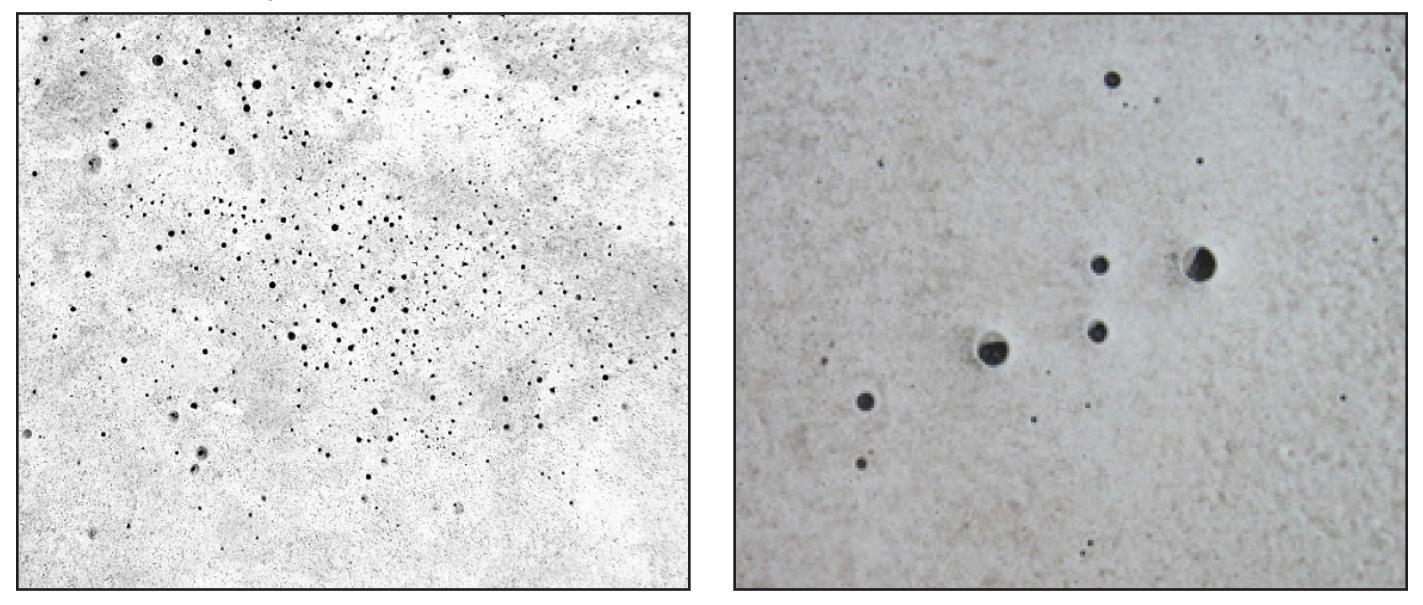
Small voids which penetrate through the coating. A crosscut will show intact base coat material, with the voids contained only in the topcoat.

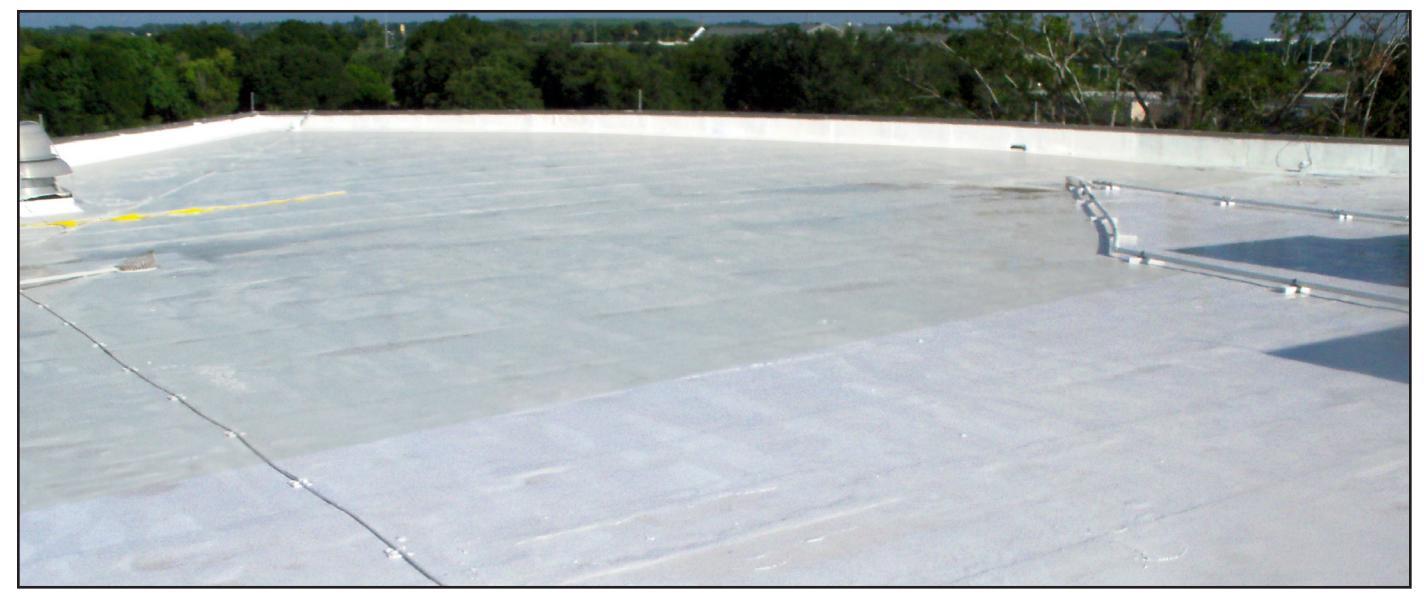
The coating appears to be different shades. This is most often noticeable in white products.

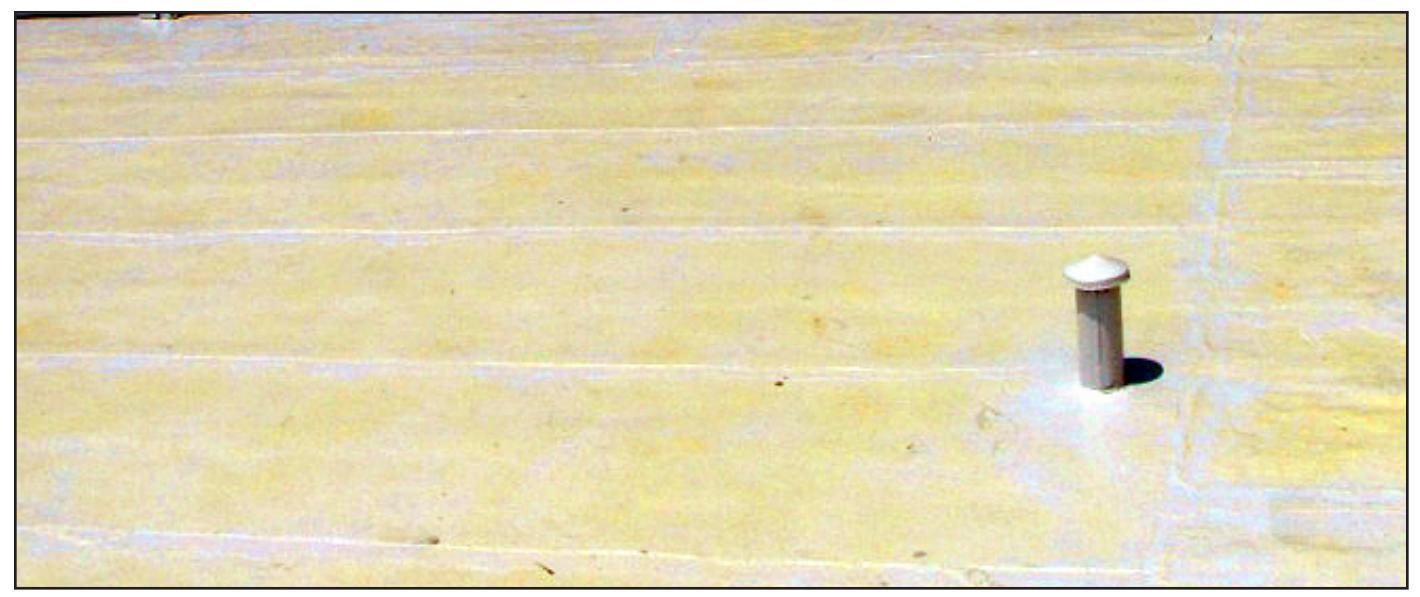
Surface of coating has taken on a yellow hue. Yellowing may be splotchy.

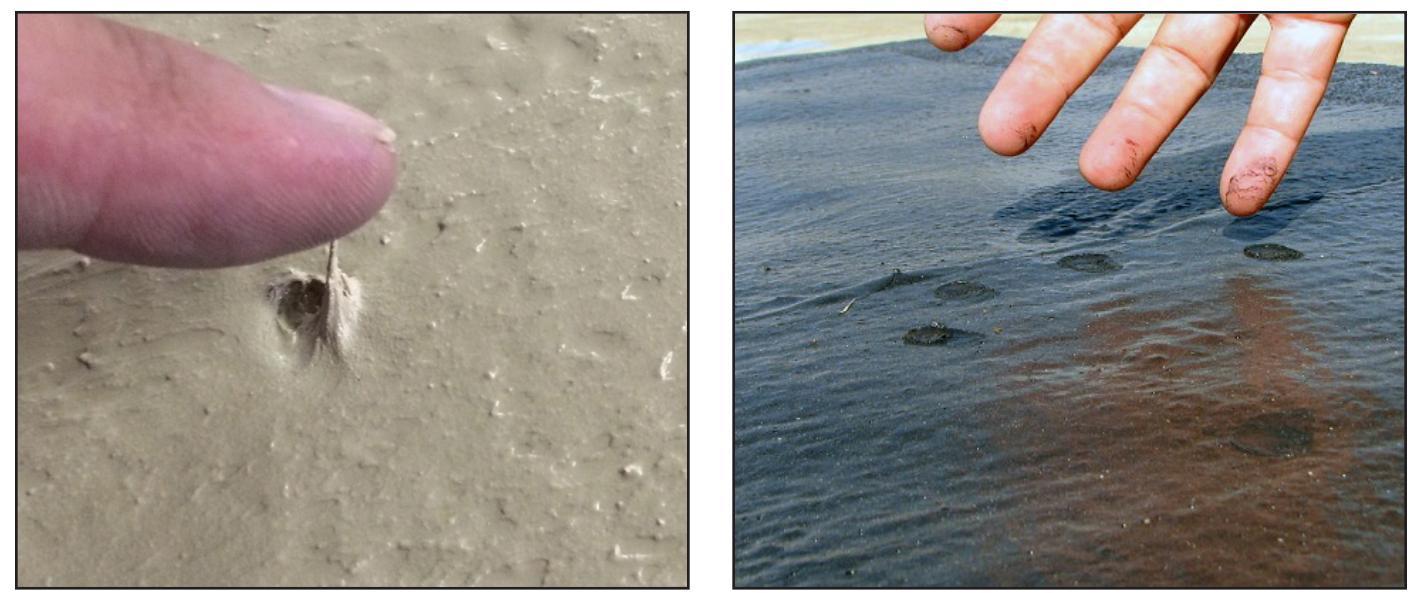
After expected curing time has elapsed, coating is still soft and may transfer when touched.

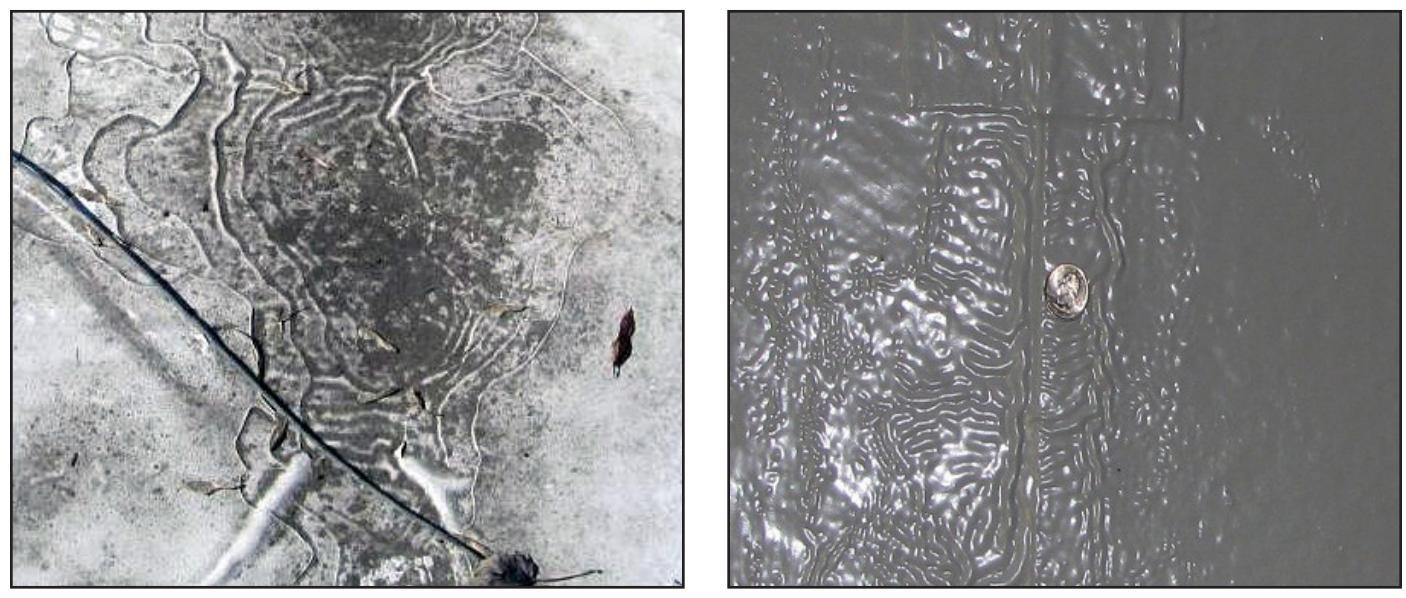
Areas of the coating appear wrinkled.

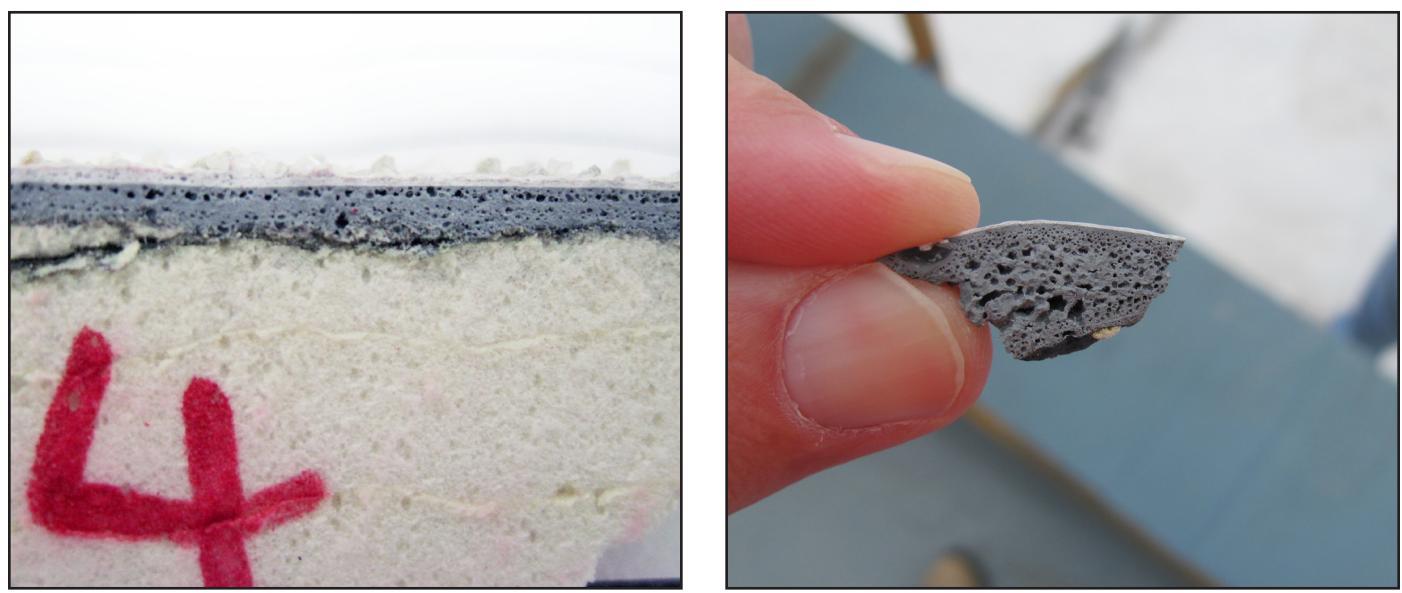
A cross section reveals a large number of open cells in the coating.

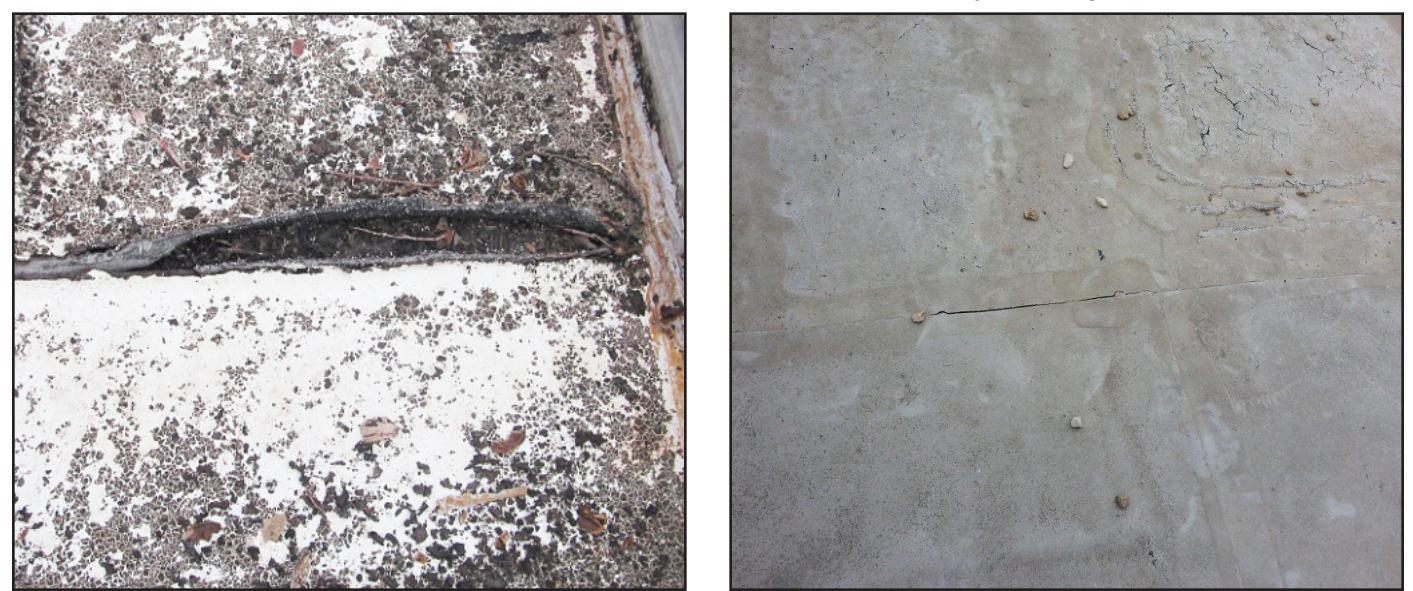
Coatings initially display a crack, transforming into a small blister-type opening. The coating will then form a fish mouth, and finally the sheet will separate and pull back to form a curled edge. Split seams typically occur in modified bitumen and asphalt cap sheets, and are compounded by ponding water.

Curled seam edge

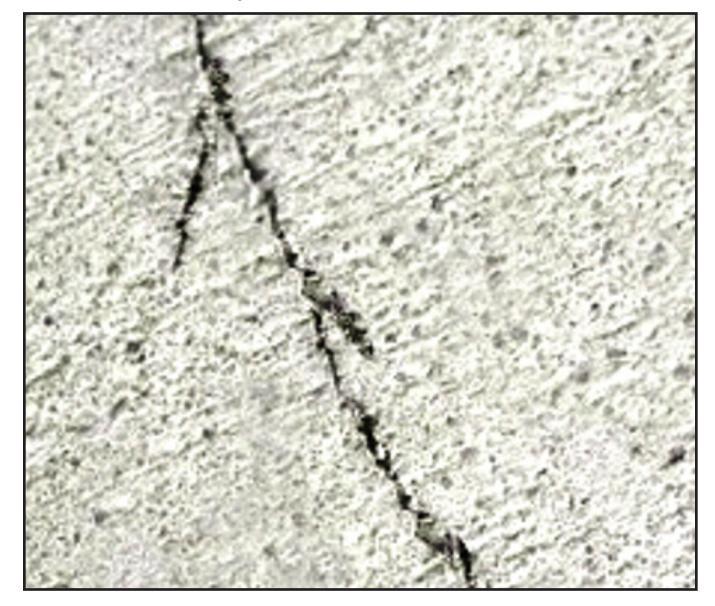
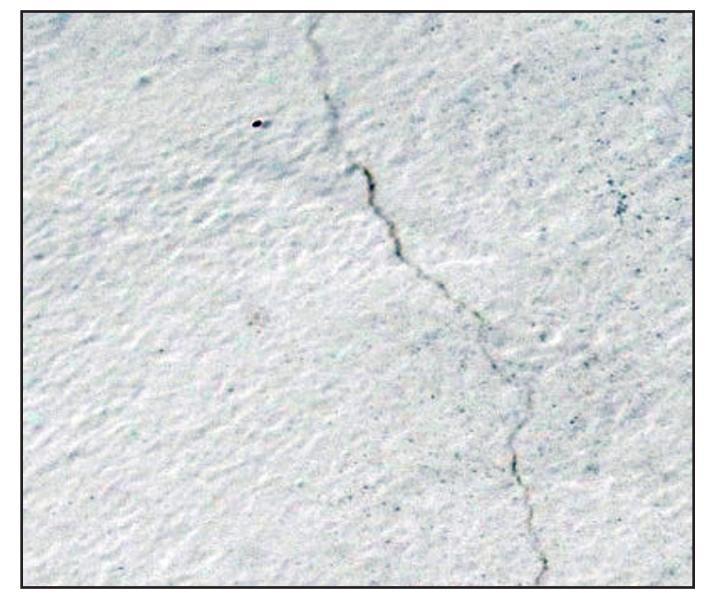
Cracks in concrete substrate may telegraph through the coating and become clearly visible. Over time, these cracks may increase in number as well as in size.

Crack before coating

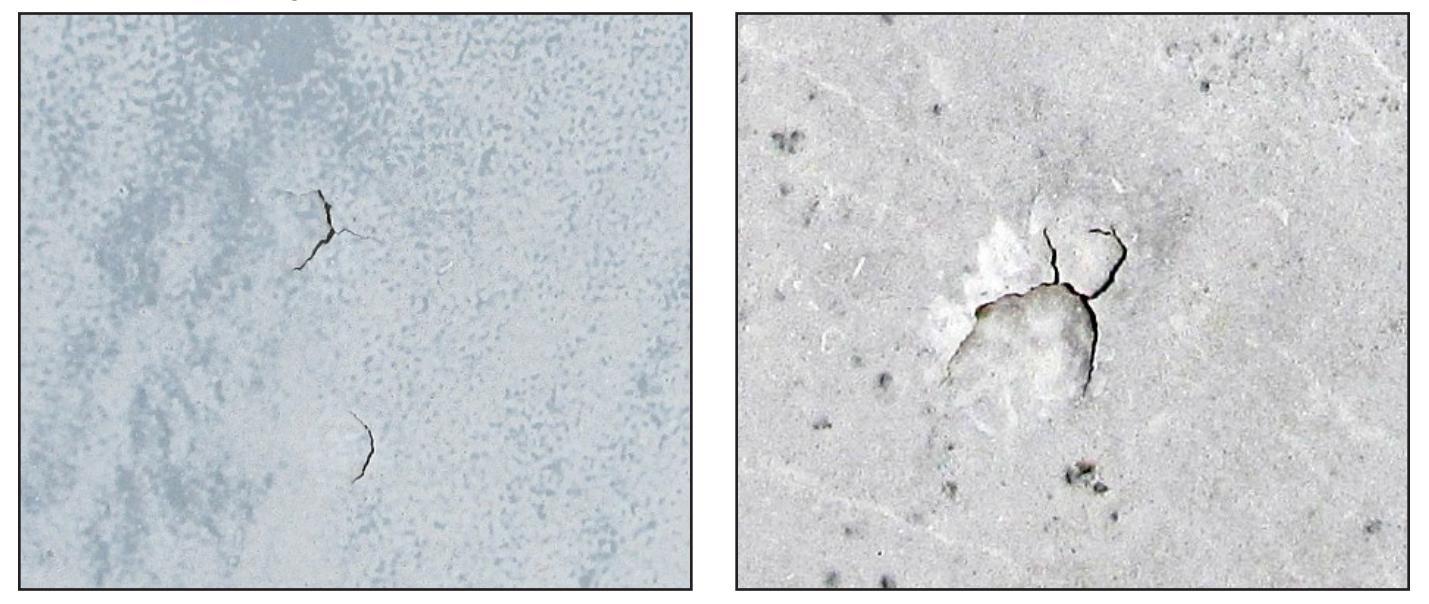
A random pattern of damage which ranges in size from  $\frac{1}{2}-1$ ", repeated throughout large areas of the roof and not limited to single occurrences.

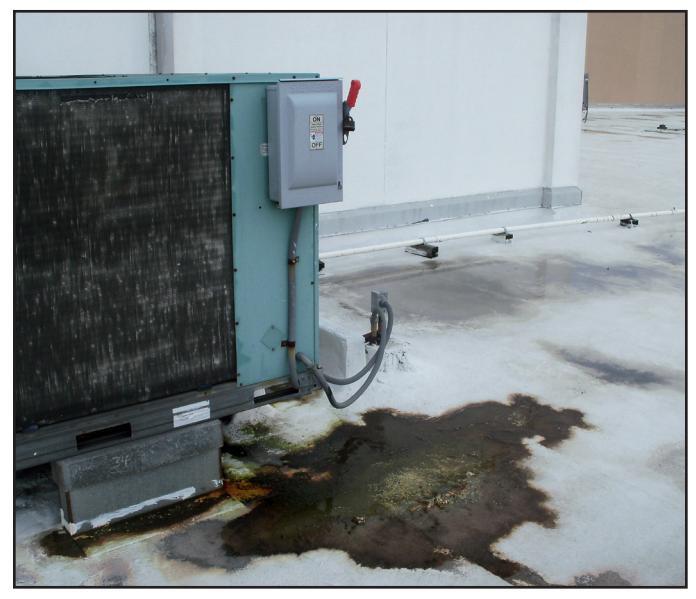
Discharge from condensation lines of rooftop equipment causes contamination of the coating.

Disconnected condensate drain lines

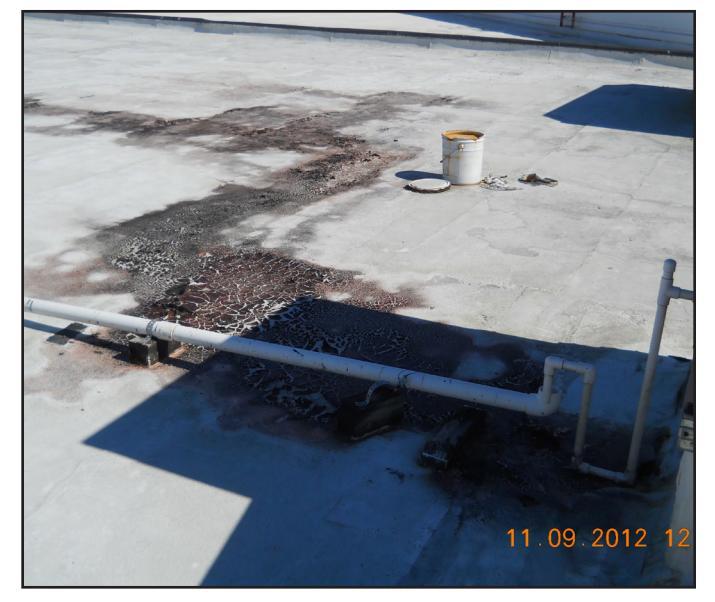
Poorly maintained condensate drain lines

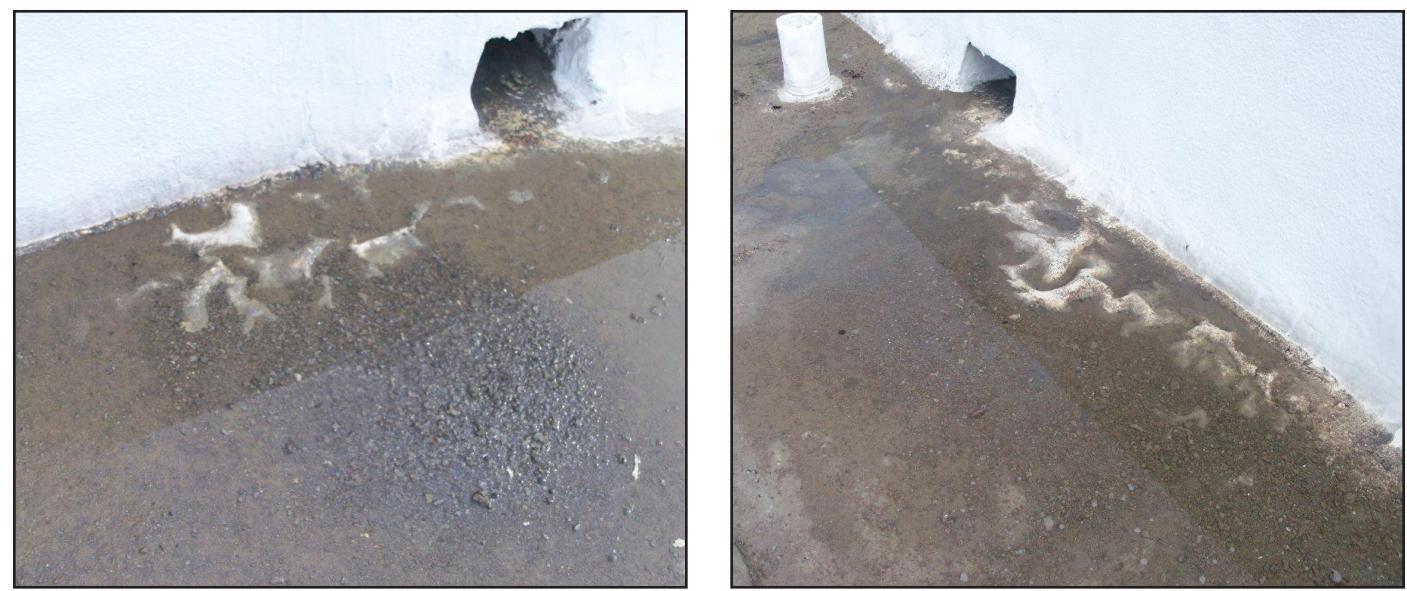
Water has ponded on the roof and has damaged the coating.

Scupper installed too high
