# Troubleshooting Guide

Causes, Repair & Prevention

March 2020

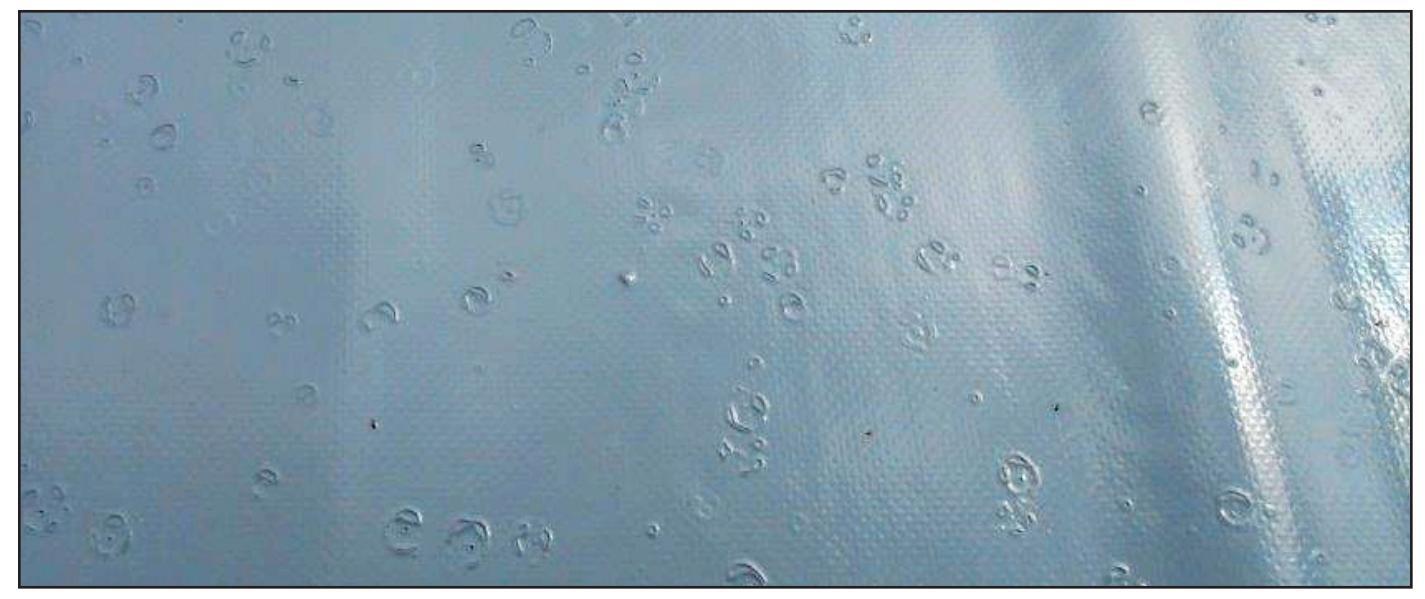
Surface has craters or dimples where rain has fallen on uncured coating.

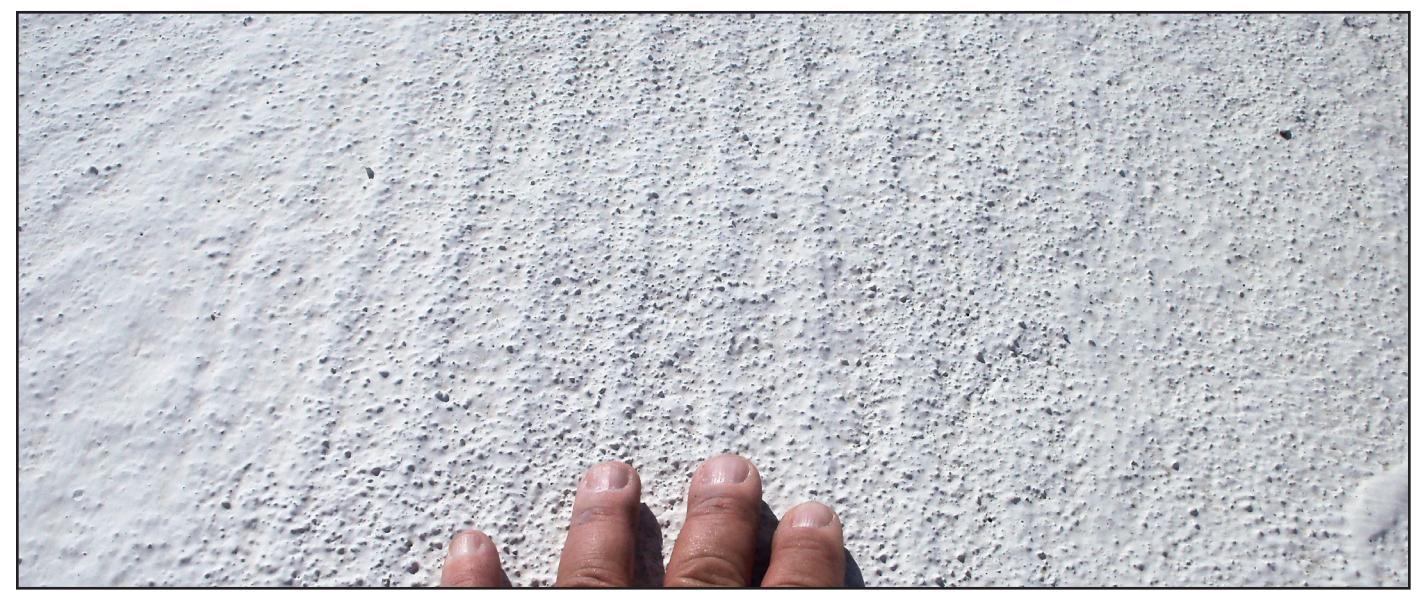
A 1/4" notched squeegee was used to apply coating, and the coating was not backrolled.
