# Troubleshooting Guide

Causes, Repair  
& Prevention

December 2023

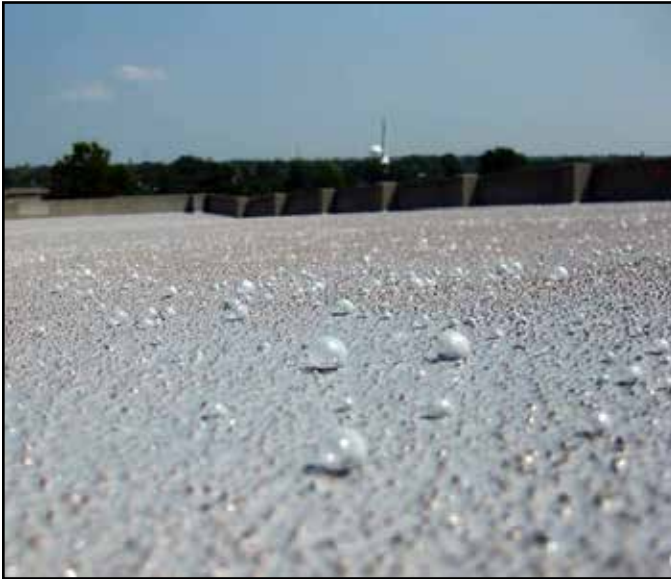
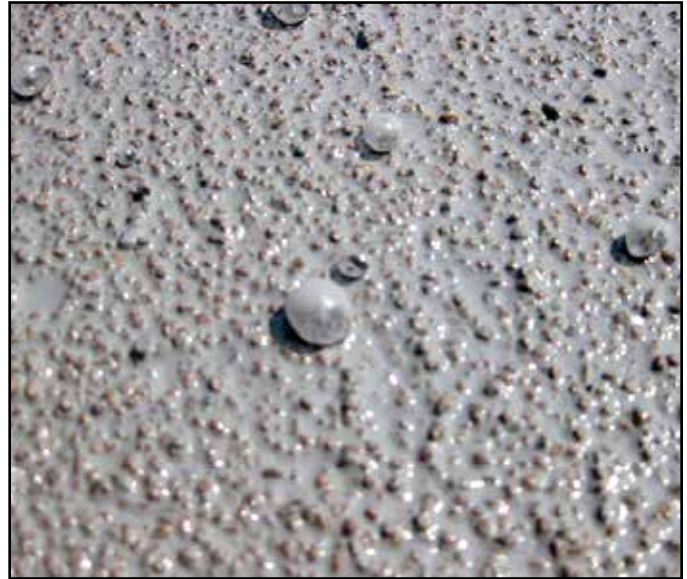
Pinholes appear as tiny blisters or bubbles. When these blisters pop they usually leave a round crater and the pinhole should be easily seen through the film.

- Porous Concrete: Concrete releases air and moisture vapor that expands as temperatures rise. Also, aggressive shot-blasting or scarifying can open concrete pores and bug holes.
- Excessive Aggregate: Air entrapped in wear coat when aggregate is applied too heavily, leaving air pockets.
- Excessive Additives: When over accelerated, coating rapidly forms a film, trapping air from the substrate, preventing escape during the curing process. Adding solvents can result in surface pinhole blisters if the solvent is not allowed to escape prior to gel.

- Porous Concrete:
  - Begin application as temperatures are dropping and continuing to drop. Rising temperatures result in expansion of the moisture and air in the concrete. Falling temperatures cause the air and moisture to contract within the concrete.

- Excessive Aggregate: Apply wear coat at specified rates, taking care to prevent aggregate from leaving entrapped air pockets.
- Excessive additives: Avoid using accelerators during hot temperatures. See Weather Impact on Coating Materials in the Support Information section of this guide.

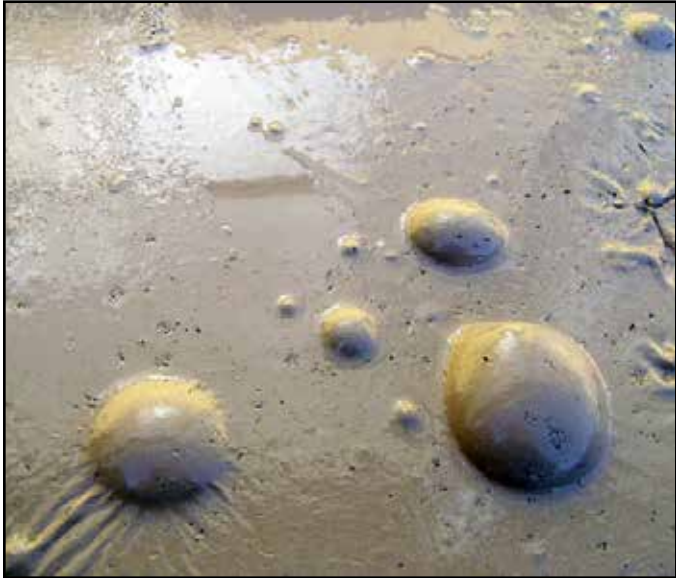
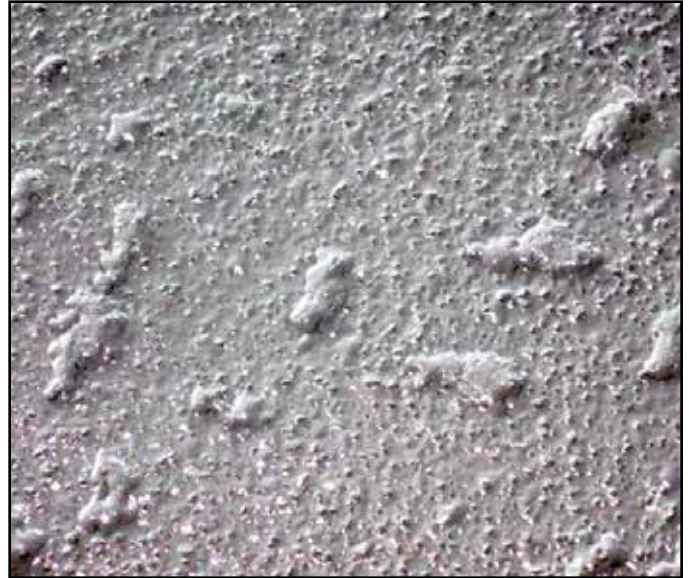
Blisters look like bubbles in the coating surface. The blisters will have a trace of water or moisture trapped inside them. Moisture between the aggregated wear coat and topcoat leaves an orange peel texture on the backside of the blister, mirroring the sand coat texture.

Water from rain, dew or other sources, mixed or rolled into wet, uncured coating. The urethane coating reacts with the water and attempts to cure on the surface, forming blisters and stress wrinkled areas.

- Do not apply coating if rain is imminent.
- Ensure that sprinkler/lawn systems remain off for the duration of the cure.
- Ambient temperature should be more than 5° above dew point. See Dew Point of Moist Air in the Support Information section of this guide for ambient temperature and relative humidity guidelines.
- Ensure that the deck is completely dry before coating. Moisture may not be readily apparent, particularly if aggregate has been introduced into the system. Conduct a moisture test before application to ensure that there is no water contamination.

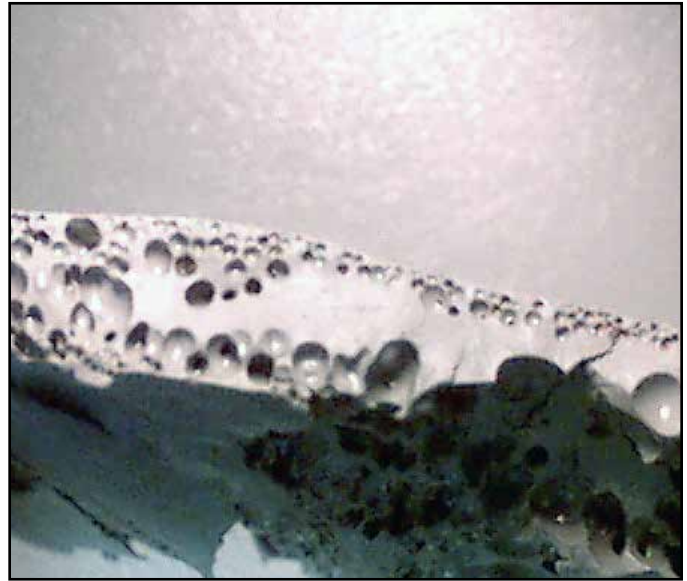
Blisters look like small to large unbroken bubbles in the coating surface and can appear round or oblong. Depending on the state of cure, they can feel spongy or fluid beneath the surface.

Coating was applied at a rate greater than application instructions.

1. Completely remove affected areas down to cured coating or substrate.
2. Reapply coating system per Neogard specifications and recommendations.

- During installation of coating, frequently check the wet film thickness by use of recommended mil gauges.
- Laying out the job prior to coating by gridding out the area will help to maintain proper and uniform coating thicknesses.
- During application, backroll to eliminate low spot areas where self-leveling coating may pool.

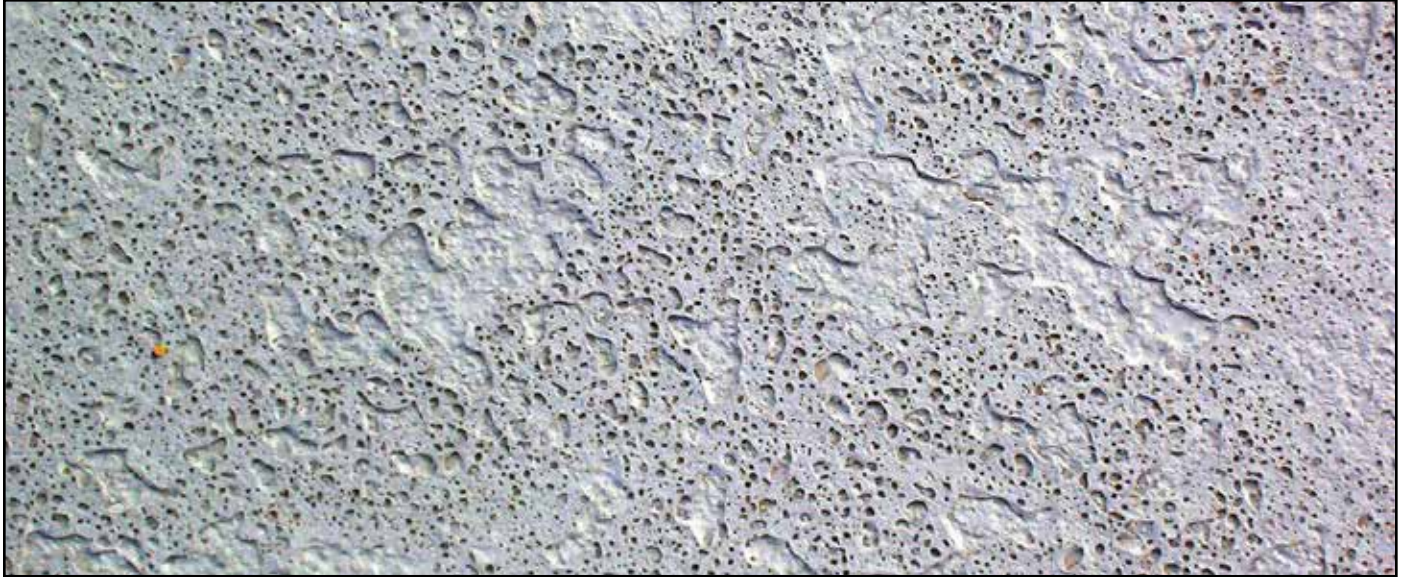
Surface has areas of sponge-like, cratered patterns where water has come in contact with uncured coating.

Heavy rain, sprinklers or other water source caused damage to uncured coating.

1. Grind all affected areas to eliminate ridges in the cratered areas.
2. Clean and allow to completely dry.
3. Re-apply coating as specified and according to Neogard recommendations.
4. In severe situations, the coating may have to be totally removed prior to re-coating.

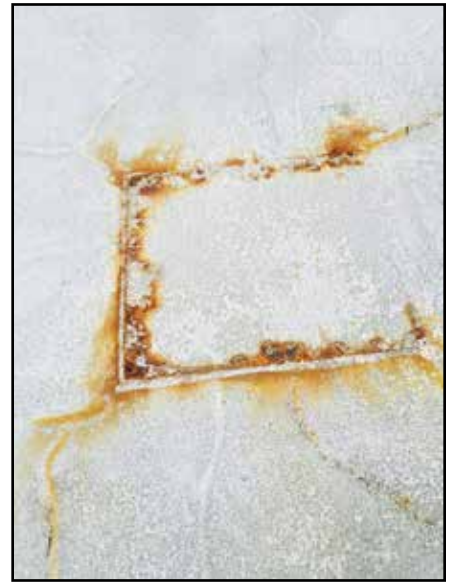
There are rusty, reddish-brown stains in the coating. The presence of rust can be purely aesthetic, or it may indicate a condition which affects the integrity of the coating system.

- Shotblast Beads: Rust stains develop when shot-blast beads utilized during surface preparation are not properly removed. Rust stains will bleed through the entire system if metal is not removed prior to applying the coating system.
- Metal in Aggregate: Rust may also develop from metal fines contained in the aggregate.
- Rebar or Mesh: Rust from rebar or mesh too close to the surface can also appear.

If the contamination source is from the surface, power washing along with the use of a rust neutralizer may remove stained area.

1. If the contamination source is located in the substrate, remove the coating down to the substrate and abrade the surface to remove all rust.
2. Apply Ureprime HS2 or HS4 at a rate of 300 sf/gal to properly prepared area and allow to cure.
3. Apply 70714/70715 Series epoxy at a rate of 100 sf/gal (16 WFT/16 DFT).
4. Re-apply coating per specifications and Neogard recommendations in the Waterproofing Application Manual.

- Shotblast Beads: Remove all iron and metal residue from the substrate, including cracks and joints.
- Metal in Aggregate: Use Neogard or Neogard-approved aggregates.
- Rebar or Mesh: After the deck is cleaned and shot-blasting completed, inspect for rebar and/or mesh near the surface. If rebar or mesh is near the surface, it may be necessary for the owner to consult with a structural engineer.

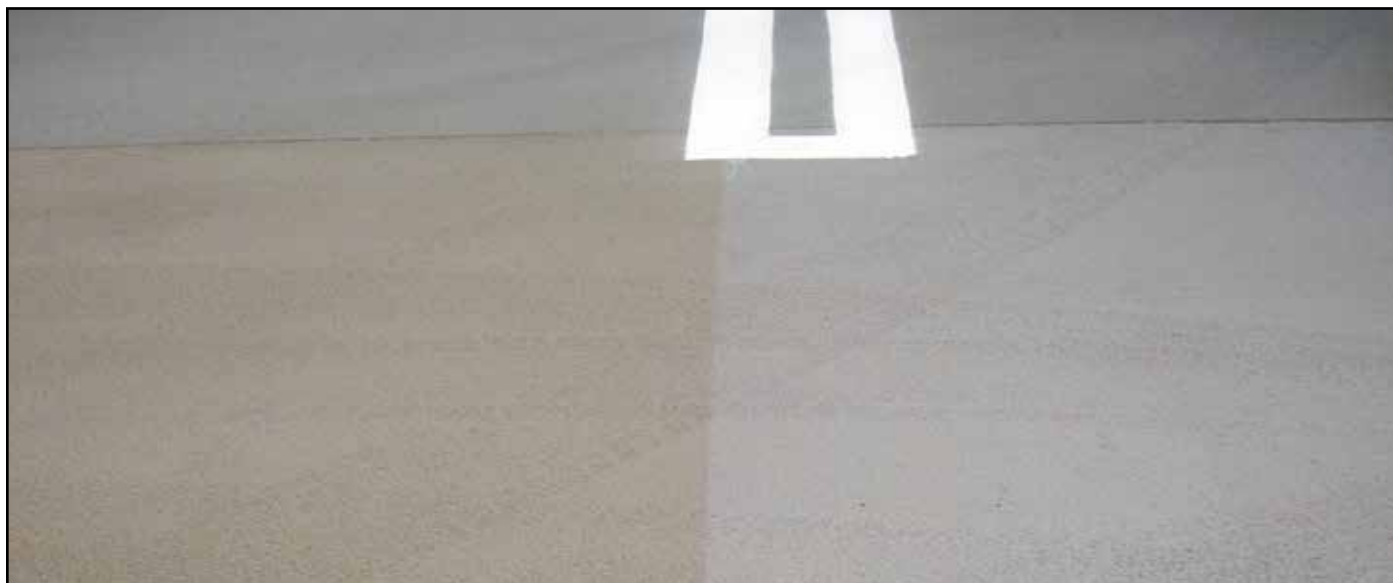
Finished waterproofing surface shows different shades of color. While considered less than aesthetically appealing, this condition does not affect the integrity of the waterproofing system.

- Different Batches of Topcoat: There may be slight shade variation from batch to batch of material.
- Deck Coated at Different Times: Older coating material has weathered and appears different than newer coating material.
- Improper Mixing: Product not mixed sufficiently to disperse pigment. See Product Mixing Instructions in this guide.

1. Apply an additional wear coat and topcoat.
2. Allow sufficient time for weathering.

- Different Batches of Topcoat: Always purchase or set aside enough topcoat from the same production batch to coat the entire surface area. Use odd batches elsewhere such as in the wear coat if applicable. If there is not enough topcoat of a single batch to complete the project, “boxing” batches is an alternative. Boxing is the process of combining all the coating you will be using as the topcoat into one large container. This is especially important when coating a large surface area or if there is insufficient coating from a single batch, where a color variation from one batch to another is likely.

- Improper Mixing: Always mix material sufficiently to properly disperse the pigment. See Product Mixing Instructions in the Support Information section of this guide.

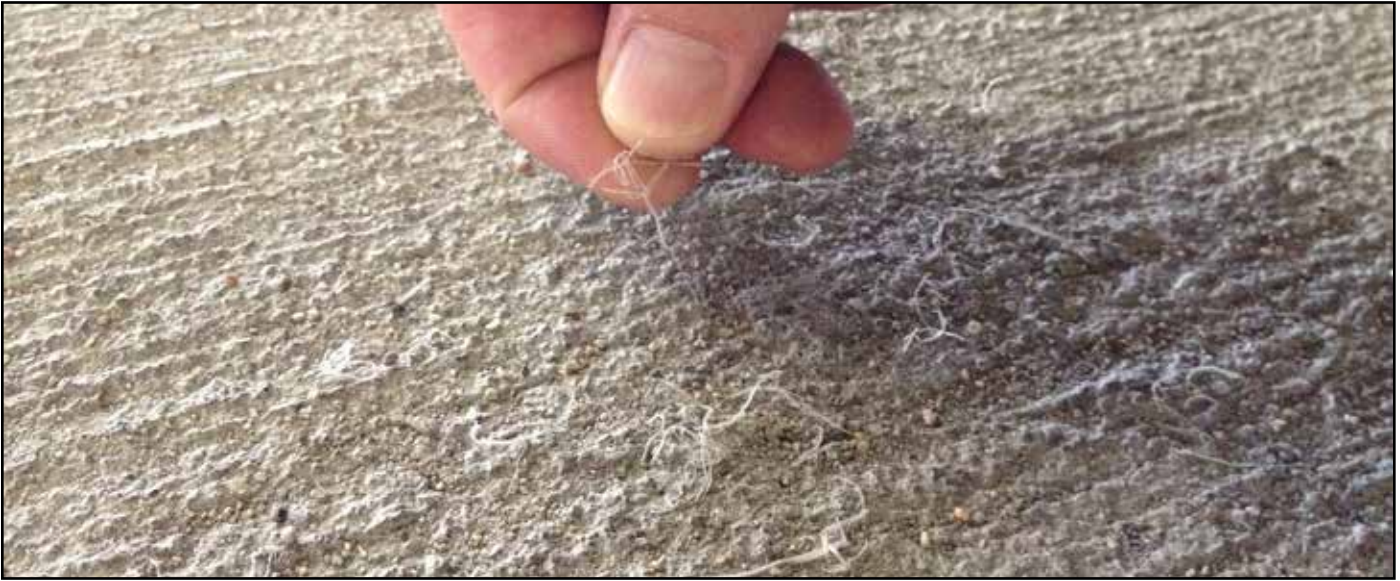
Fibers have been added to the concrete mix to control shrinkage cracks and to improve other physical properties. These fibers will protrude and breach the coating system and may cause future leaks.

Fibers added to the concrete mix will protrude through the concrete surface.

1. Mechanically prepare surface by shot-blasting to industry-standard texture (ICRI CSP3–CSP4) without causing defects to substrate.
2. Remove fibers by burning with a propane torch.
3. Remove any remaining residue prior to coating application.

It is not recommended to use fibers in the concrete mix when a coating is to be applied. If fibers are present, remove them before applying coating.

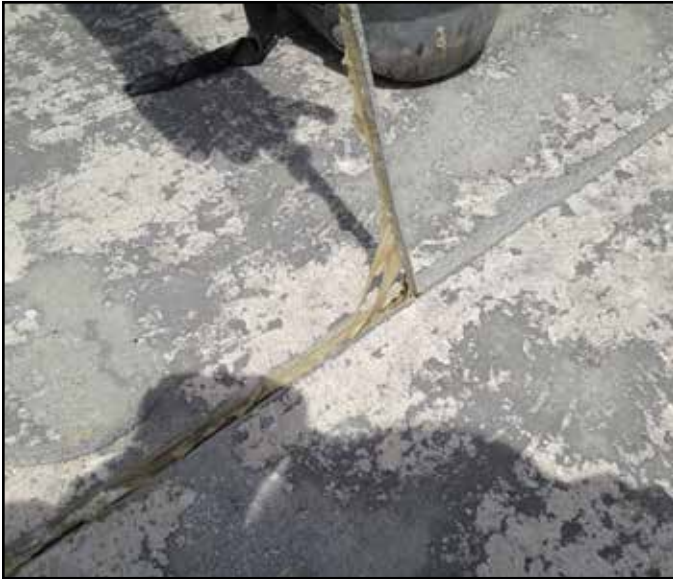
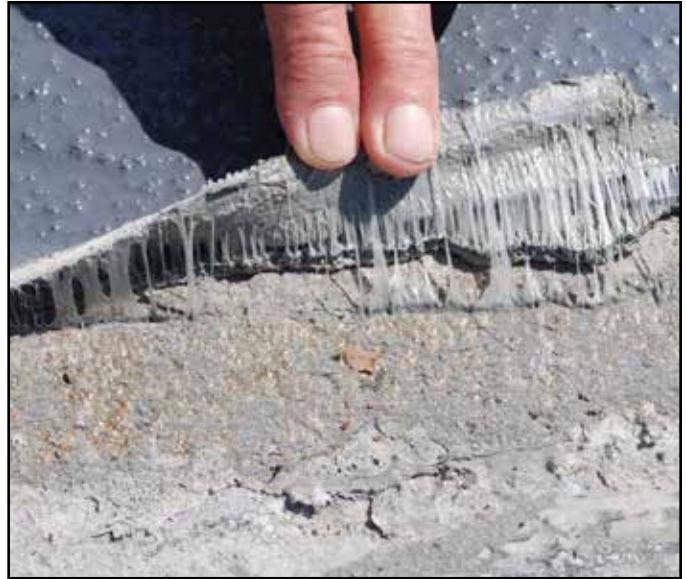
Coating delamination has occurred due to off-ratio, uncured sealant.

Two-component sealant was improperly mixed or was contaminated.

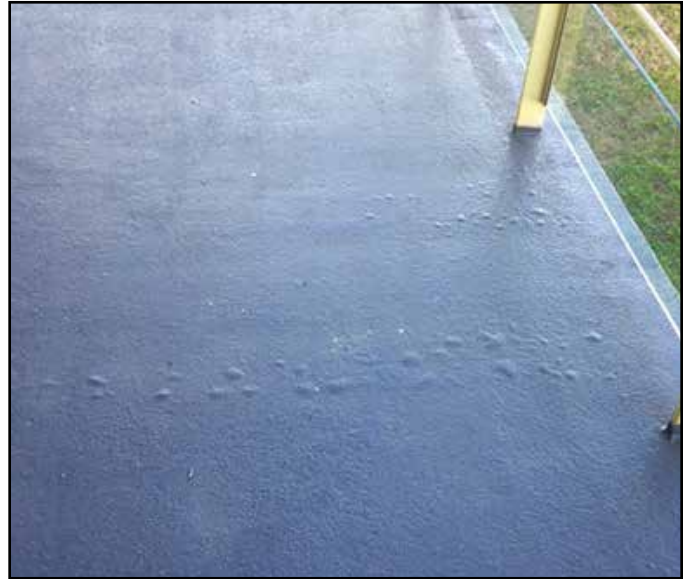
The coating system fails due to delamination caused by moisture migration in the concrete substrate.

Trapped excess moisture in or below the concrete substrate.

1. Identify the source of the moisture.
2. Remove coating in affected areas down to clean substrate.
3. Re-apply coating as specified and according to Neogard recommendations.

- **Moisture Contamination:** Ensure that the deck is completely dry prior to coating. Moisture may not be readily apparent, particularly if aggregate has been introduced into the system. Monitor the ambient surface temperature for the entire duration of the application process. See Dew Point Chart in the Support Information section of this manual for ambient temperature and relative humidity guidelines.
- **Moisture Test:** Ensure that the deck is completely dry before coating. Moisture may not be readily apparent, particularly if aggregate has been introduced into the system. Conduct a moisture test before application to ensure that there is no water contamination.

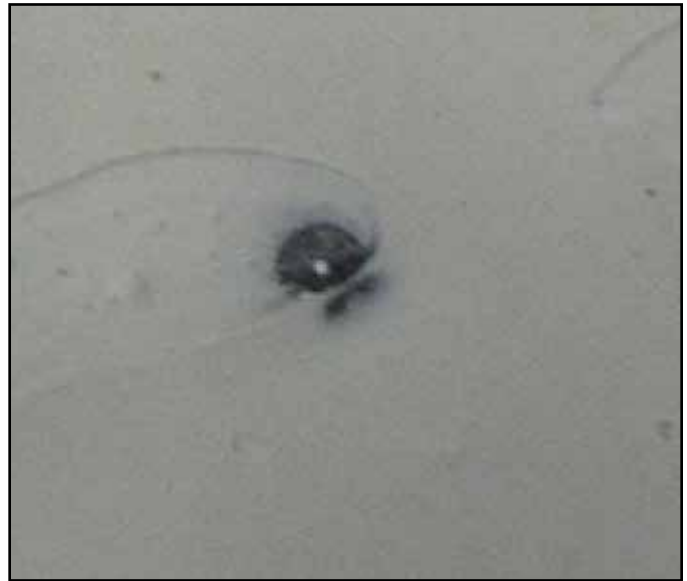
Fish eyes are round indentations or separation in the coating finish. Upon closer examination, they look like a crater with a rim around the perimeter of the defect along with a very small dot in the center.

**Silicone Contaminants:** Certain manufacturing processes such as welding or spraying can deposit silicones on the floor causing fish eyes to appear.

**Oil/Grease Contaminants:** Oil or grease contaminants can cause the coating to function improperly and fish eyes to appear.

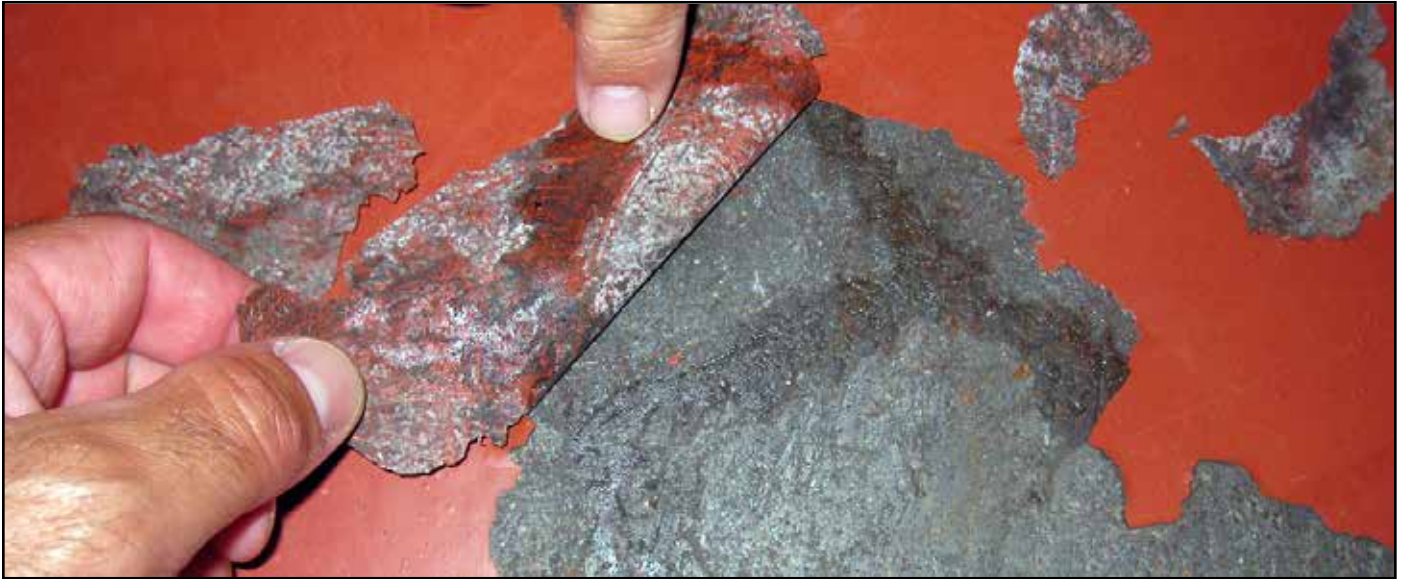
Coating is peeling or de-bonding from the substrate.

- Inadequate Cleaning: Coating will not adhere to oil, grease or other contaminants.
- No Primer Used: Without primer, peeling/delamination may occur.
- Moisture Vapor Transmission: Water vapor penetrating through the substrate can cause peeling/delamination. After removing delaminated areas, moisture may be visible or the concrete may be dark in appearance.

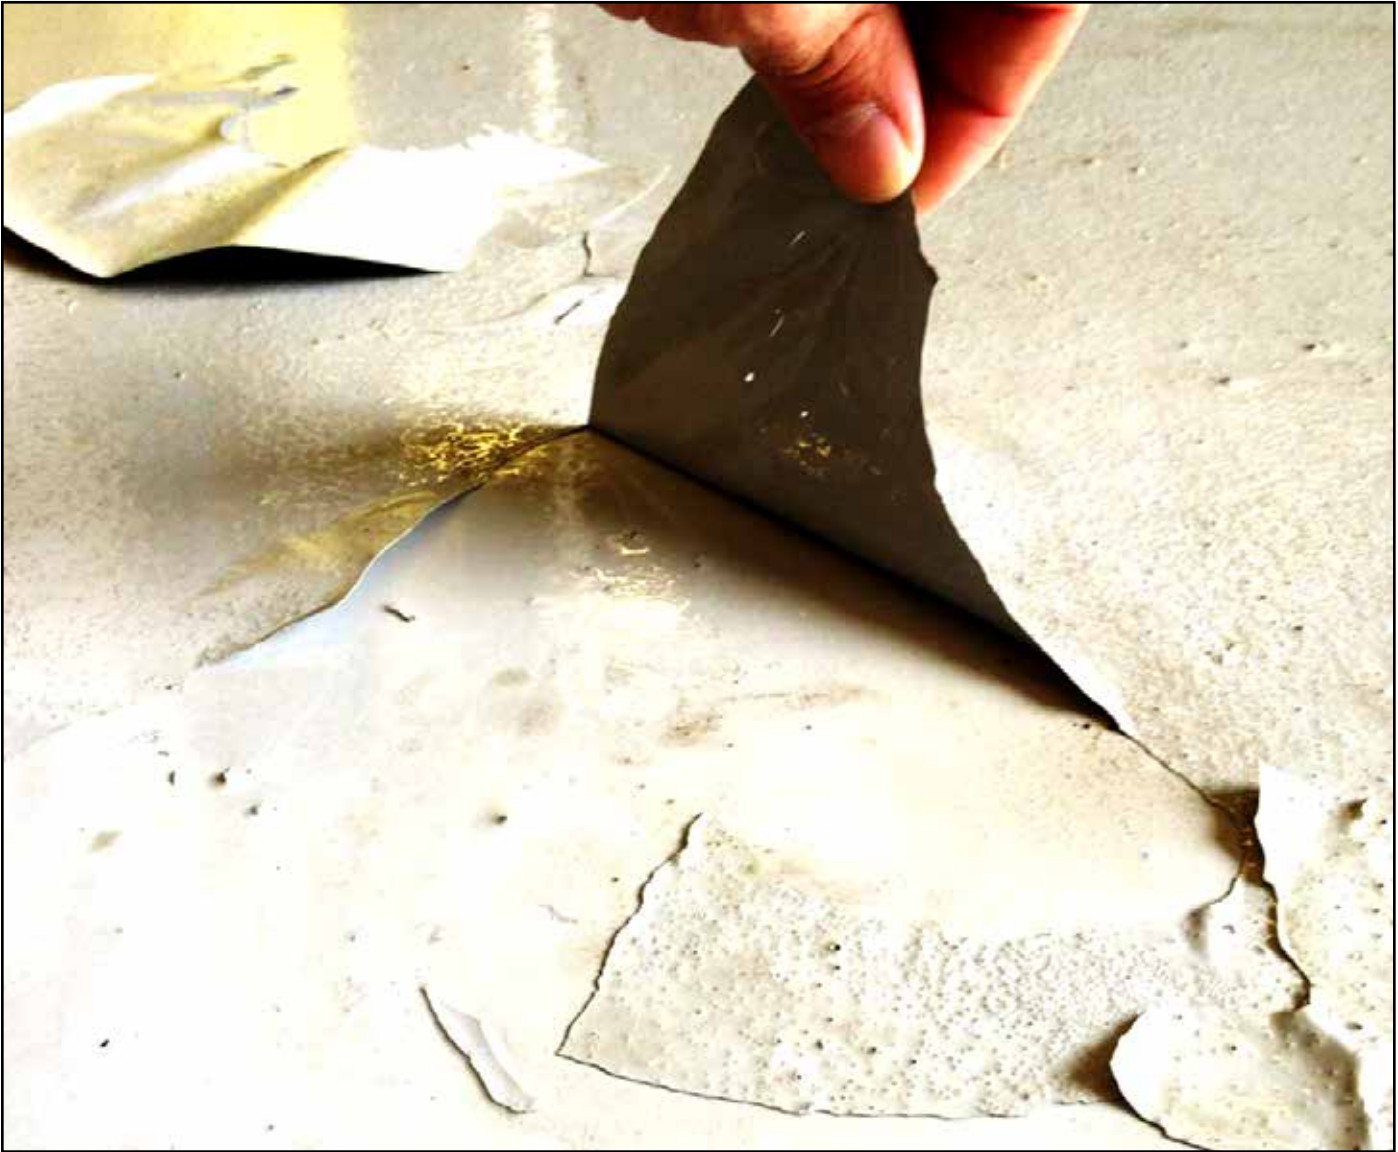
Coating is peeling or de-bonding between layers of coating.

- Beyond Recoat Window: Coating was not applied within 24 hours of previous coat.
- Surface Contamination: Surface was contaminated by water, humidity, oil, grease, or dust.
- Improper Mixing: Coating was not mixed at proper mix ratio, or not mixed for a minimum of 3 minutes.

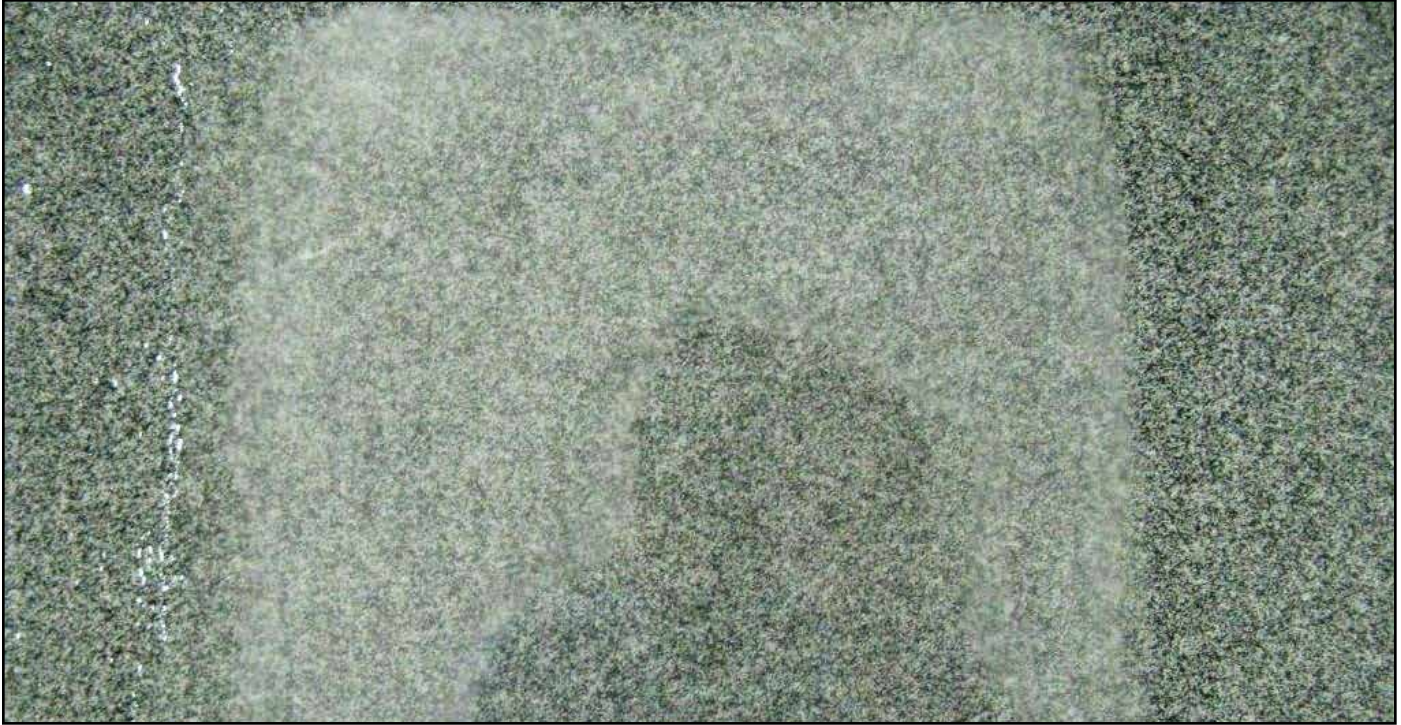
There is a milky or cloudy appearance in wet or cured coating material.

- **Moisture:** Moisture in the concrete or high humidity levels can cause moisture to be present on the surface when the material is applied, or before it is fully cured. This can result in a milky appearance or greasy film. This condition is sometimes referred to as “blush” and is more prevalent with certain epoxies.
- **Thick Application:** A milky or cloudy appearance may result from the coating being applied too thick. In this case, the milky appearance will be more noticeable if the coating is clear.

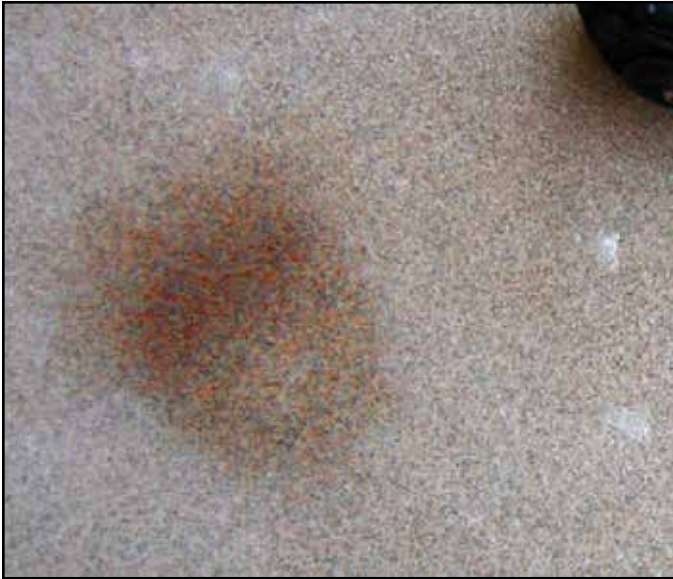
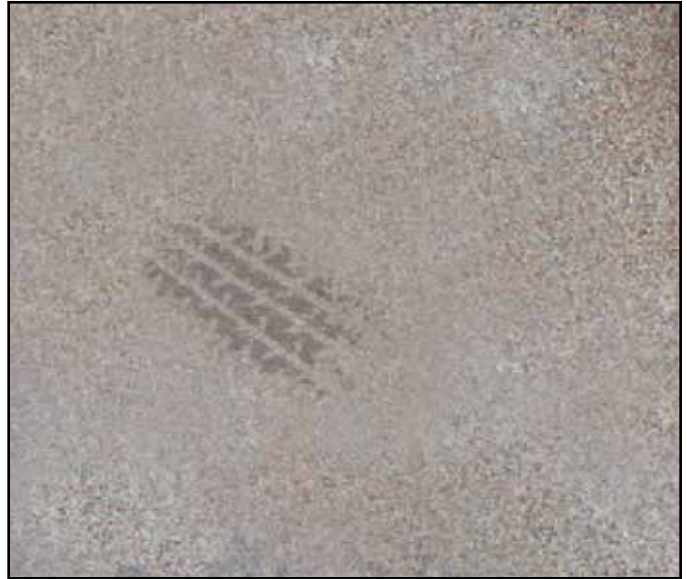
There are dark or discolored spots in the coating system.

- Chemical Exposure or Spills: Floor has been exposed to chemicals.
- Tire Marks: Floor has been exposed to vehicular traffic.

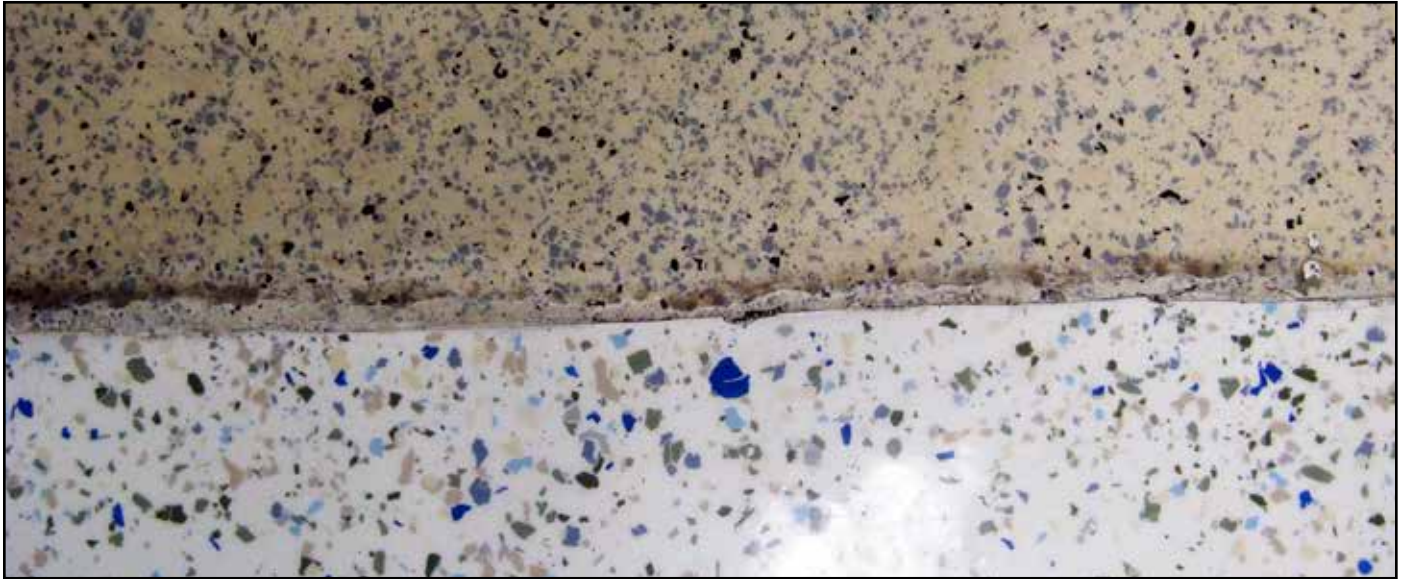
Topcoat has developed a yellow hue. This problem will affect epoxies regardless if the epoxy is clear or not.

Epoxy has been exposed to partial or direct sunlight.

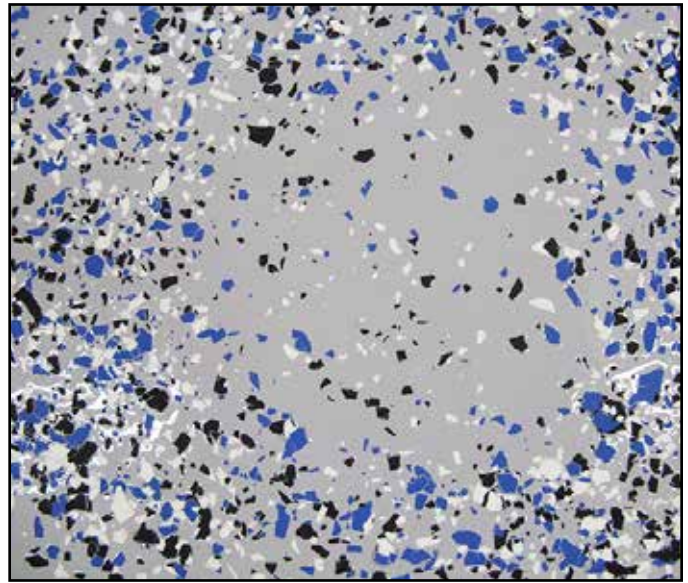
Even flake disbursement is a key factor in the aesthetics of a random flake flooring system. Having the same size and coverage of flakes is key to a uniform appearance.

- **Flakes Broadcast Too Quickly:** This leaves an uneven disbursement in the base coat. To ensure uniform coverage, make certain the broadcaster takes their time.
- **Flakes Crushed During Broadcast:** This causes variations in the size of flakes. Size variation of flakes in the floor is caused by crushing the flakes in hand as they are broadcast. Also, reaching for the flakes in the bucket, they are inadvertently crushed.
- **Clumped Flakes:** If clumped flakes are introduced into the wet base coat, they will dry in a clumped formation.

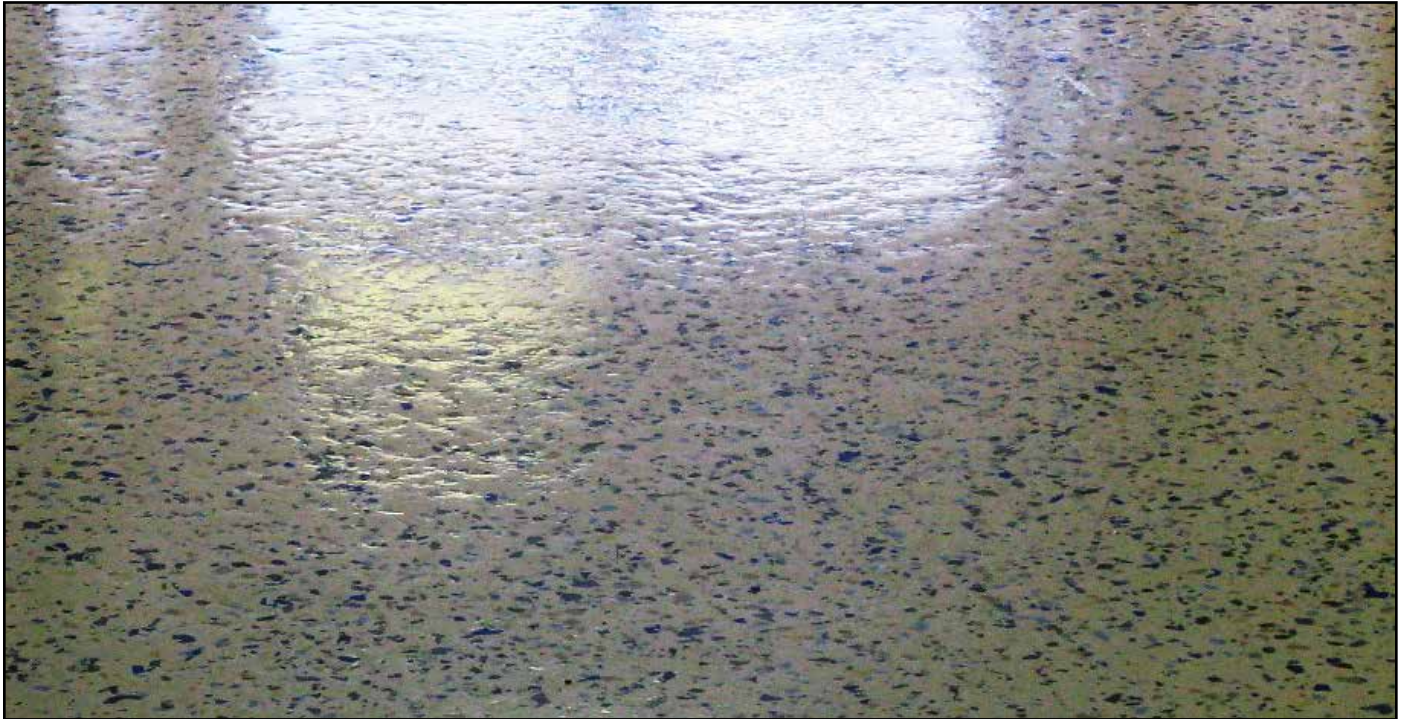
Orange peel is a stipple finish appearance in the final topcoat of epoxy or urethane flooring system. Some flooring manufacturers offer this finish; however, it is not always desirable to the customer.

- **Cold Substrate/Materials:** If the substrate temperature is below 50°F/10°C, the epoxy or urethane will not flow and level out, and can produce the orange peel finish. This will be more prevalent if the topcoat is applied in a thin layer, somewhere between 3–6 wet mils. The combination of a cold substrate and cold materials can readily produce this type of finish.
- **Hot Substrate/Materials:** Hot temperatures can also result in an orange peel finish. If the substrate is above 90°F/32°C, the topcoat may cure too quickly. This rapid curing will cause the material not to flow and level out. Just as in cold temperatures, thin topcoat layers, hot substrate temperatures and hot material can produce an orange peel finish.

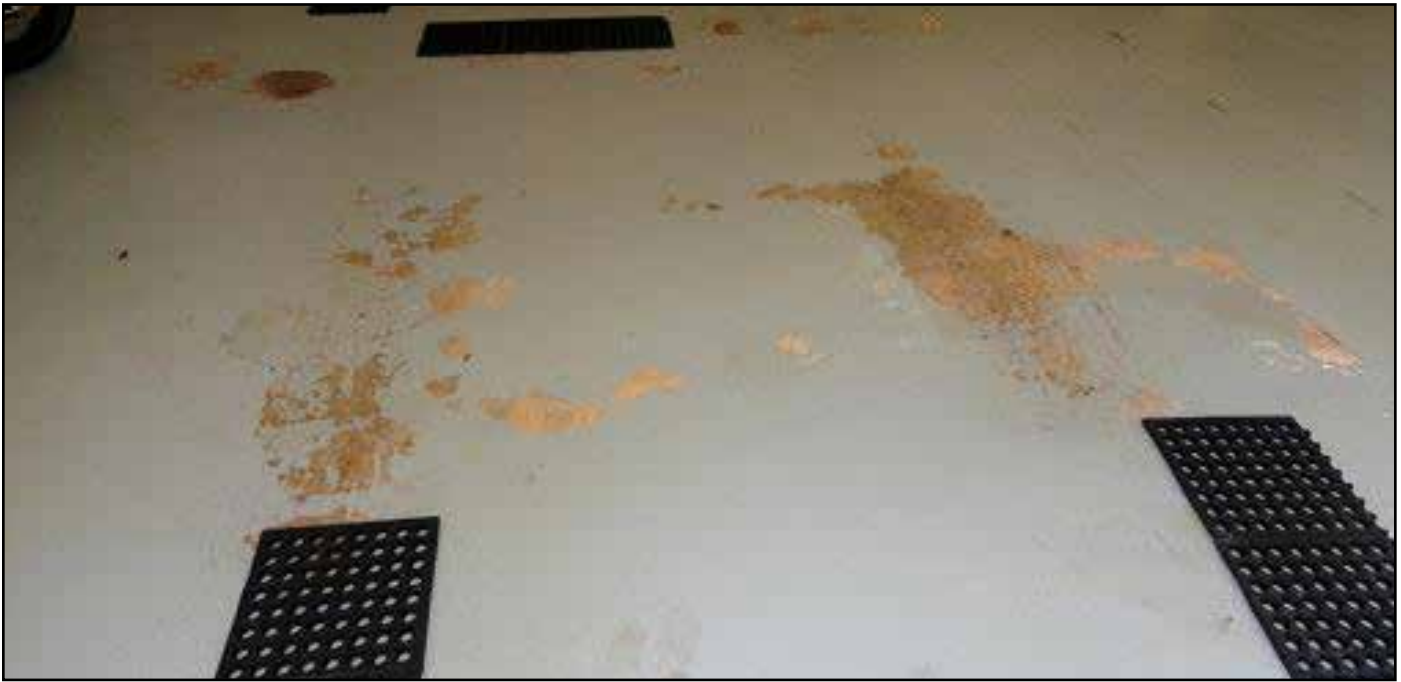
Flooring system is delaminating and peeling in areas where tires are consistently in contact with the coating.

- Thin System Application: A floor coating system applied at insufficient coverage rates may delaminate.
- Project Specification: The applied system was not designed for project conditions.
- Poor Surface Preparation: Substrate was not properly prepared for acceptance of coating system.
- Improper Cure Time: Coating was not fully cured.

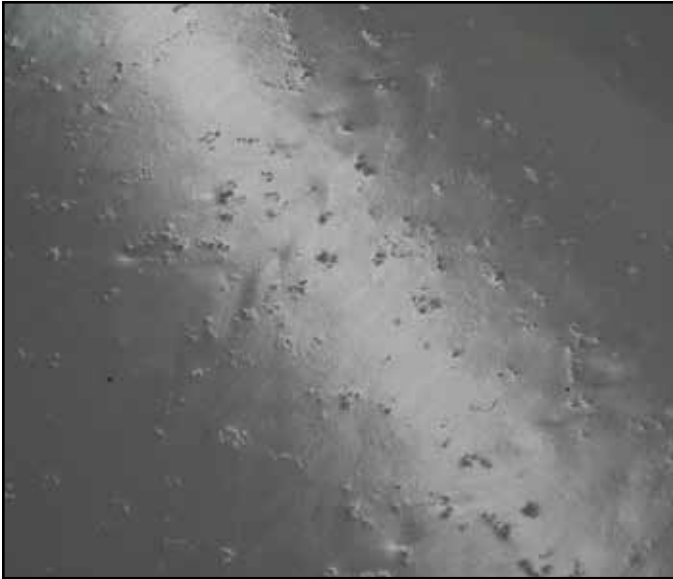
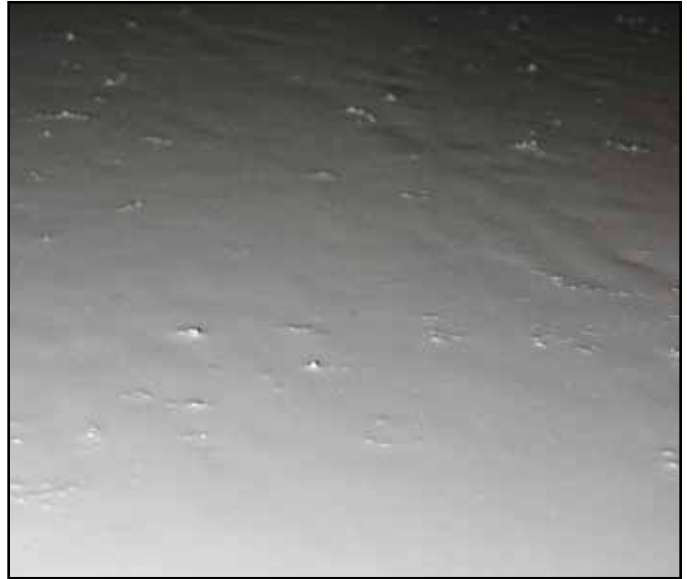
Roller lint is embedded in the coating after application.

- Low-quality roller covers were used.
- Roller nap was too long.

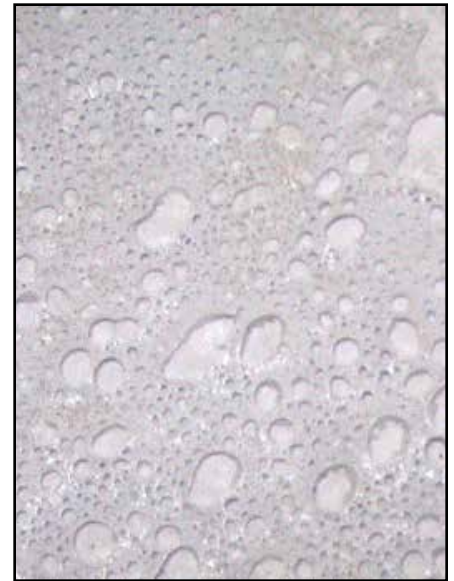
**Roof with moisture contamination**

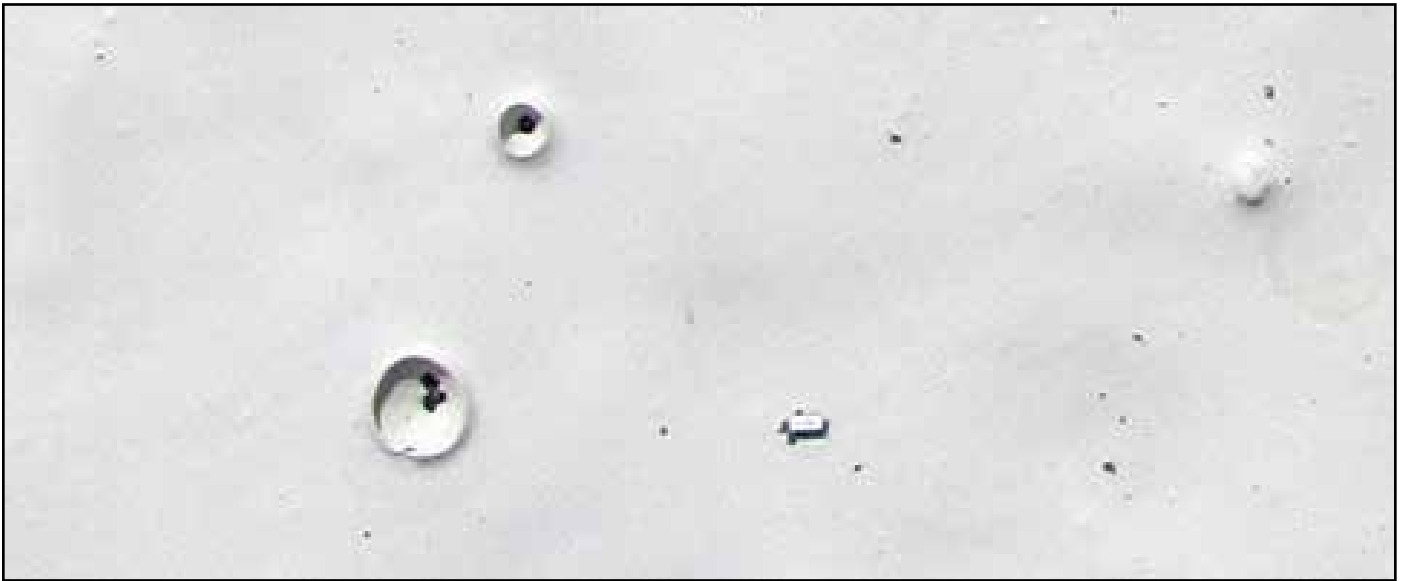
Appear as tiny blisters or bubbles. When these blisters pop they usually leave a round crater. The pinhole should be easily seen through the film. Concrete decks are susceptible to this condition.

Develop from small open pockets or voids in concrete, known as pinholes. The coating may initially bridge these small openings. However, as temperatures rise, the concrete releases air and moisture vapor, blowing a bubble or blister, which typically ruptures.

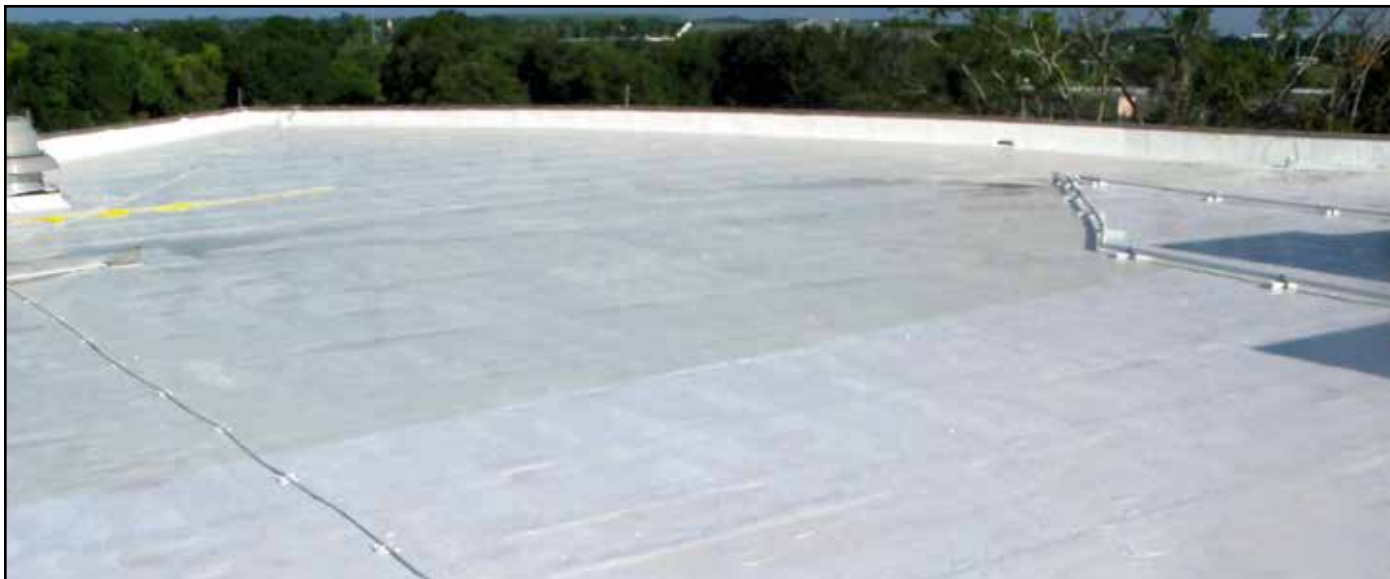
The coating appears to be different shades. This is most often noticeable in white products.

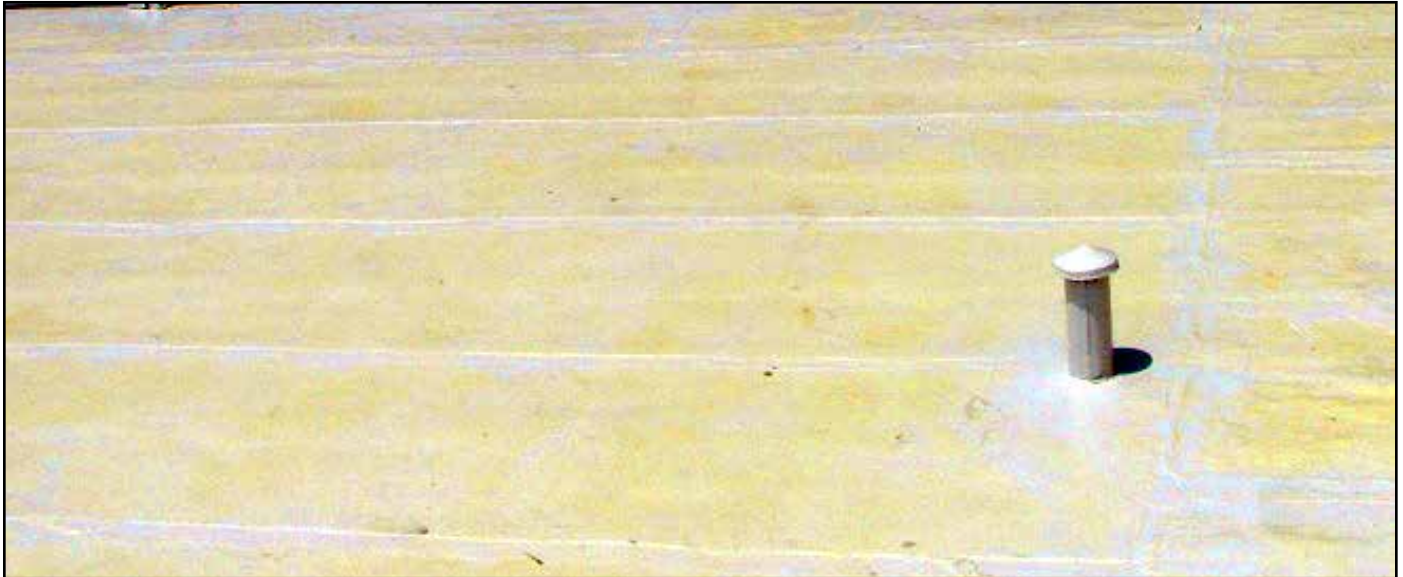
Surface of coating has taken on a yellow hue. Yellowing may be splotchy.

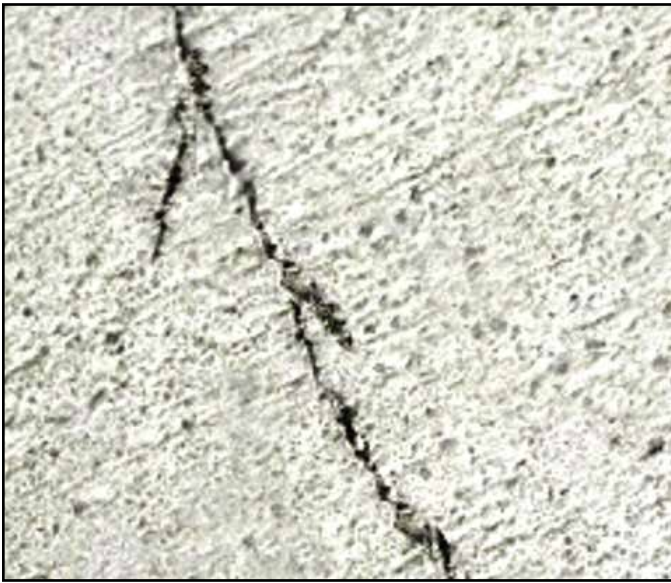
**Crack before coating**

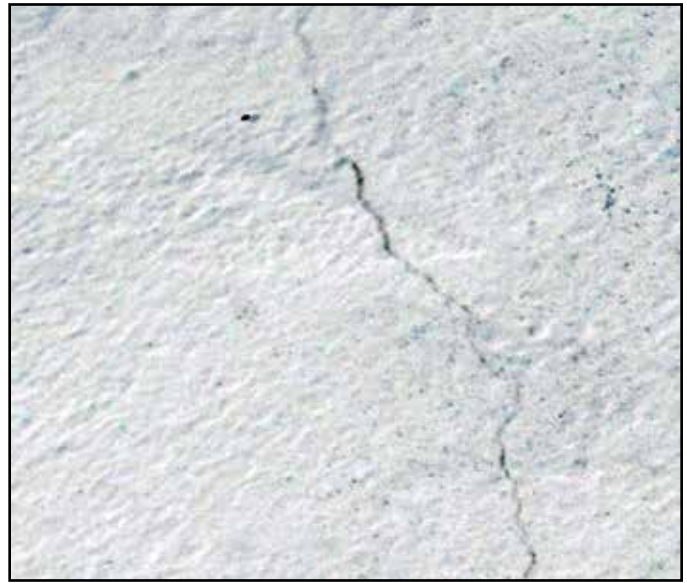
Cracks in concrete substrate may telegraph through the coating and become clearly visible. Over time, these cracks may increase in number as well as in size.

**Crack in coating telegraphed from concrete**

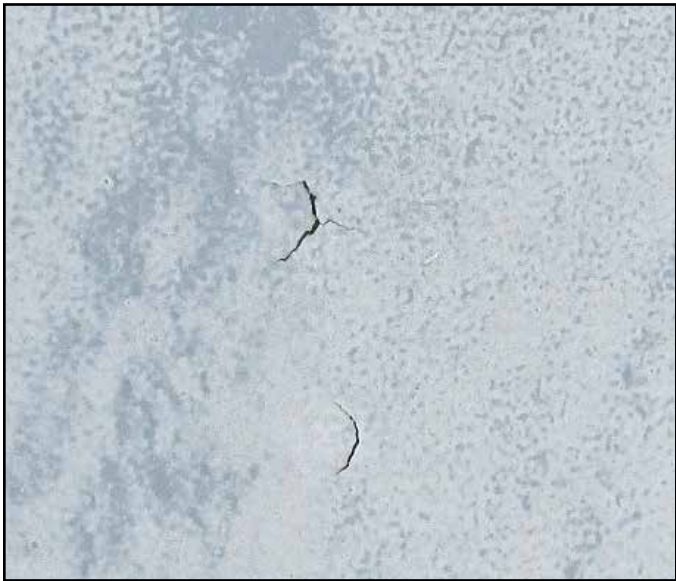
A random pattern of damage which ranges in size from ½–1", repeated throughout large areas of the roof and not limited to single occurrences.

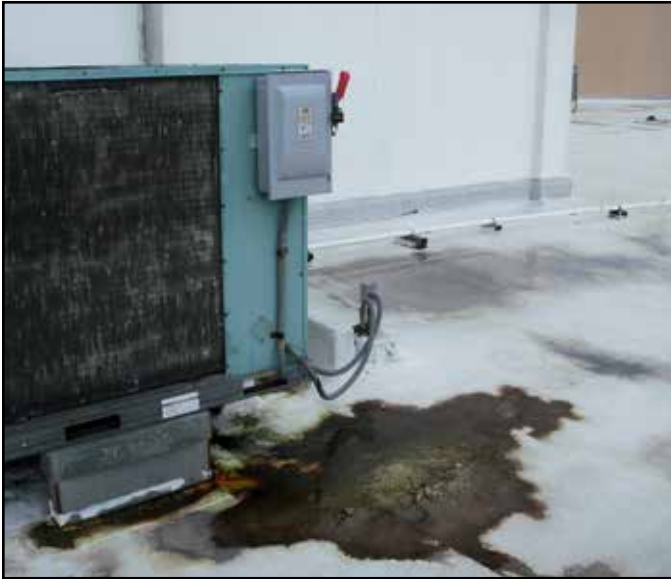
Discharge from condensation lines of rooftop equipment causes contamination of the coating.

**Disconnected condensate drain lines**

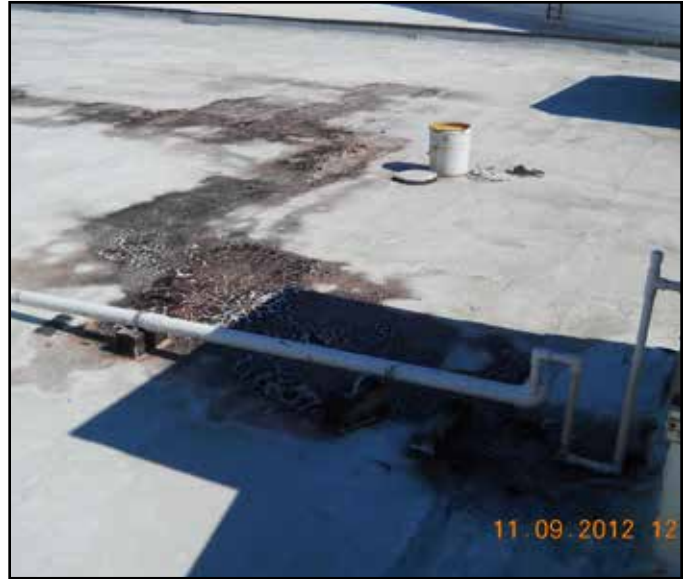
**Poorly maintained condensate drain lines**
