# Troubleshooting Guide

Causes, Repair  
& Prevention

December 2023

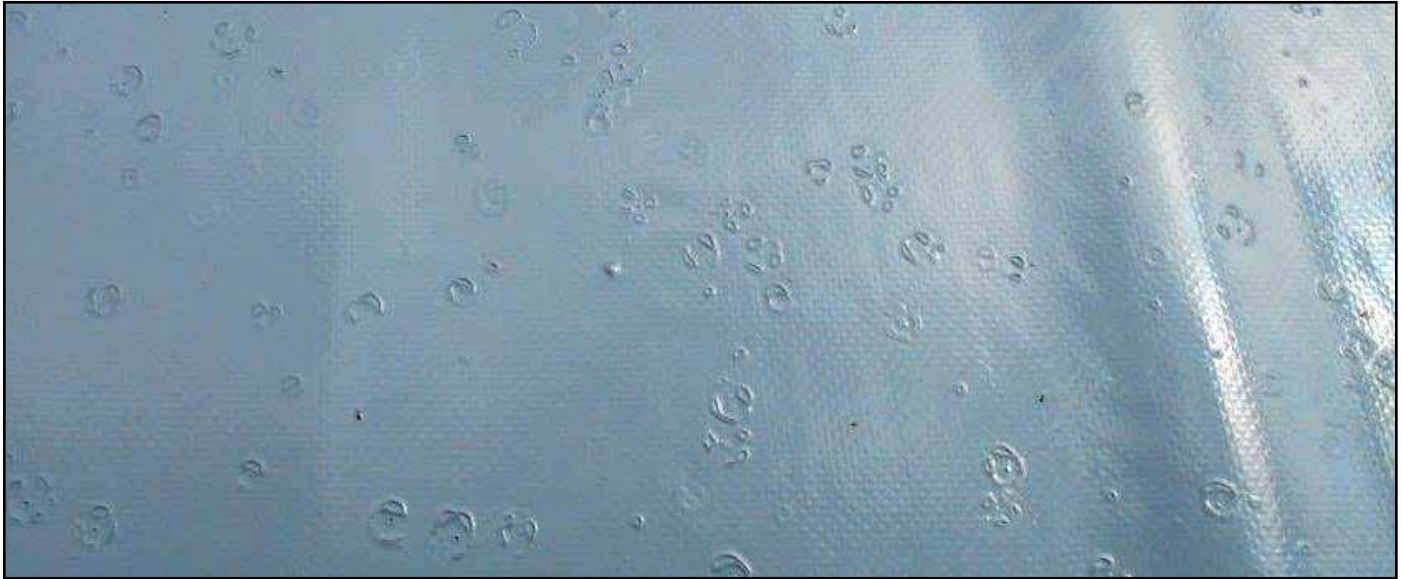
Surface has craters or dimples where rain has fallen on uncured coating.

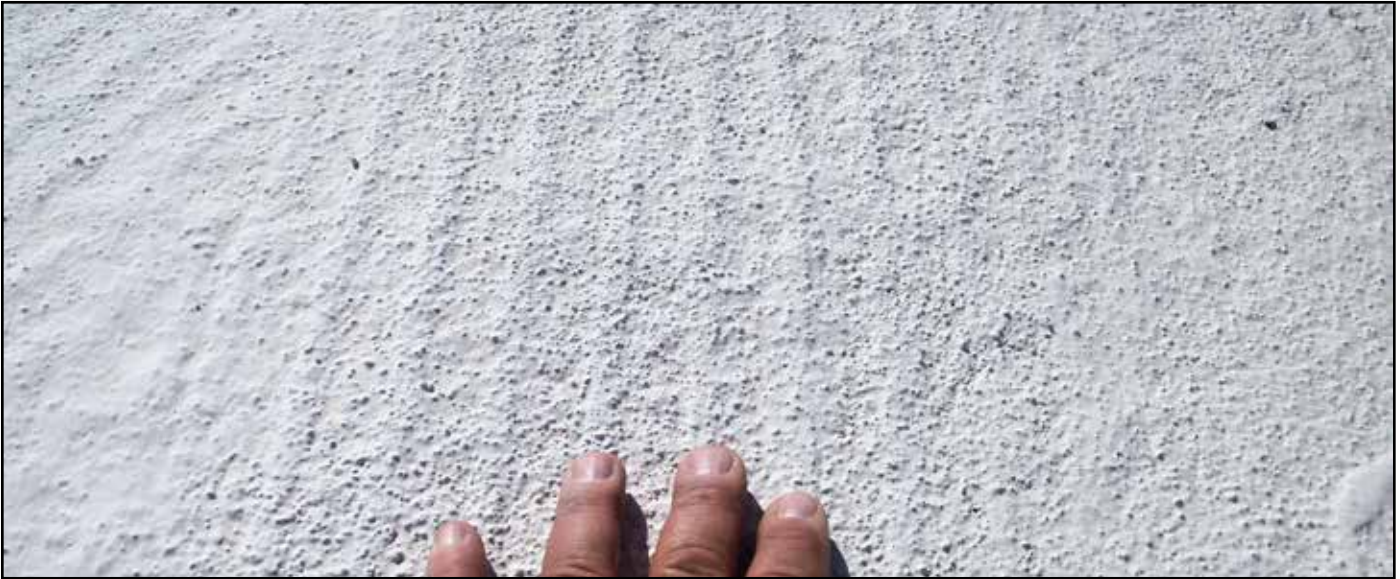
A 1/4" notched squeegee was used to apply coating, and the coating was not backrolled.
