TECHNICAL GUIDE **TROUBLESHOOTING**

Prepared by NEOGARD® Technical Service • November, 2014

WATERPROOFING, FLOORING & ROOFING
CAUSE, REPAIR, & PREVENTION

November 2015 Edition

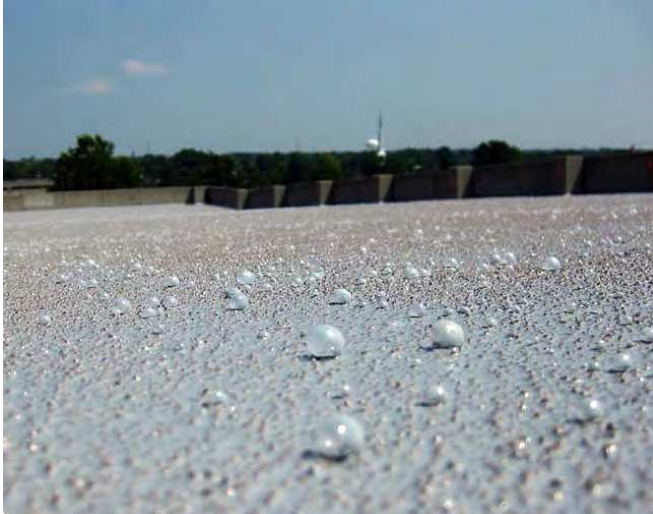
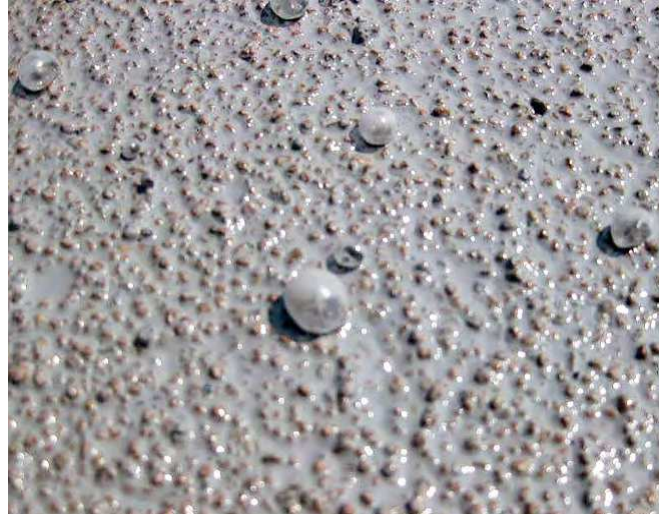
Pinholes appear as tiny blisters or bubbles. When these blisters pop they usually leave a round crater and the pinhole should be easily seen through the film.

- **POROUS CONCRETE:** Concrete releases air and moisture vapor that expands as temperatures rise. Also, aggressive shot-blasting or scarifying can open concrete pores and bug holes.
- **EXCESSIVE AGGREGATE:** Air entrapped in wear coat when aggregate is applied too heavily, leaving air pockets.
- **EXCESSIVE ADDITIVES:** When over accelerated, coating rapidly forms a film, trapping air from the substrate, preventing escape during the curing process. Adding solvents can result in surface pinhole blisters if the solvent is not allowed to escape prior to gel.

- **POROUS CONCRETE:**
 - Begin application as temperatures are dropping and continuing to drop. Rising temperatures result in detrimental expansion of the moisture and air in the concrete. Falling temperatures do the opposite; the air and moisture are contracting within the concrete. See **Weather Impact** in the Support Information section of this manual.

- **EXCESSIVE AGGREGATE:** Apply wear coat at specified rates, taking care to prevent aggregate from leaving entrapped air pockets.
- **EXCESSIVE ADDITIVES:** Avoid using accelerators during hot temperatures. See **Weather Impact** in the Support Information section of this manual.

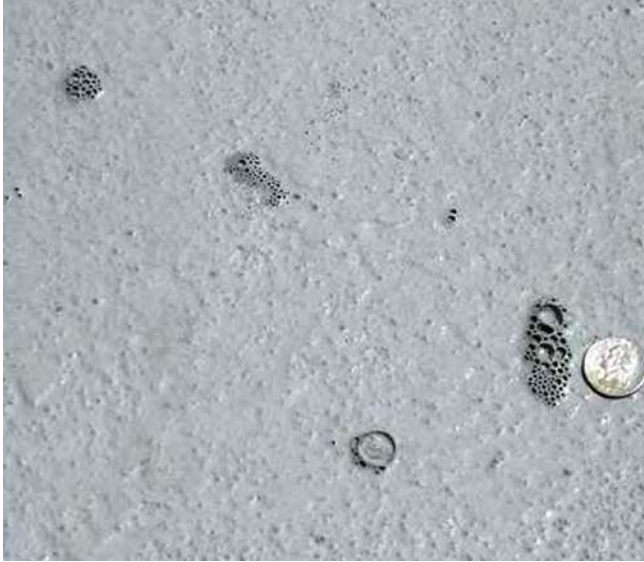
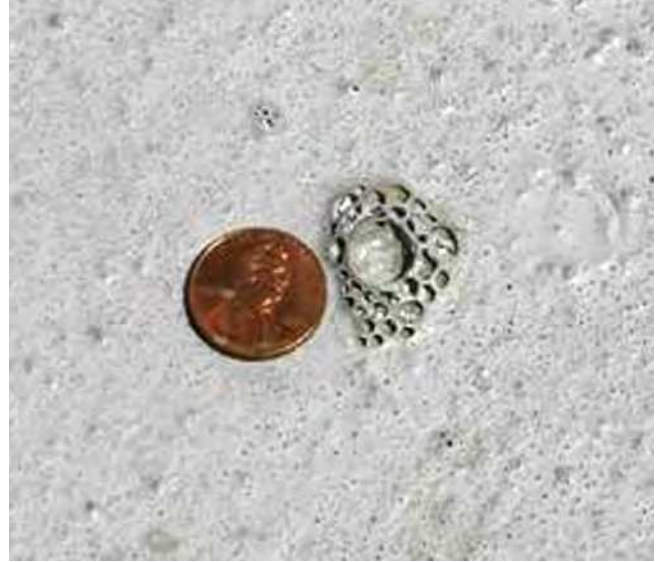
CRATERS DUE TO MOISTURE CONTAMINATION

Craters due to moisture will typically occur in clusters.

- Moisture from relative humidity or moisture contaminated aggregate will react with the coating material and cause a bubbling effect as shown above. This is caused by a chemical reaction between moisture and the urethane coating material.

- Ensure that the deck is completely dry before coating. Moisture may not be readily apparent, particularly if aggregate has been introduced into the system. Conduct a moisture test before coating application to ensure that there is no contamination.
- Keep aggregate dry as it can be a source of moisture contamination.
- Ambient surface temperature should be more than 5°F above dew point. See **Dew Point Chart** in the Support Information section of this manual for ambient temperature and relative humidity guidelines.

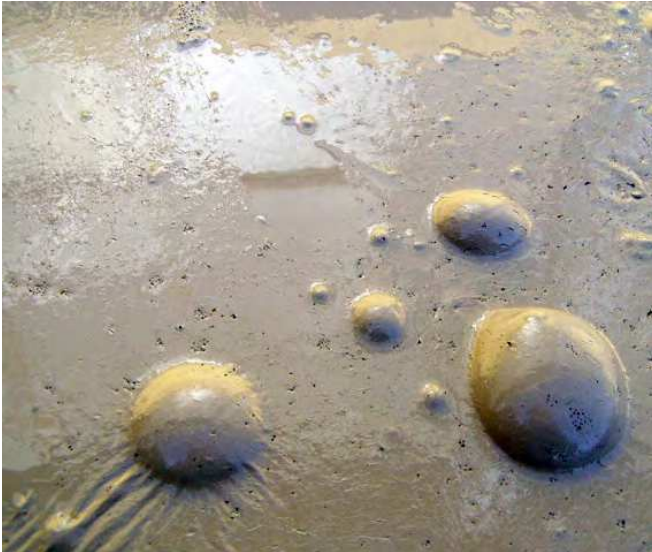
Blisters look like bubbles in the coating surface. The blisters will have a trace of water or moisture trapped inside them. Moisture between the aggregated wear coat and topcoat leaves an orange peel texture on the backside of the blister, mirroring the sand coat texture.

Blisters from rain/sprinkler system

- Do not apply coating if rain is imminent.
- Ensure that sprinkler/lawn systems remain off for the duration of the cure.
- Ambient temperature should be more than 5° above dew point. See **Dew Point Chart** in the Support Information section of this manual for ambient temperature and relative humidity guidelines.
- Ensure that the deck is completely dry before coating. Moisture may not be readily apparent, particularly if aggregate has been introduced into the system. Conduct a moisture test before application to ensure that there is no water contamination.

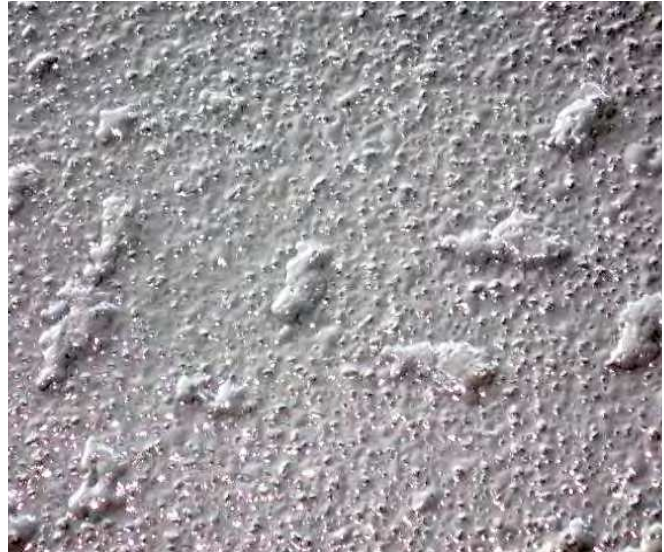
Blisters from dew

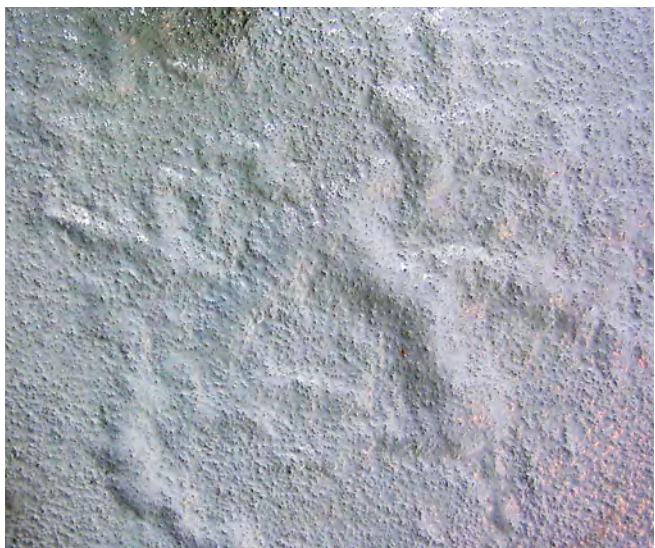
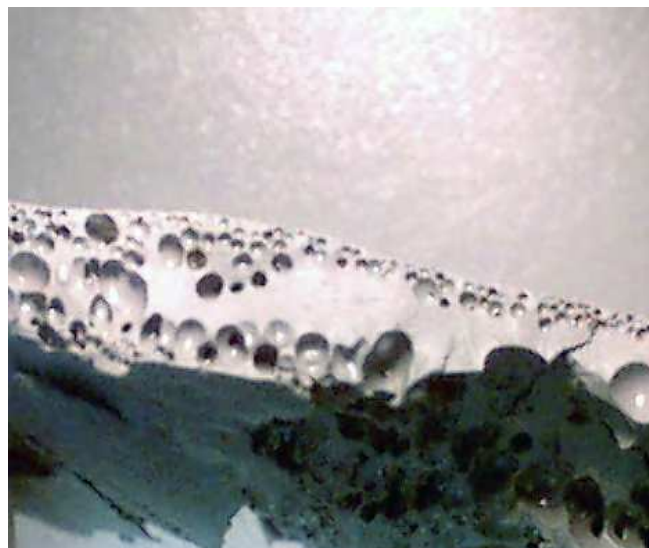
Blisters look like small to large unbroken bubbles in the coating surface and can appear round or oblong. Depending on the state of cure, they can feel spongy or fluid beneath the surface.

- Coating was applied at a rate greater than application instructions.

1. Completely remove affected areas down to cured coating or substrate.
2. Reapply coating system per NEOGARD® specifications and recommendations.

- During installation of coating, frequently check the wet film thickness by use of recommended mil gauges.
- Laying out the job prior to coating by gridding out the area will help to maintain proper and uniform coating thicknesses.
- During application, backroll to eliminate low spot areas where self-leveling coating may pool.

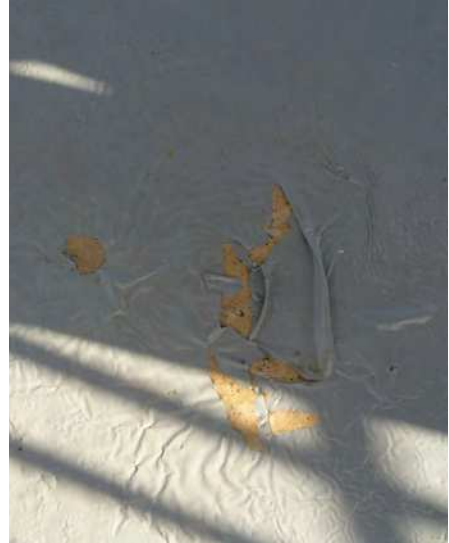
Coating is wrinkled in appearance. Multiple lines of parallel wrinkling may occur.

- **UNCURED/OFF-RATIO COATING:** Material applied over uncured or off-ratio coating, causing stress on topcoat.
- **COATING TOO THICK:** Coating applied at a thickness that exceeds application instructions.

- **UNCURED COATING:** Ensure that coatings are completely cured prior to proceeding with the application of additional coats.
- **COATING TOO THICK:** Apply coatings at recommended coverage rates.
- **OFF-RATIO COATING:** Mix all materials thoroughly, following mix ratios printed on product labels or the Product Data Sheet. See **Product Mixing Instructions** in the Support Information section of this manual.

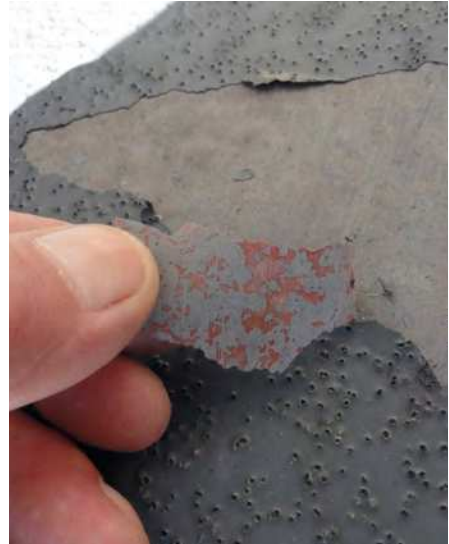
Delamination due to improper surface preparation

- **IMPROPER SURFACE PROFILE:** Surface was not shot-blasted or abraded prior to applying membrane or the base coat was applied over epoxy primer after the 24 hour window.
- **MOISTURE:** There was dew or other moisture on the surface that was coated.
- **CONTAMINATION FROM DUST, DIRT, ETC.:** Coating over contaminated surfaces will lead to coating failures such as loss of bond.
- **INCOMPATIBLE MATERIALS:** Materials that are incompatible with the coating will cause an array of issues including delamination.
- **THIN TOPCOAT APPLICATION:** A final topcoat applied at insufficient coverage rates may delaminate and peel from the coating system.

1. Remove all loosely bonded material.
2. If substrate is exposed, abrasion may be necessary.
3. Clean repair area.
4. Re-apply material as specified and per NEOGARD® recommendations.

- **IMPROPER SURFACE PROFILE:** Substrate should be shot-blasted or abraded and cleaned prior to application of primer. Surface should ideally be shot-blasted to the required ICRI surface texture (CSP3 to CSP4) to remove surface contamination or concrete laitance and allow for optimal bonding. Base coat must be applied within 24 hours of primer application. If base coat cannot be applied within 24 hours, clean and re-apply primer or consult NEOGARD® Technical Services.
- **CONTAMINATION**—Ensure deck is clean and dry prior to application of material.
- **INCOMPATIBLE MATERIALS:** Perform field adhesion test prior to application of the coating when installing coating over existing coating system. See **Field Adhesion Testing** in Support Information section of this manual.
- Apply coating at specified rates and per NEOGARD® recommendations.

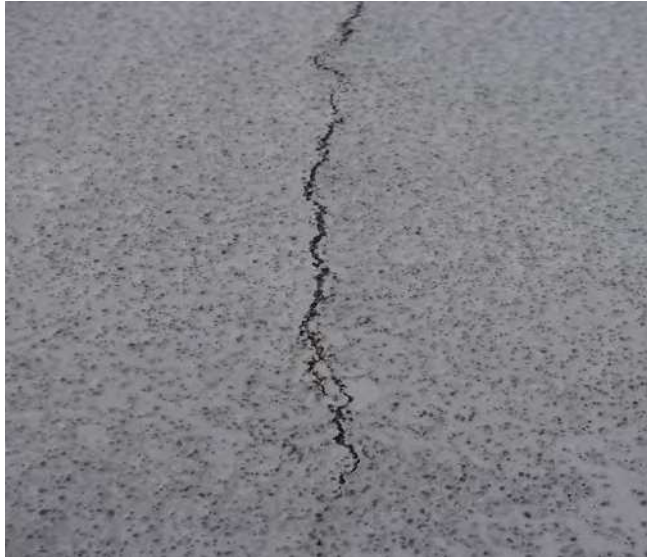
CRACKS

Cracks in concrete substrate may telegraph through the coating and become clearly visible. Over time, these cracks may increase in number as well as in size.

- **SETTLING:** Substrate cracks are caused by shifting and settling of the structure after original construction.
- **EXPANSION/CONTRACTION:** Concrete structures continually experience expansion and contraction driven by temperature, moisture and load. All cracks should receive detail treatment prior to application of the base coat.

1. Route cracks.
2. Fill with NEOGARD® 70991 or 70995 polyurethane sealant and strike flush. Allow sealant to fully cure.
3. Clean repair area with NOEGARD's 8500 BioDegradable Cleaner or solvent wipe. Extend cleaning 6"–8" beyond the affected area.
4. Prime any exposed concrete.
5. Install a detail coat of base coat material extended to a minimum of 2" on either side of the crack to yield a thickness of 30 dry mils. Allow to cure and then apply required system.
6. Option to # 5 Above: Apply base coat material extended to a minimum of 3" on either side of the crack at 30 dry mils and embed reinforcing fabric into wet coating. Center fabric over urethane sealant and allow to fully cure. Apply additional base coat material as necessary to fully encapsulate reinforcing fabric. Allow detail coats to cure, then apply required system.

- Prior to application of the coating system, perform proper surface preparation including crack detail:
 - Hairline cracks (<1/16") should receive a 30 mil detail coat utilizing base coat material, a minimum of 2" on either side of crack.
 - Large cracks (>1/16") should be routed and filled with NEOGARD® 70991 or 70995 polyurethane sealant. After sealant is fully cured, apply a 30 mil detail coat utilizing base coat material extended to a minimum of 2" on either side of the crack. Reinforcing fabric is optional.

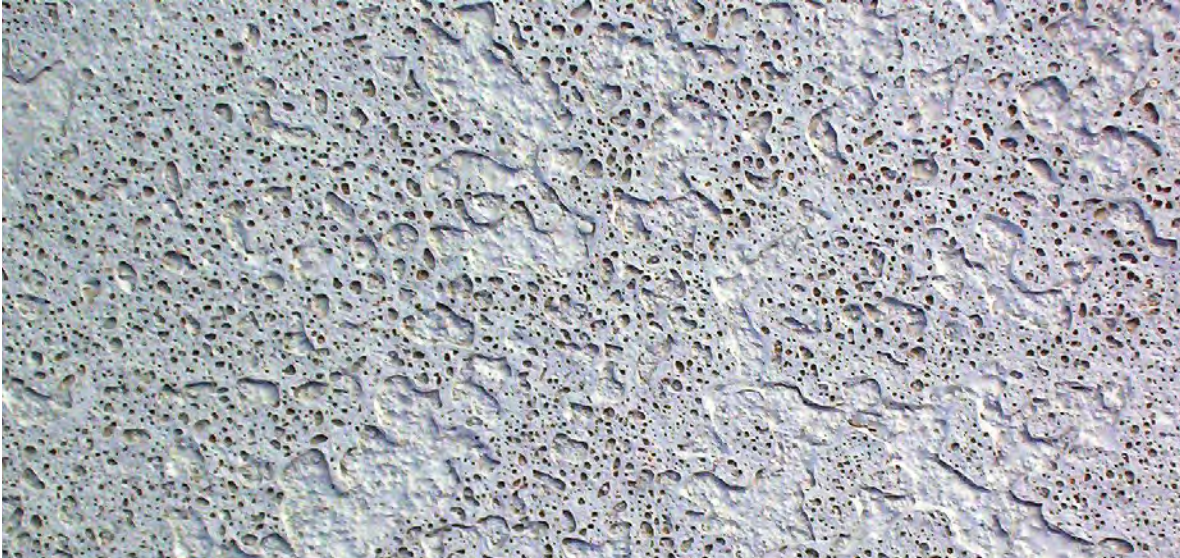
WATER DAMAGE TO UNCURED COATING

Surface has areas of sponge-like, cratered patterns where water has come in contact with uncured coating.

- Heavy rain, sprinklers or other water source caused damage to uncured coating.

1. Grind all affected areas to eliminate ridges in the cratered areas.
2. Clean and allow to completely dry.
3. Re-apply coating as specified and according to NEOGARD® recommendations.
4. In severe situations, the coating may have to be totally removed prior to re-coating.

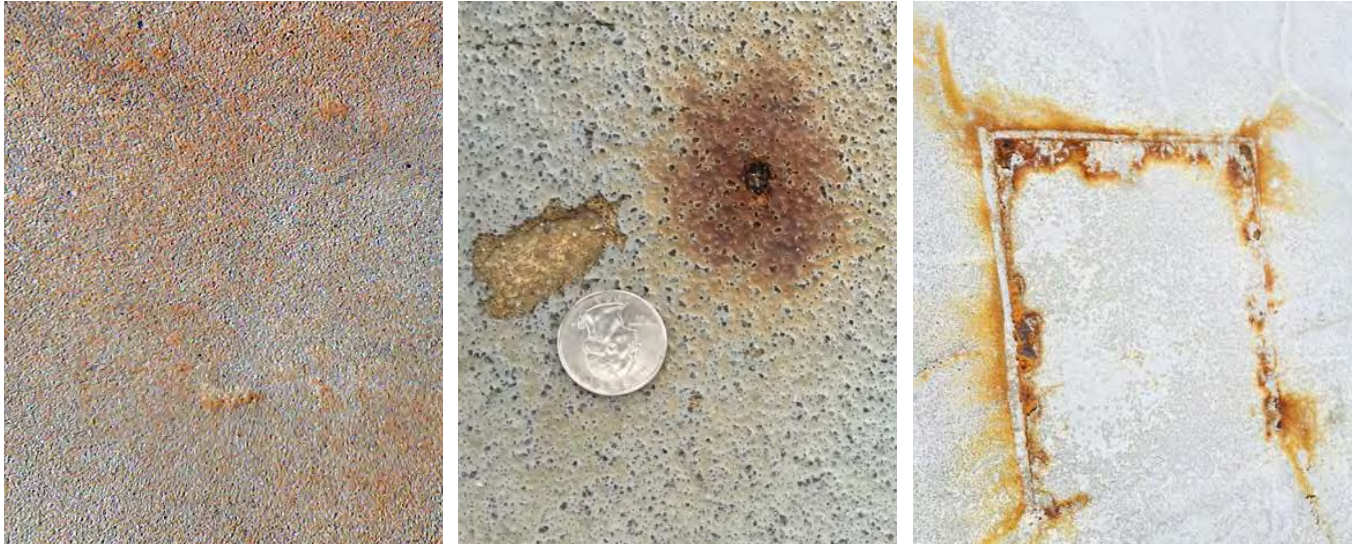
RUST/METAL CONTAMINATION

There are rusty, reddish-brown stains in the coating. The presence of rust can be purely aesthetic or may indicate a condition which affects the integrity of the coating system.

- **SHOT-BLAST BEADS:** Rust stains develop when shot-blast beads utilized during surface preparation are not properly removed. Rust stains will bleed through the entire system if metal is not removed prior to applying the coating system.
- **METAL IN AGGREGATE:** Rust may also develop from metal fines contained in the aggregate.
- **REBAR OR MESH:** Rust from rebar or mesh too close to the surface can also appear.

- **SURFACE CONTAMINATION:**
 - If the contamination source is from the surface, power washing along with the use of a rust neutralizer may remove stained area.
- **SUBSTRATE CONTAMINATION:**
 1. If the contamination source is located in the substrate, remove the coating down to the substrate and abrade the surface to remove all rust.
 2. Apply Ureprime HS2 or HS4 at a rate of 300 sf/gal to properly prepared area and allow to cure.
 3. Apply 70714/70715 Series epoxy at a rate of 100 sf/gal (16 WFT/16 DFT).
 4. Re-apply coating per specifications and NEOGARD® recommendations in the Waterproofing Application Manual.

- **SHOT-BLAST BEADS:** Remove all iron and metal residue from the substrate surface including cracks and joints.
- **METAL IN AGGREGATE:** Use NEOGARD® or NEOGARD® approved aggregates.
- **REBAR/MESH:** After the deck is cleaned and shot-blasting completed, inspect for rebar and/or mesh near the surface. If rebar or mesh is near the surface, it may be necessary for the owner to consult with a structural engineer.

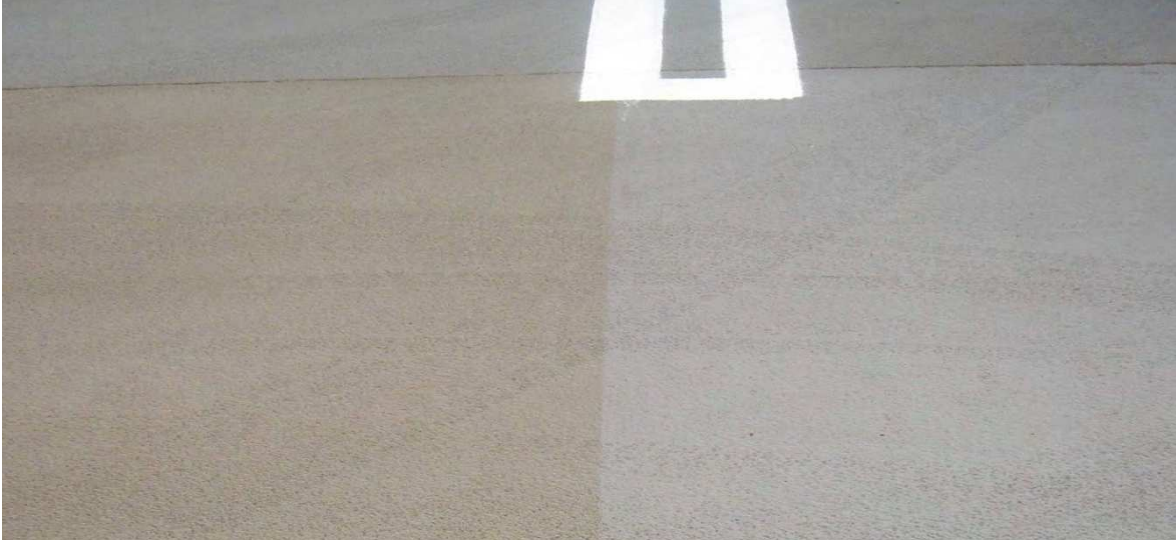
Finished waterproofing surface shows different shades of color. While considered less than aesthetically appealing, this condition does not affect the integrity of the waterproofing system.

- DIFFERENT BATCHES OF TOPCOAT: There may be slight shade variation from batch to batch of material.
- DECK NOT COATED ALL AT ONCE: The older material has weathered.
- IMPROPER MIXING: Product not mixed sufficiently to disperse pigment. See **Product Mixing Instructions** in the Support Information section of this manual.

- Apply an additional wear coat and topcoat.
- Allow sufficient time for weathering.

- DIFFERENT BATCHES OF TOPCOAT: Always purchase or set aside enough topcoat from the same production batch to coat the entire surface area. Use odd batches elsewhere such as in the wear coat if applicable. If there is not enough topcoat of a single batch to complete the project, “boxing” batches is an alternative. Boxing is the process of combining all the coating you will be using as the topcoat into one large container. This is especially important when coating a large surface area or if there is insufficient coating from a single batch, where a color variation from one batch to another is likely.

- IMPROPER MIXING: Always mix material sufficiently to properly disperse the pigment. See **Product Mixing Instructions** in the Support Information section of this manual.

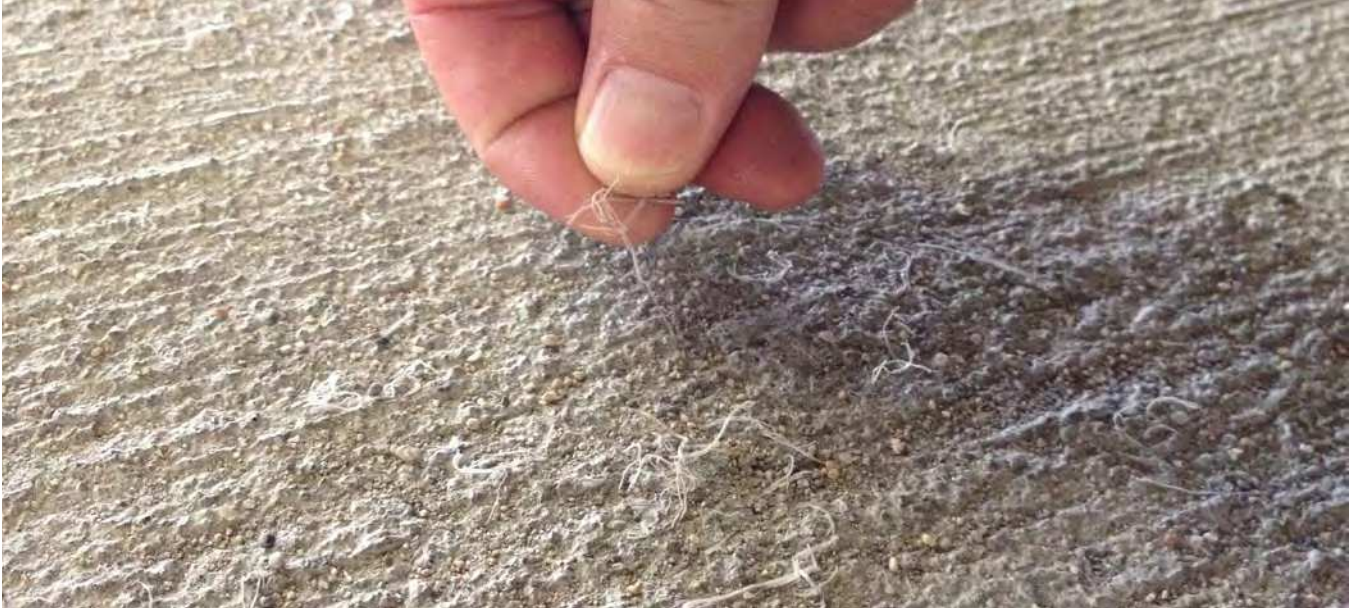
Fibers have been added to the concrete mix to control shrinkage cracks and to improve other physical properties. These fibers will protrude and breach the coating system and may cause future leaks.

- Fibers that have been added to the concrete mix will protrude through the concrete surface.

- Mechanically prepare surface by shot-blasting to industry standard texture (ICRI CSP3–CSP4) without causing defects to substrate.
- Remove fibers by burning with a propane torch.
- Remove any remaining residue prior to coating application.

- It is not recommended to use fibers in the concrete mix when a coating is to be applied. If fibers are present, remove prior to application of coating.

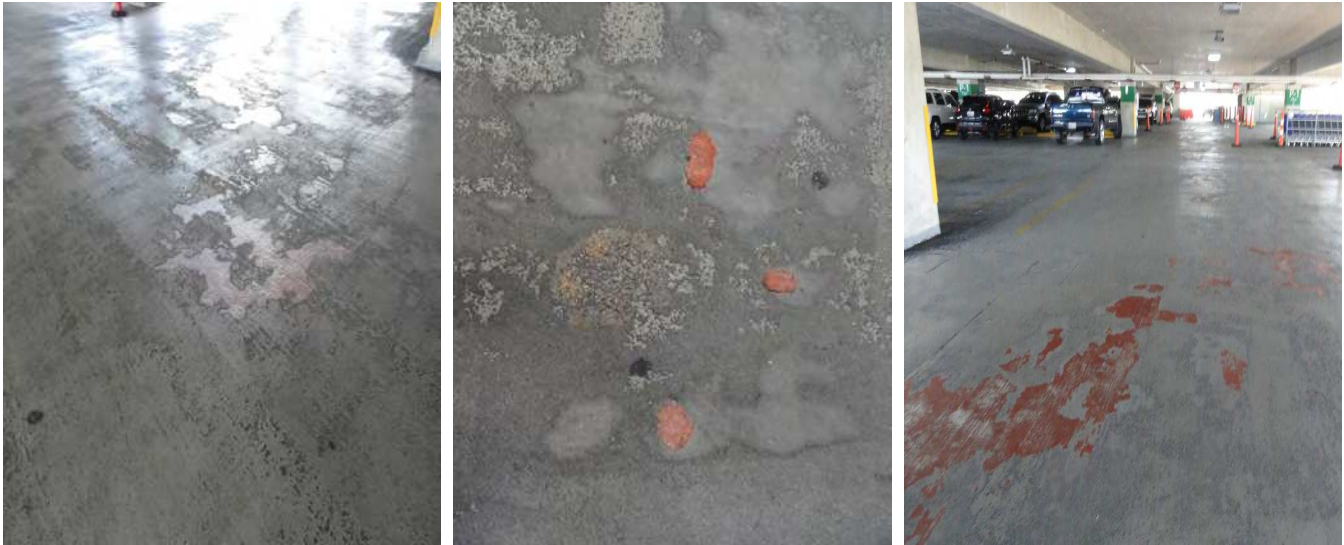
EXCESSIVE WEAR

Coating is worn, exposing primer and bare concrete.

- **INAPPROPRIATE APPLICATION:** Excess aggregate in wear coat and insufficient topcoat material led to premature wear.
- **WRONG SYSTEM SPECIFIED:** Applied system not designed for heavy duty areas such as drive lanes, turns, ticket splitters, etc.
- **MOISTURE CONTAMINATION:** Premature wear due to moisture contamination during application.
- **IMPROPER MIXING:** Failure to mix components properly prior to installation, scraping unmixed material from walls of buckets, insufficient mixing time for proper dispersion, or a contaminated mixing paddle, resulting in off-ratio components and prohibiting the proper development of physical properties.

1. Remove all loosely bonded material. In areas where primer is exposed, grind to expose substrate.
2. Clean repair area with NEOGARD® 8500 BioDegradable Cleaner and solvent wipe.
3. Re-apply coating as specified and according to NEOGARD® recommendations.

- **INSUFFICIENT COATING:** Apply system as recommended by manufacturer; include heavy duty application in designated areas.
- **SYSTEM SPECIFICATIONS:** Ensure that the appropriate system is specified for existing project conditions and use.

- **MOISTURE CONTAMINATION:** Ensure that the deck is completely dry prior to coating. Moisture may not be readily apparent, particularly if aggregate has been introduced into the system. Monitor the ambient surface temperature for the entire duration of the application process. See **Dew Point Chart** in the Support Information section of this manual for ambient temperature and relative humidity guidelines.

- **IMPROPER MIXING:** Mix all materials thoroughly following recommended mix ratios printed on product labels or the Product Data Sheet. All mixing equipment should be clean to prevent contamination. See **Product Mixing Instructions** in the Support Information section of this manual.

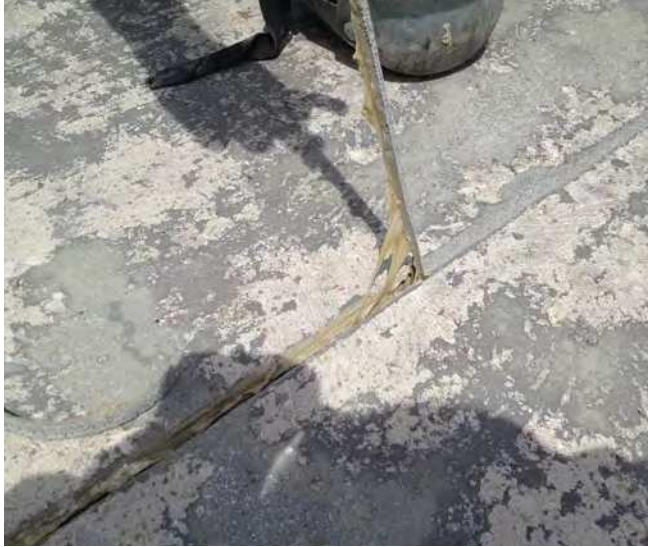
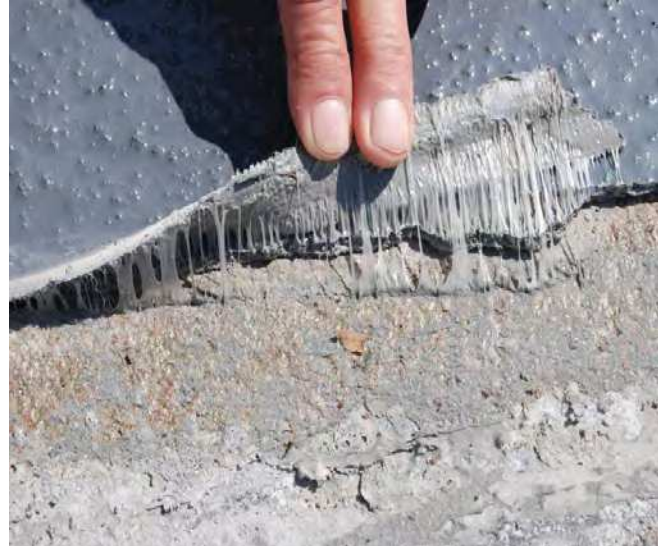
DELAMINATION CAUSED BY SEALANT

Coating delamination has occurred due to off-ratio, uncured sealant.

- Two-component sealant was improperly mixed or was contaminated.

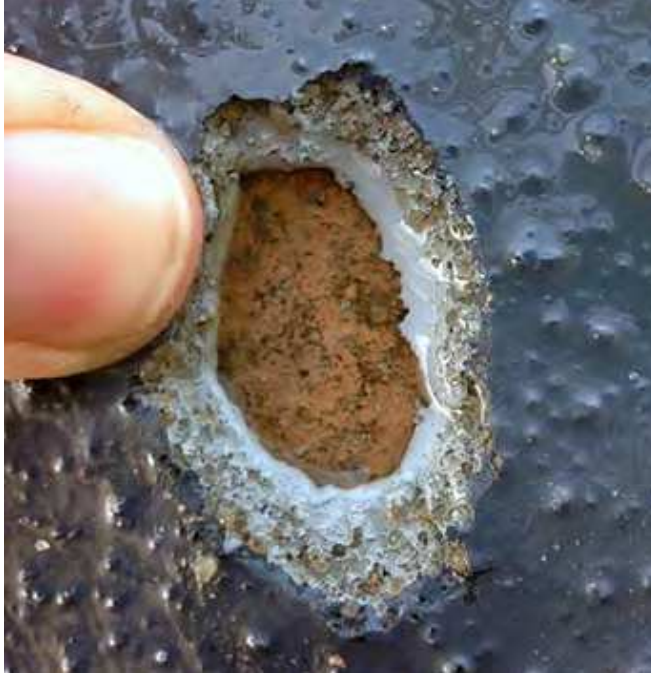
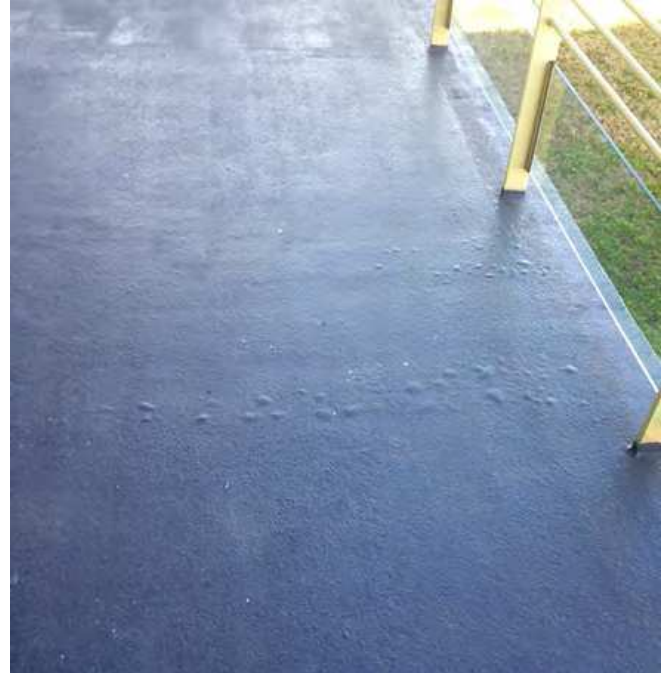
BLISTERS CAUSED BY TRAPPED MOISTURE

The coating system fails due to delamination caused by moisture migration in the concrete substrate.

- Trapped excess moisture in or below the concrete substrate.

1. Identify the source of the moisture.
2. Remove coating in affected areas down to clean substrate.
3. Re-apply coating per specifications and recommendations in the NEOGARD® Waterproofing Application Manual.

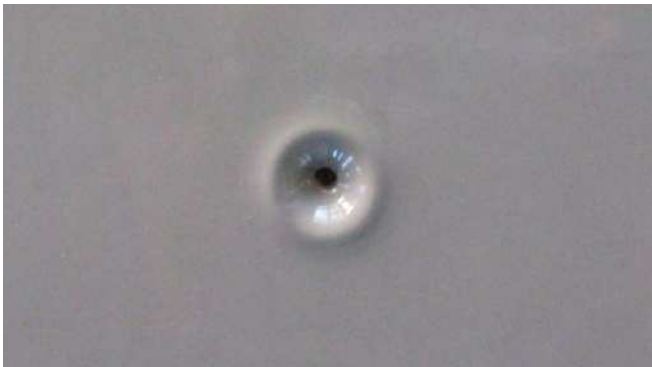
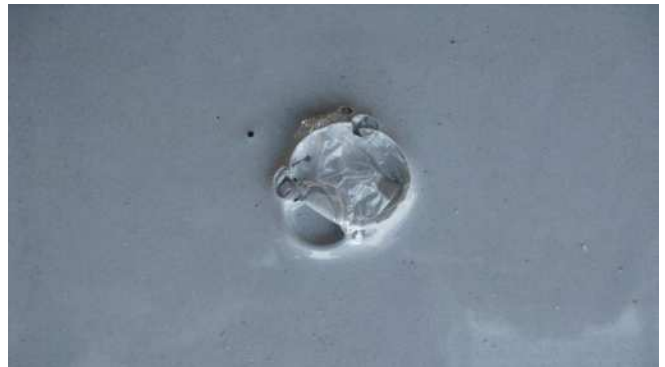
Pinholes appear as tiny blisters or bubbles. When these blisters pop they usually leave a round crater and the pinhole should be easily seen through the film.

- **OUTGASSING:** Air escapes from porous concrete and becomes trapped in the coating.
- **AIR MOVEMENT:** Excessive air movement from vents, doors or other sources may cause flash drying and prevent necessary air release from coating.
- **TEMPERATURE/HUMIDITY:** Too hot or too humid conditions can result in rapid drying that results in air entrapment in coating.
- **DIRECT SUNLIGHT:** Floors exposed to direct sunlight can tack off before sufficient air release has occurred, forming bubbles.
- **IMPROPER MIXING:** Fast speed mixing equipment and improper mixing procedures may result in entrapped air.
- **ROLLER COVERS:** Too short or too long of a nap roller can cause air to be introduced into the coating causing air bubbles.
- **SURFACE PREP:** Aggressive shot-blasting or sandblasting will open up pores in the concrete causing air to become trapped when coating is applied.

- **AIR MOVEMENT:** Avoid any condition that can generate fast air movement across the coating. When providing ventilation, always exhaust air rather than blowing with fans.

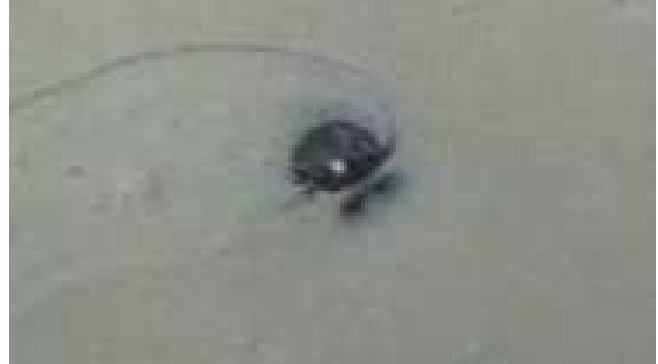
Fish eyes are round indentations or separation in the coating finish. Upon closer examination, they look like a crater with a rim around the perimeter of the defect along with a very small dot in the center – hence the name “fish eye”.

- **SILICONE CONTAMINANTS:** Certain manufacturing processes such as welding or spraying can deposit silicones on the floor causing fish eyes to appear.
- **OIL/GREASE CONTAMINANTS:** Oil or grease contaminants can cause the coating to function improperly and fish eyes to appear.

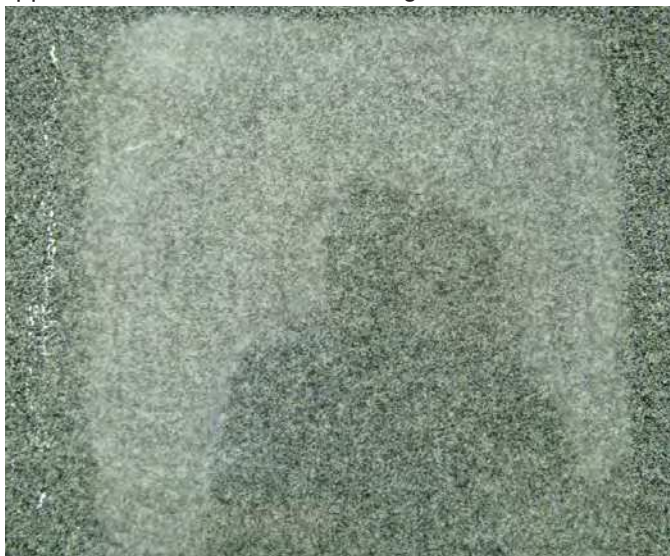
There is a milky or cloudy appearance in wet or cured coating material.

- **MOISTURE:** Moisture in the concrete or high humidity levels can cause moisture to be present on the surface when the material is applied, or before it is fully cured. This can result in a milky appearance or greasy film. This condition is sometimes referred to as “blush” and is more prevalent with certain epoxies.
- **THICK APPLICATION:** A milky or cloudy appearance may result from the coating being applied too thick. In this case, the milky appearance will be more noticeable if the coating is clear.

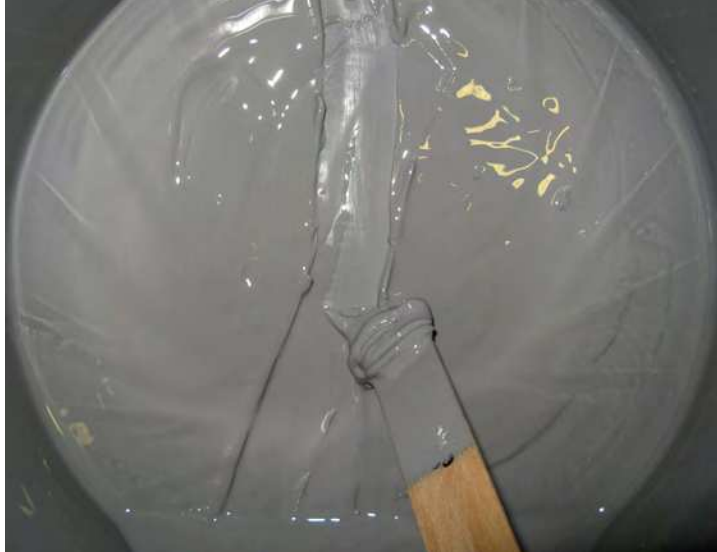
Solid material settles in the bottom of the bucket. This typically occurs in the pigmented/color side of a product.

- TIME: Some products have a tendency to settle over time.

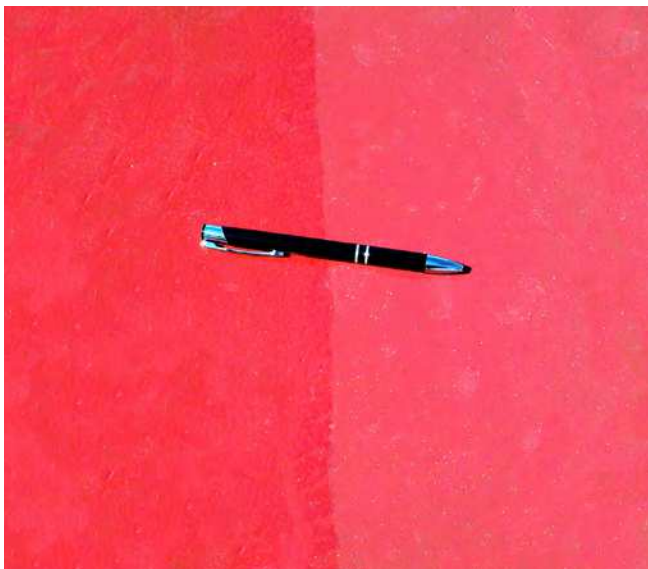
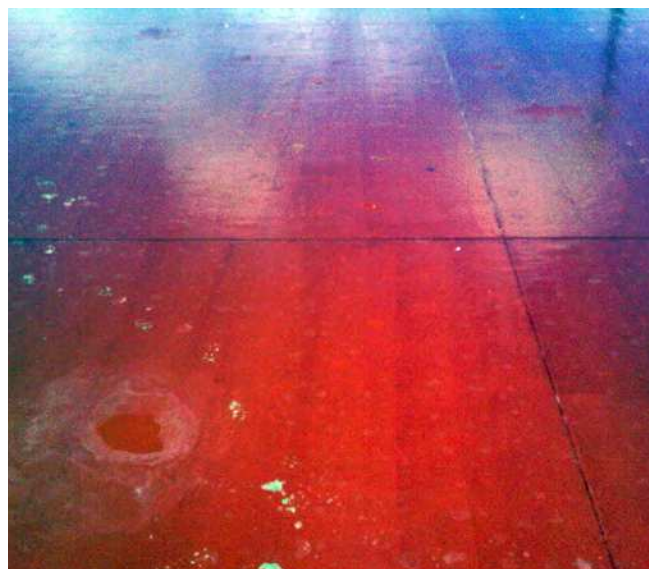
Coated surface has different shades of color.

- **RETOUCHING AFTER 15 MINUTES:** Color float issues arise when a pigmented material has been applied and it is retouched after it has been sitting for 15 minutes or longer. Different shades in color may appear.
- **DIFFERENT BATCH NUMBERS:** As coloring can vary from batch to batch, using different batch numbers at a job site can also cause differences in color appearance.

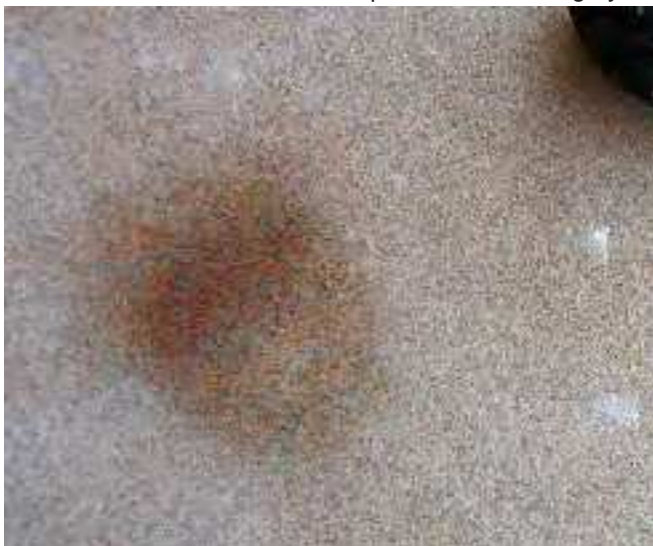
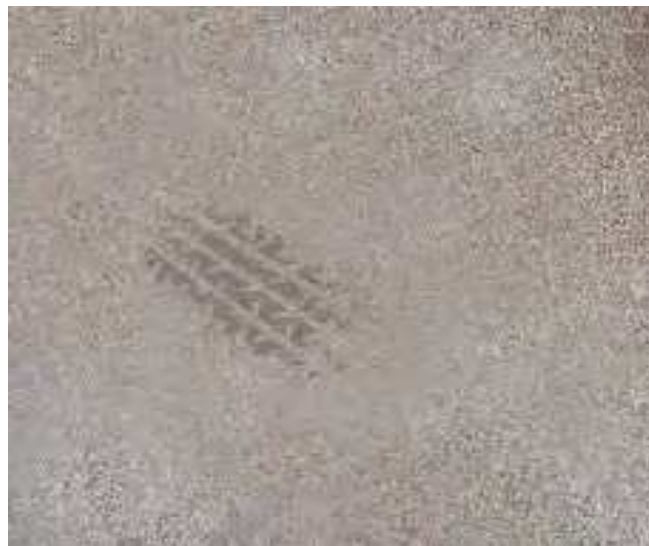
There are dark or discolored spots in the coating system.

- **CHEMICAL EXPOSURE OR SPILLS:** Floor has been exposed to chemicals.
- **TIRE MARKS:** Floor has been exposed to vehicular traffic.

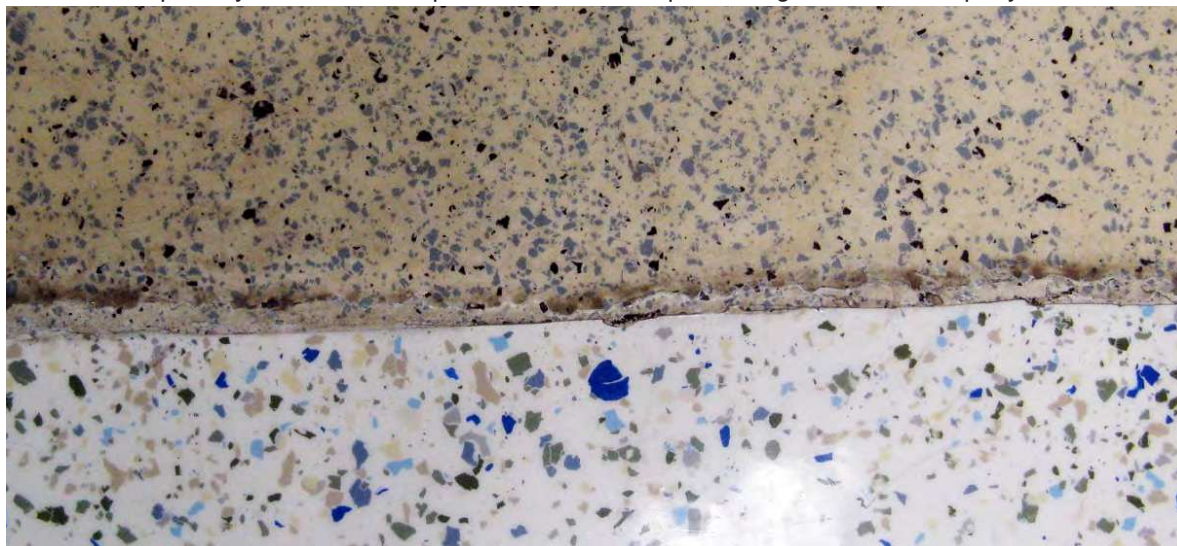
Topcoat has developed a yellow hue. This problem will affect epoxies regardless if the epoxy is clear or not.

- Epoxy has been exposed to partial or direct sunlight.

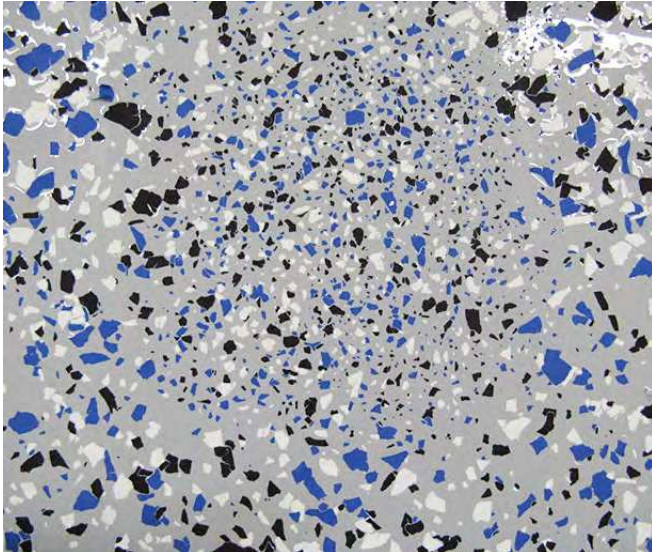
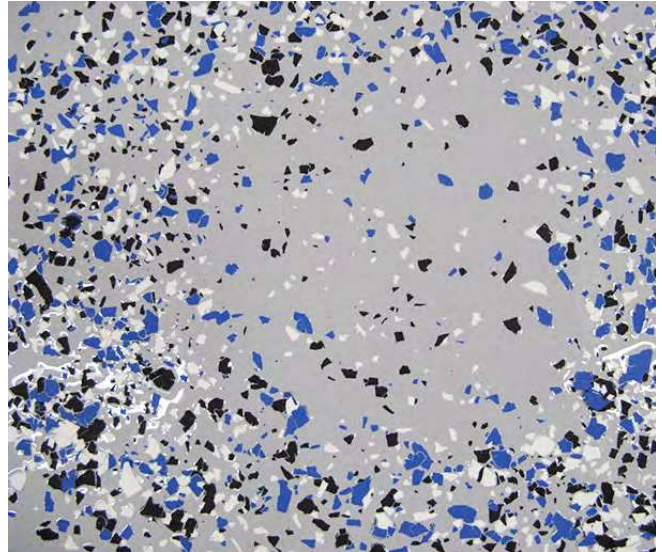
Even flake disbursement is a key factor in the aesthetics of a random flake flooring system. Having the same size and coverage of flakes is key to a uniform appearance. **Note: It is best to do a mock-up for this type flooring system, allowing the owner to see the color blend, amount and size of flake, and finish texture.**

- **FLAKES BROADCASTED TOO QUICKLY:** This leaves an uneven disbursement in the base coat. It is important that the person broadcasting the flakes take their time to ensure coverage is uniform.
- **FLAKES CRUSHED DURING BROADCAST:** This causes variations in the size of flakes. Size variation of flakes in the floor is caused by crushing the flakes in your hand as you broadcast them. In addition, each time you reach for more flakes in the bucket, you inadvertently crush them.
- **CLUMPED FLAKES:** Once clumped flakes are introduced into the wet base coat, they will remain so and dry in a clumped formation.

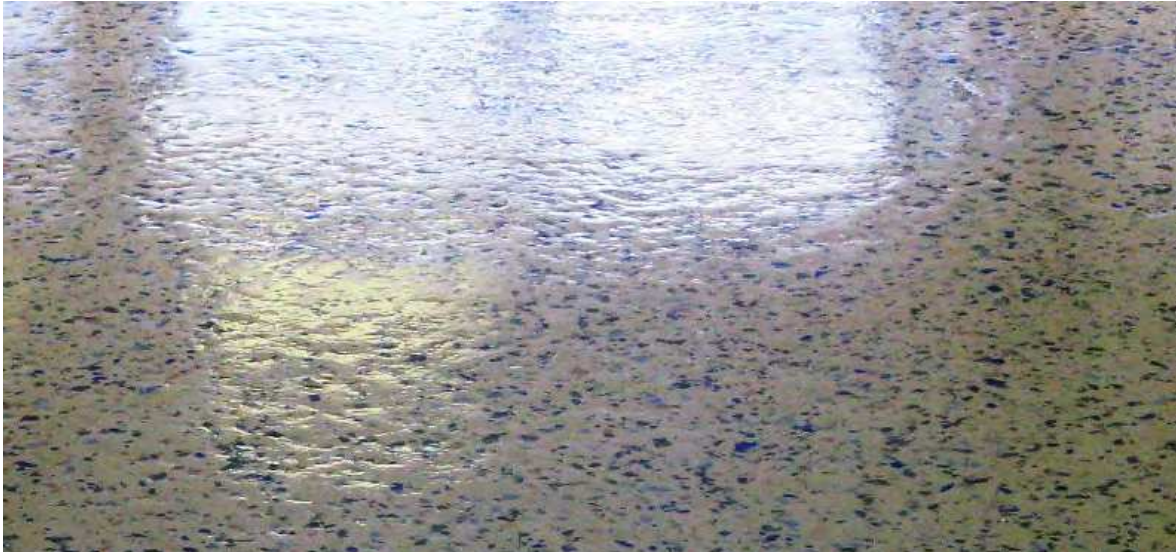
Orange peel is a stipple finish appearance in the final topcoat of epoxy or urethane flooring system. Some flooring manufacturers offer this finish as part of their systems; however, it is not always desirable to the customer.

- **COLD SUBSTRATE/MATERIALS:** If the substrate temperature is below 50°F, the epoxy or urethane will not flow and level out, and can produce the orange peel finish. This will be more prevalent if the topcoat is applied in a thin layer, somewhere between 3-6 wet mils. The combination of a cold substrate and cold materials can readily produce this type of finish.
- **HOT SUBSTRATE/MATERIALS:** Hot temperatures can also result in an orange peel finish. If the substrate is above 90°F, the topcoat may cure too quickly. This rapid curing will cause the material not to flow and level out. Just as in cold temperatures, thin topcoat layers, hot substrate temperatures and hot material can produce an orange peel finish.

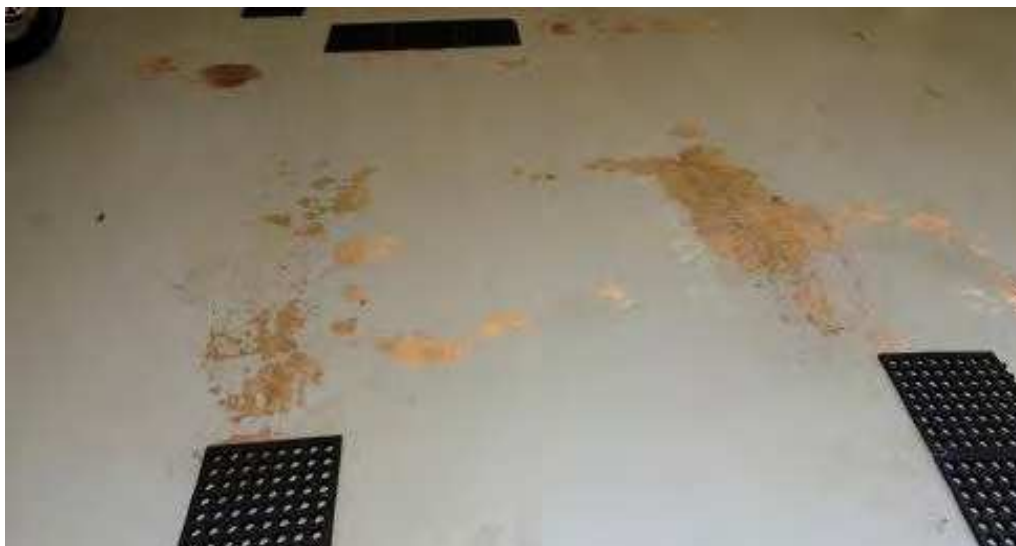
Flooring system is delaminating and peeling in areas where tires are consistently in contact with the coating.

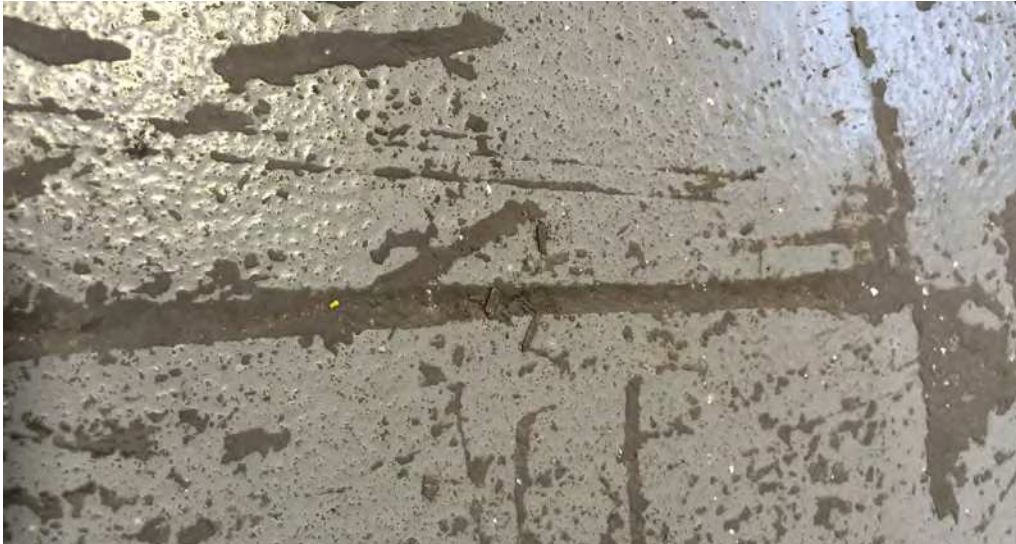
Flooring system has been scratched and/or gouged.

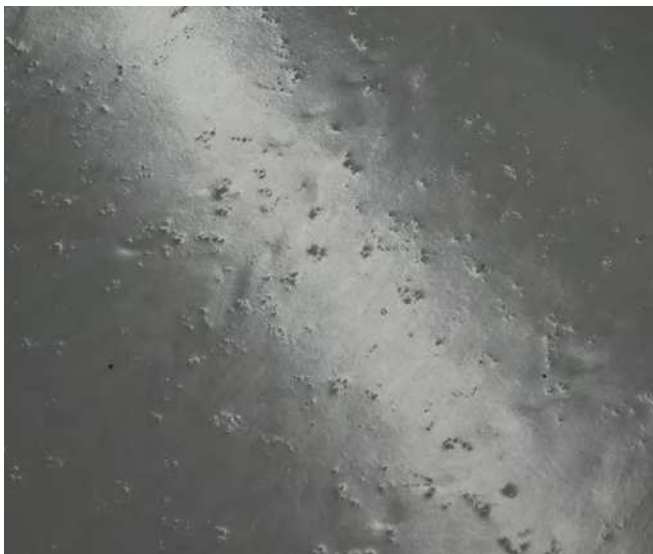
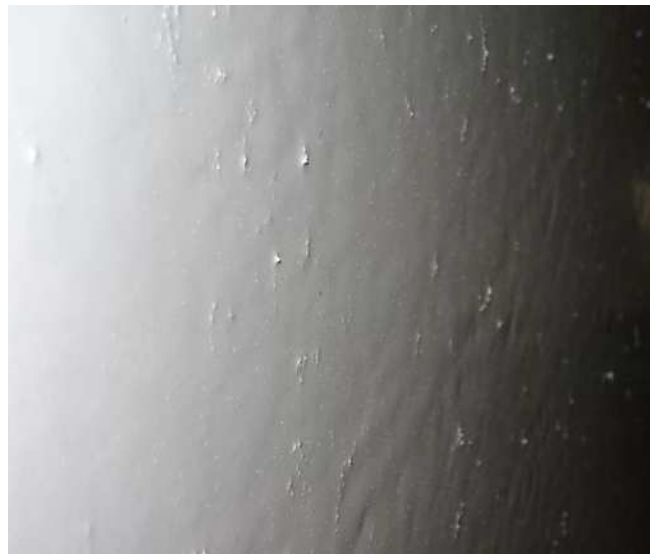
Roller lint is embedded in the coating after application.

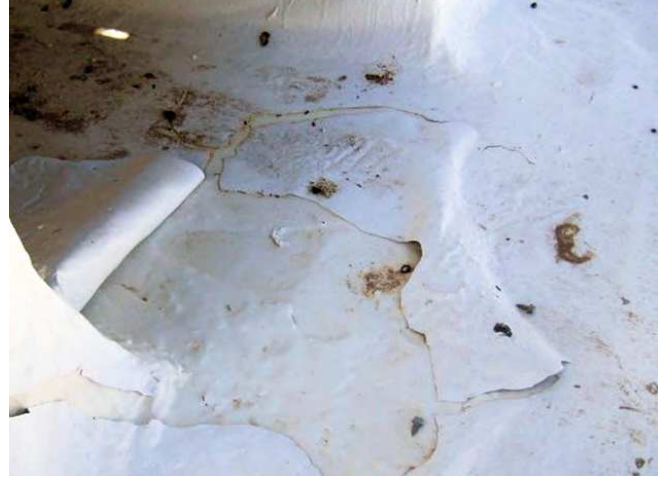
Delamination due to improper cleaning

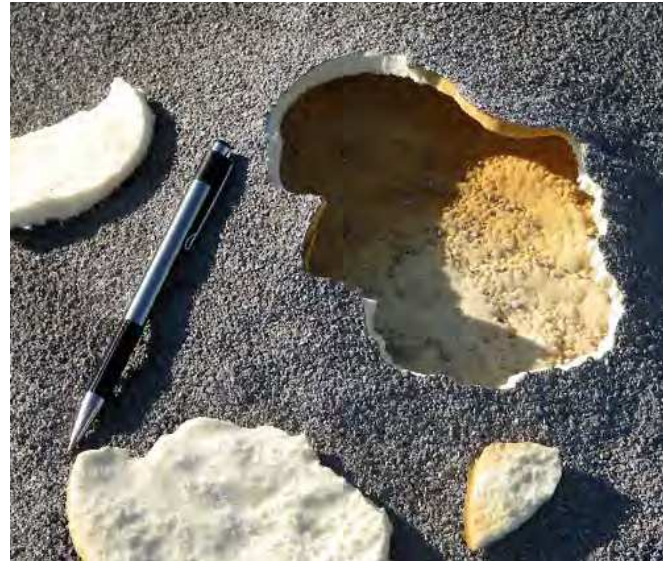
Foam blister that has been cut open

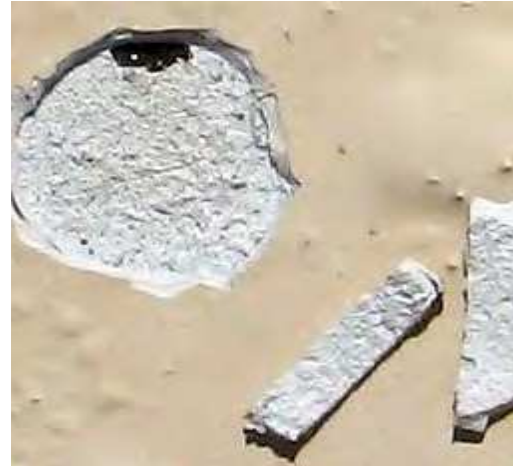
Blisters due to trapped solvent
