TECHNICAL GUIDE **TROUBLESHOOTING**

Prepared by NEOGARD® Technical Service • November, 2014

WATERPROOFING, FLOORING & ROOFING
CAUSE, REPAIR, & PREVENTION

November 2015 Edition

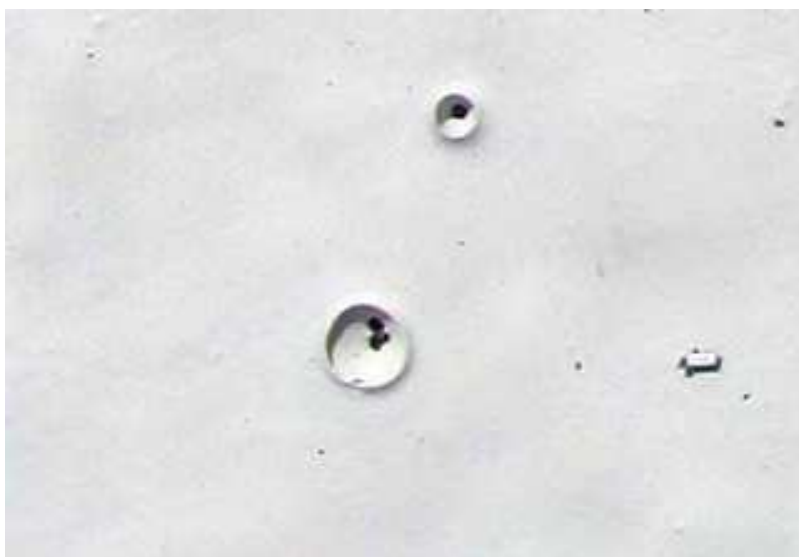
Pinholes due to outgassing appear as tiny blisters or bubbles. When these blisters pop they usually leave a round crater and the pinhole should be easily seen through the film. This condition most often occurs when applying a coating system to concrete roof decks.

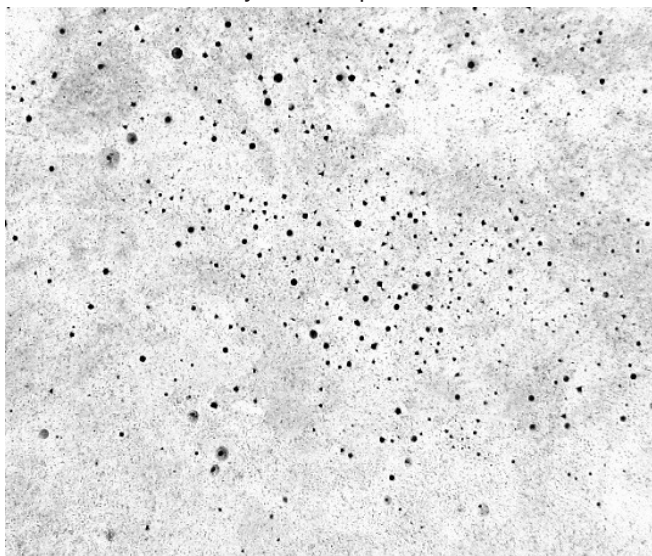
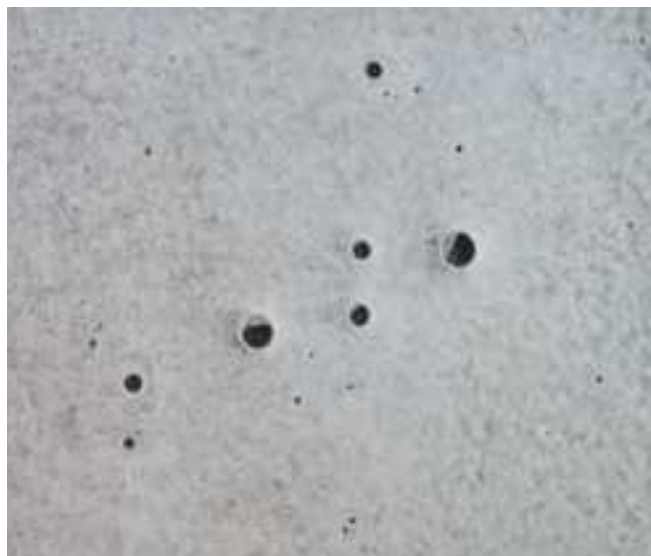
There are small voids which penetrate through the coating. A crosscut will show intact base coat material, with the voids contained only in the topcoat.

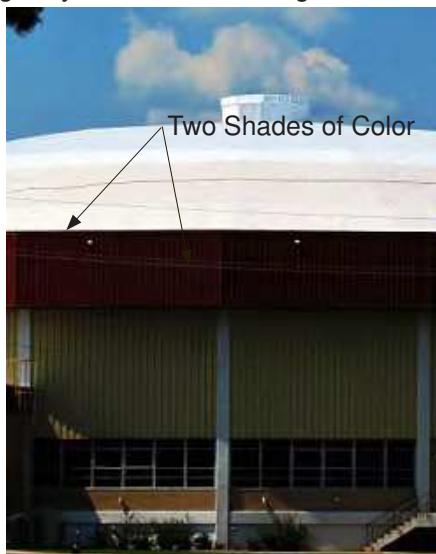
Roof with moisture contamination

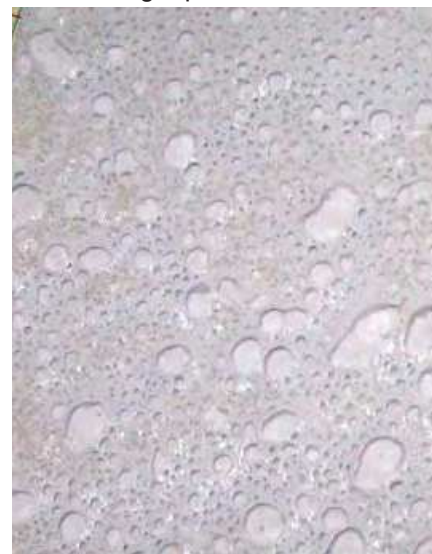
Magnified view of darker area

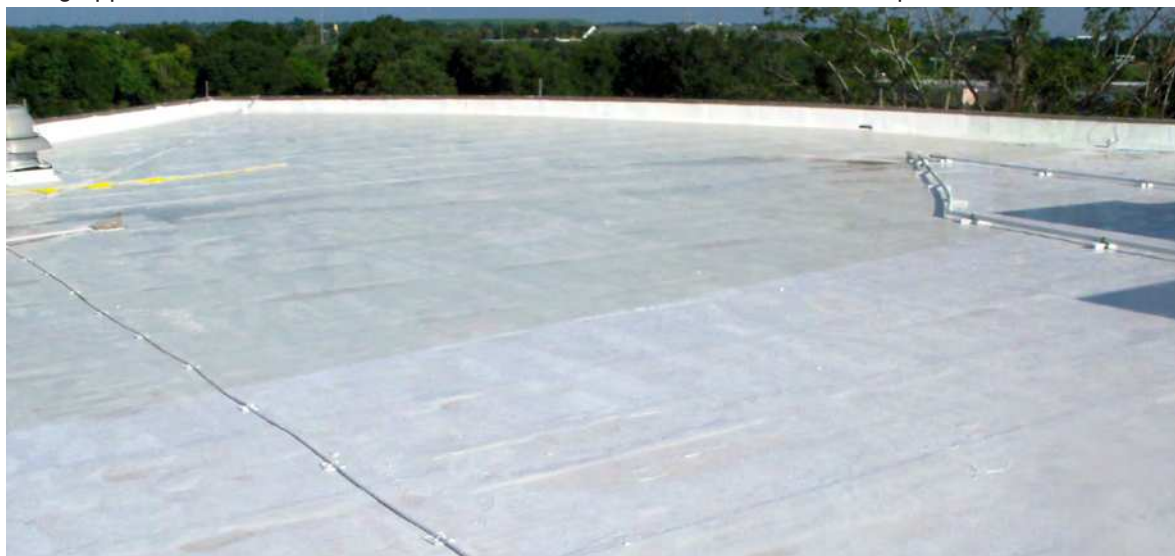
The coating appears to be different shades. This is most often noticeable in white products.

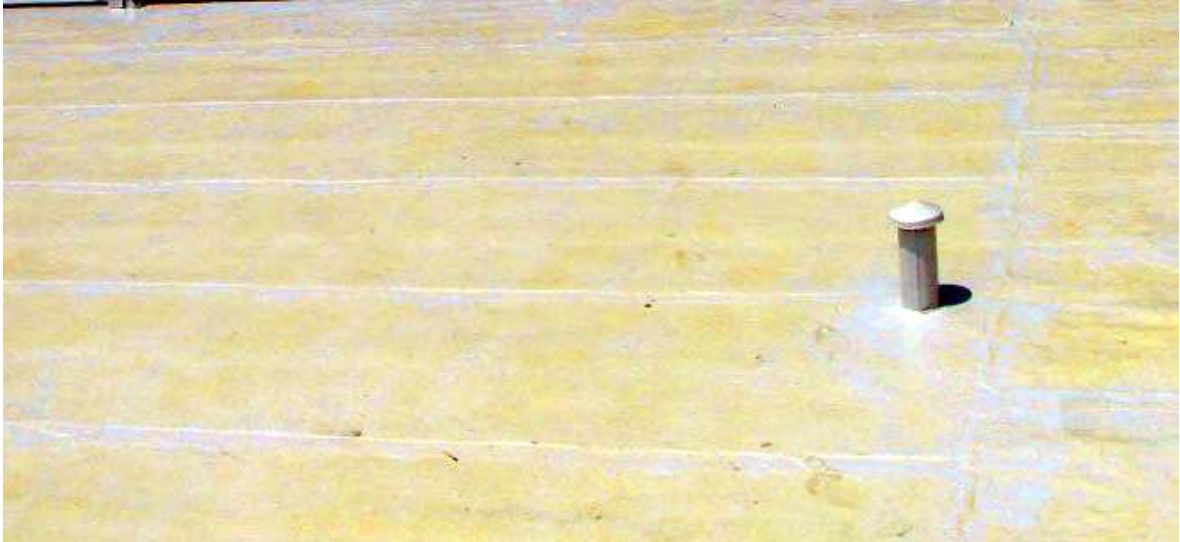
Surface of coating has taken on a yellow hue. Yellowing may be splotchy.

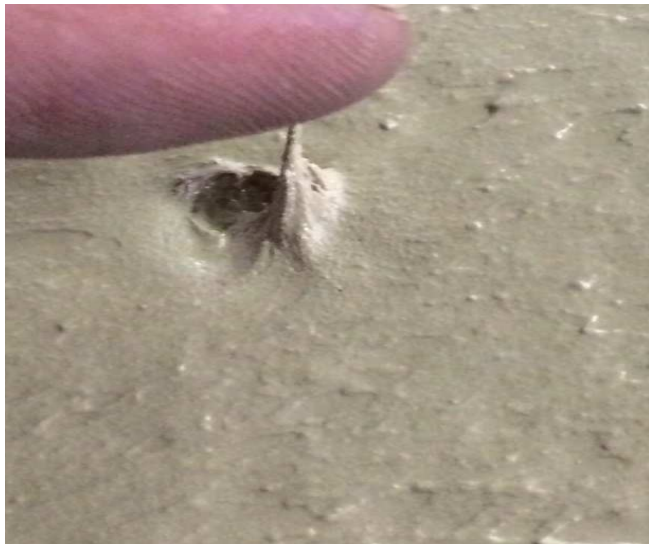
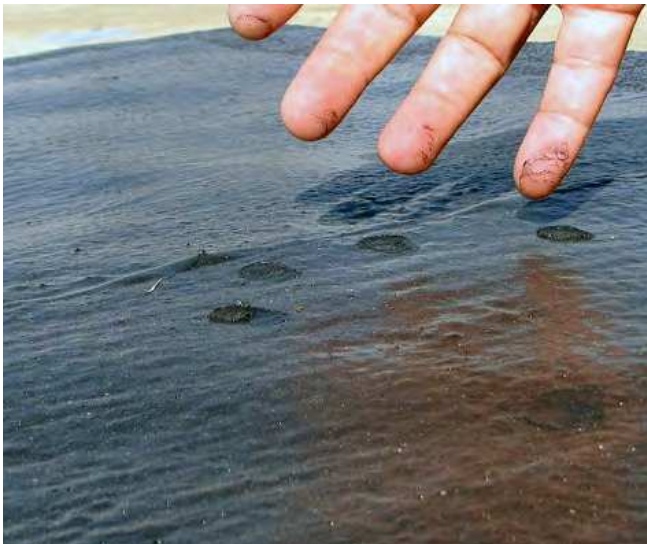
After expected curing time has elapsed, coating is still soft and may transfer when touched.

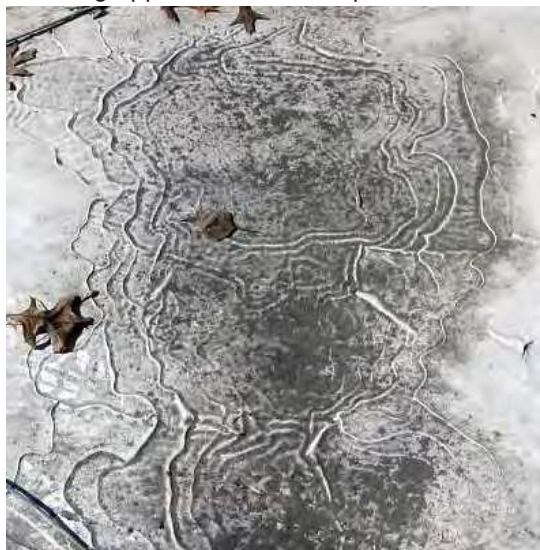
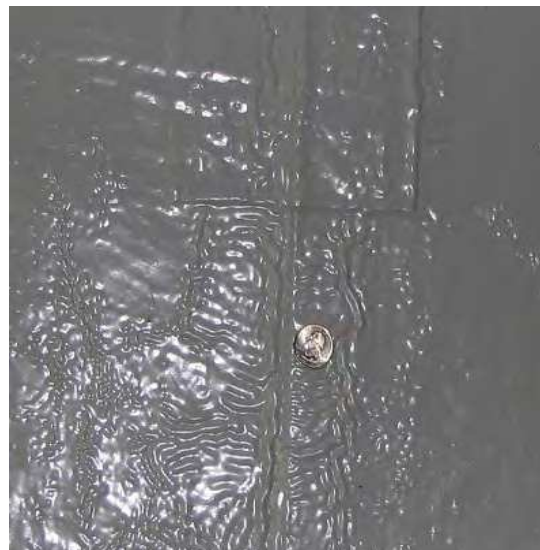
Coating appears wrinkled in places.

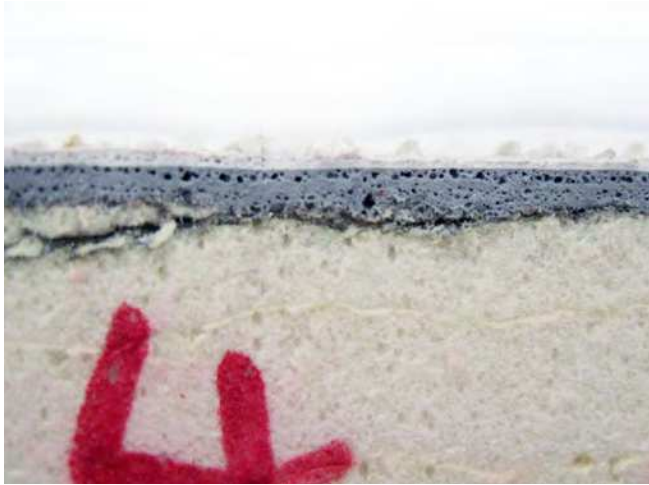
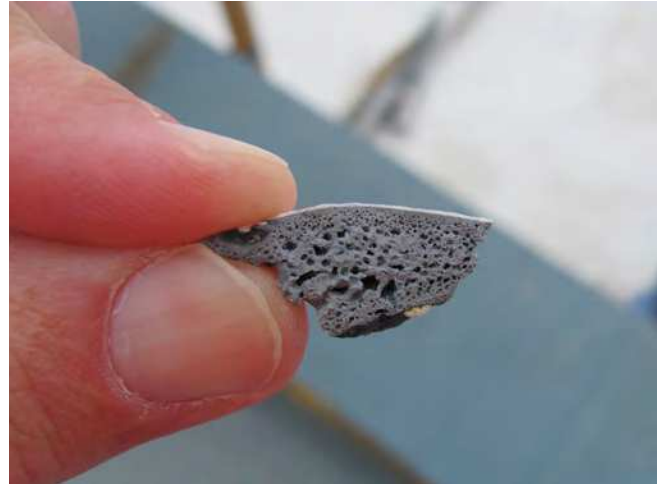
A cross section reveals a large number of open cells in the coating. During the curing process, the coating can surface cure. The chemical reaction of isocyanate and moisture develops gas bubbles which are trapped in the coating film.

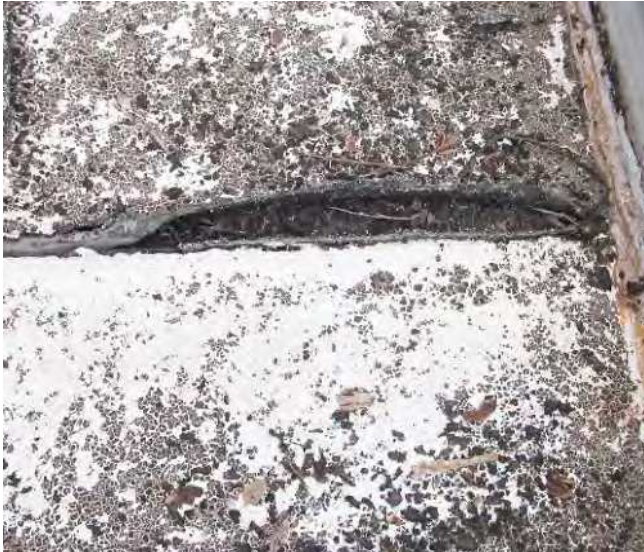
Splitting at the seams typically occurs in modified bitumen and asphalt cap sheets and is compounded by ponding water conditions. Coatings will initially display a crack transforming into a small blister type opening. The coating will then form a fish mouth, and finally the sheet will separate and pull back to form a curled edge.

Curled seam edge

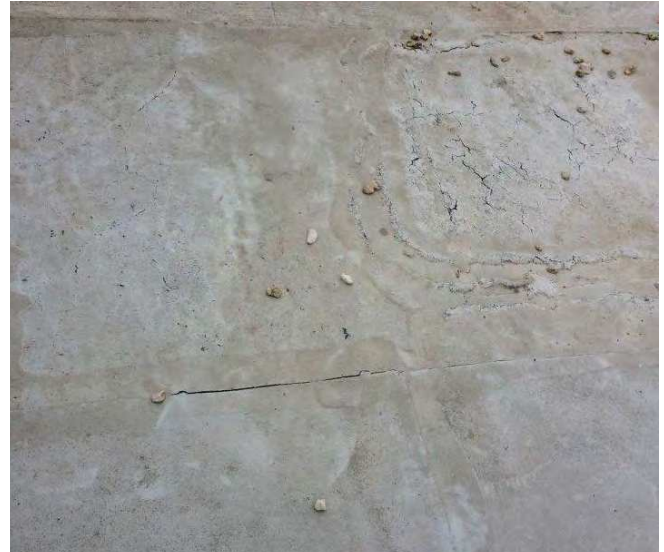
Split seam

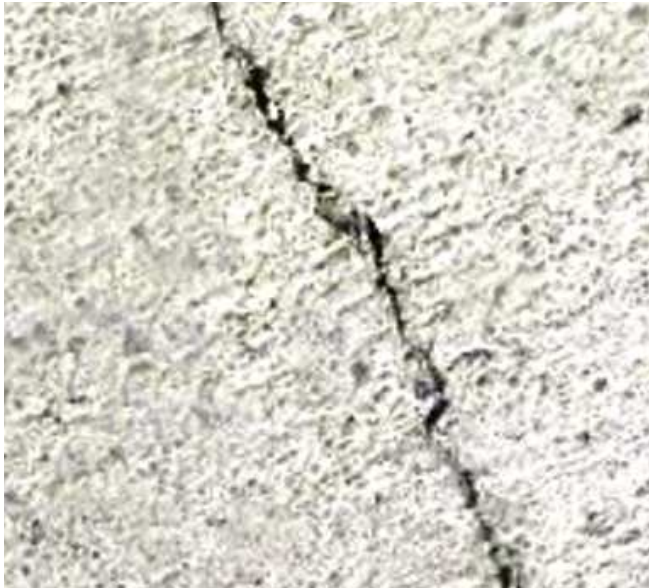
Crack before coating

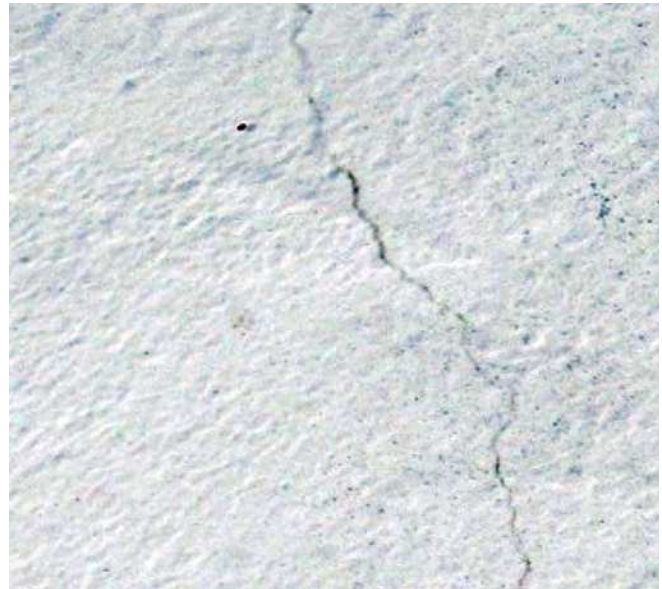
Cracks in concrete substrate may telegraph through the coating and become clearly visible. Over time, these cracks may increase in number as well as in size.

Crack in coating telegraphed from concrete deck

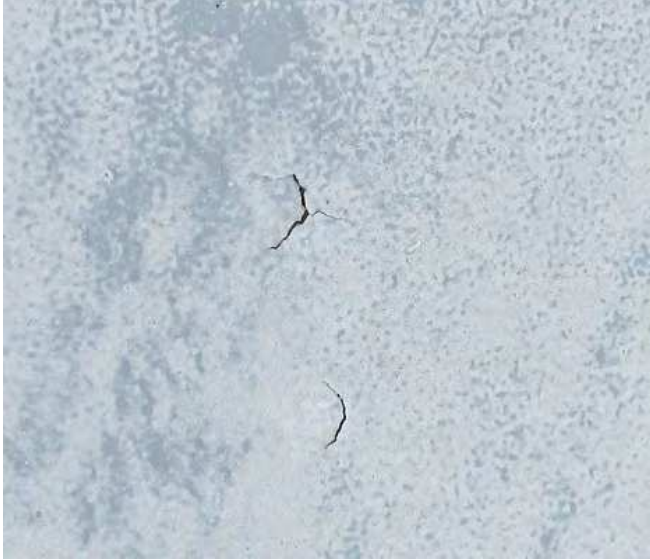
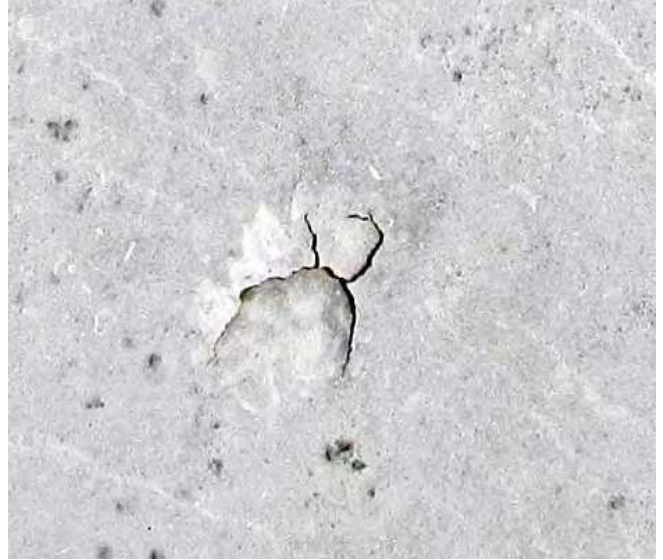
Hail damage is a random pattern of physical damage which ranges in size from that of a dime to that of a half dollar. Hail damage is generally repeated throughout large areas of the roof and not limited to single occurrences.

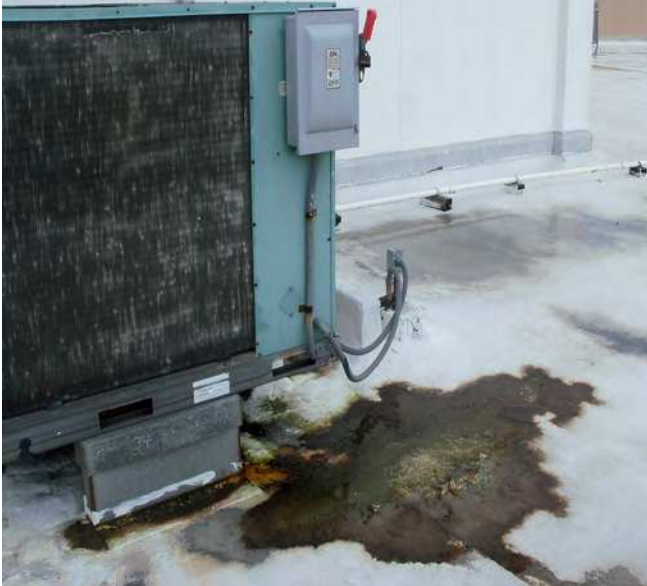
Discharge from condensation lines of rooftop equipment causes contamination of the coating.

Disconnected condensate drain lines contaminated coating.

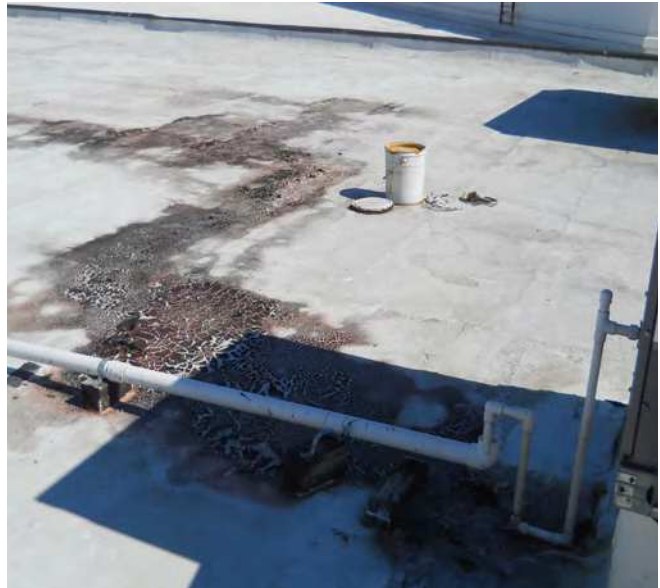
Poorly maintained condensate drain lines results in contaminated coating.

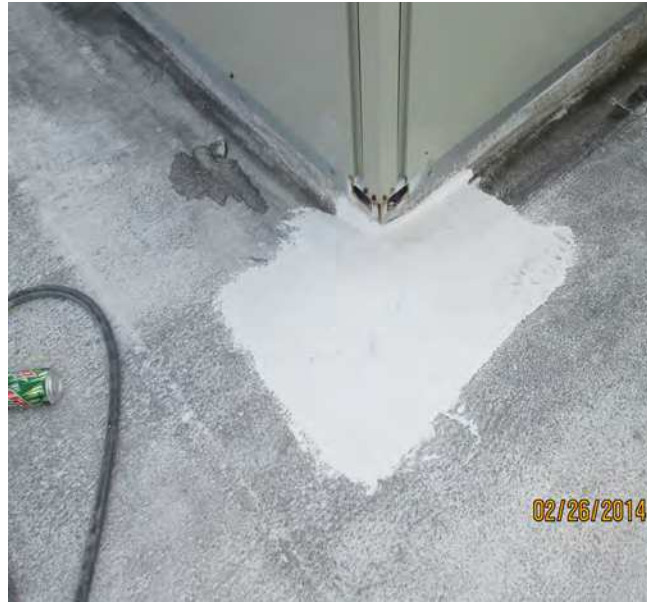
All repairs and/or recoats require a clean, dry substrate to sufficiently bond and accept new coating material. Without proper cleaning the roof coating system repair may not provide a watertight condition.

Area was not cleaned prior to repair.

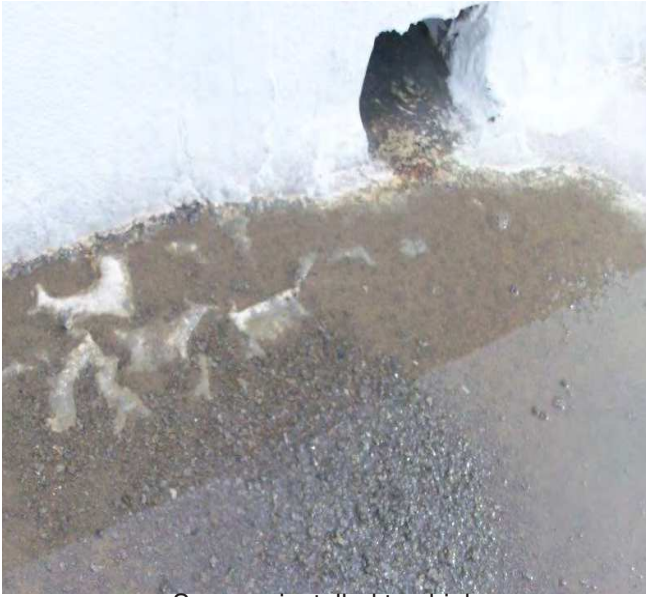
An improperly installed scupper can result in ponding of water and prevent drainage of low spots. Drains should be cleaned periodically to remove debris and allow for proper roof drainage.

Scupper installed too high

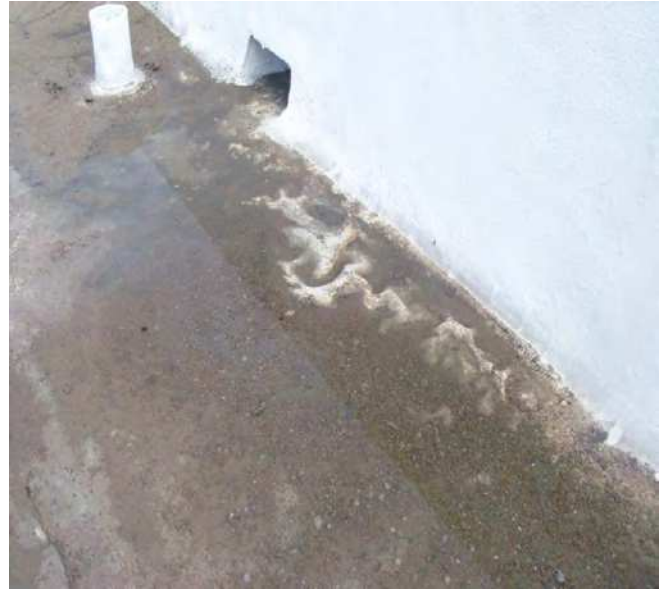
Topcoat delaminating from ponding due to clogged roof drain.

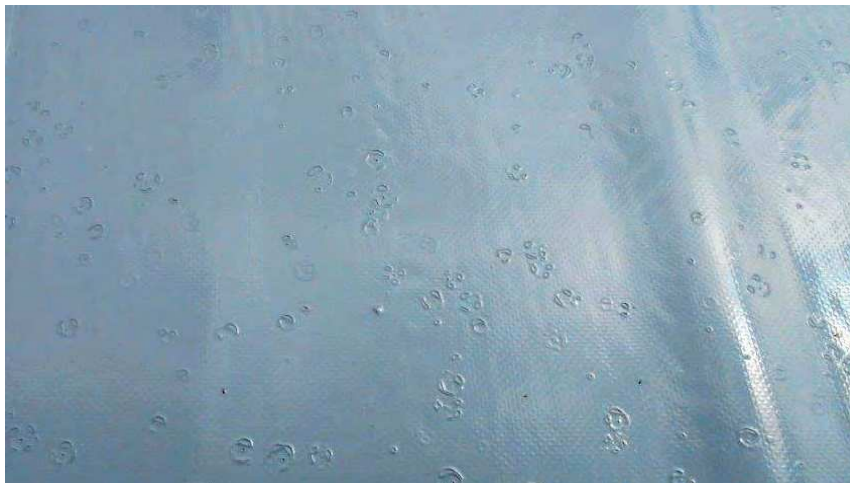
Surface has craters or 'dimples' where rain has come in contact with uncured coating.

Rain on uncured coating.

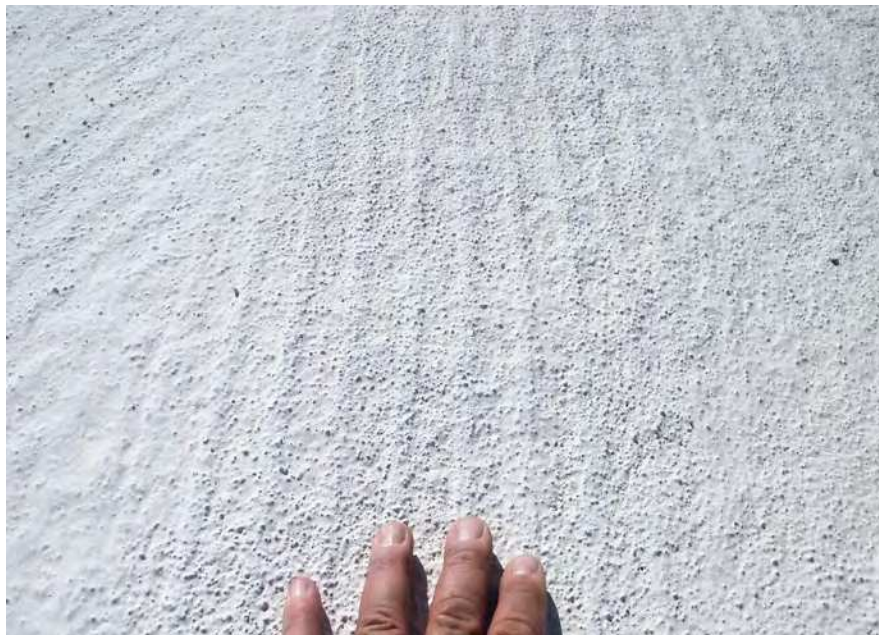
A 1/4" notched squeegee was used to apply coating and was not backrolled.

Coverage rates and aggregate distribution is inconsistent

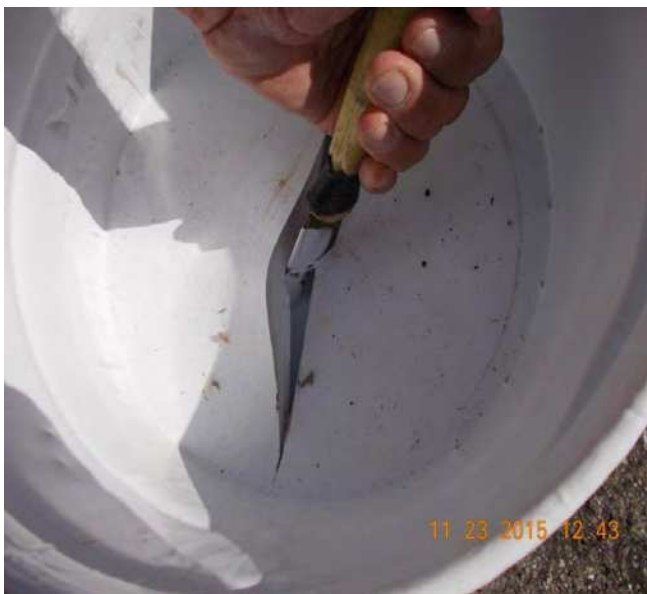
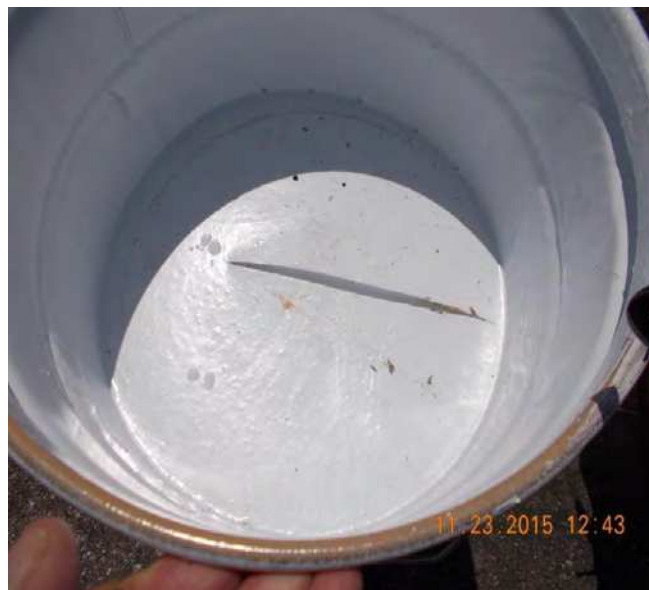
A skin forms on the top of the product in a pail or barrel.
