JOINT FILLER SEPARATION - Minor to Severe

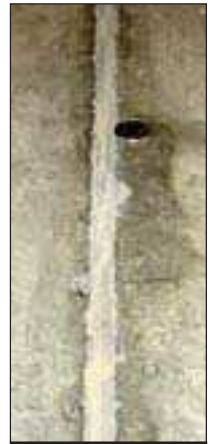
Ex. Finished Area

Overfill voids with appropriate semi-rigid filler. Monitor carefully as voids will likely require refilling as filler settles and trapped air is released. Allow filler to cure, then razor flush.

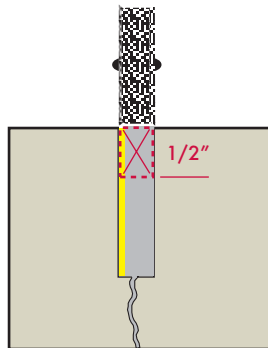
Use joint cleaning saw or right angle grinder equipped with a braided wire wheel to remove existing joint filler to a nominal depth of 1/2" below surface. It's important that all filler residue remaining on joint walls be removed back to clean concrete. A diamond blade may be required to achieve this. Vacuum joint clean.
