## ***Parking Garage Re-done with Miracote Repair Mortar and Protective Coating***

Washington Dental Service Parking Garage –  
Top Deck Restoration and Waterproofing –  
Seattle, WA

Project Contractor: Construction Solutions and Services  
Inc. – Kenmore, WA

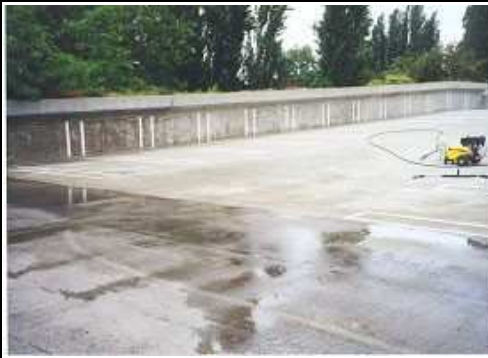
1. The first part of the project was pre-paring the surfaces. This included removing and storing for future reinstallation all of the pre-cast parking bumpers, then pressure washing the entire top deck.

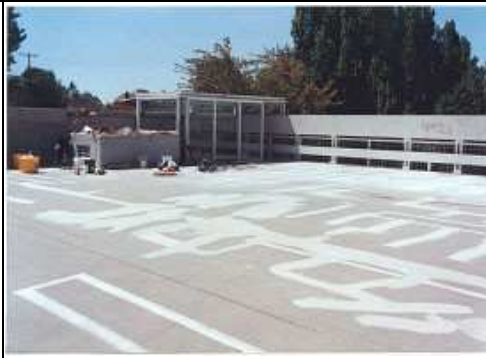
2. The next step required repairing all cracks larger than 1/16 inch with Miracote Protective Coating and imbedded fiberglass tape.

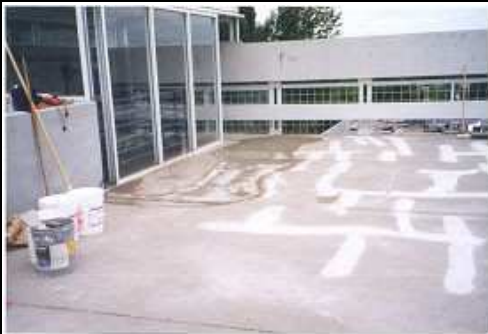
3. The low spots in the flat areas of the deck were then filled with Miracote Repair Mortar to eliminate ponding.

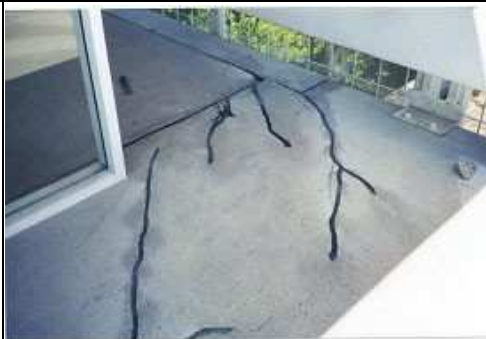
4. The largest cracks that appeared to be working and leaking directly through the topping slab and "T" slab were routed out with a crack chaser and filled with a pliable sealant.

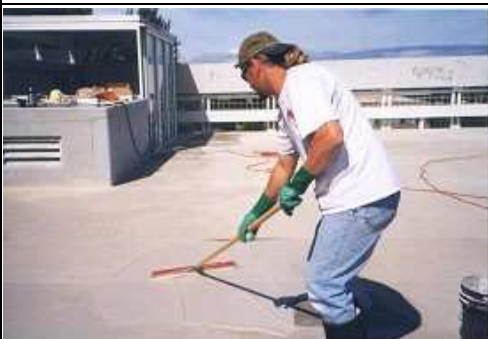
5. Next, the process of applying the first "scratch" coat of Miracote Protective Coating to smooth and fill surface voids.

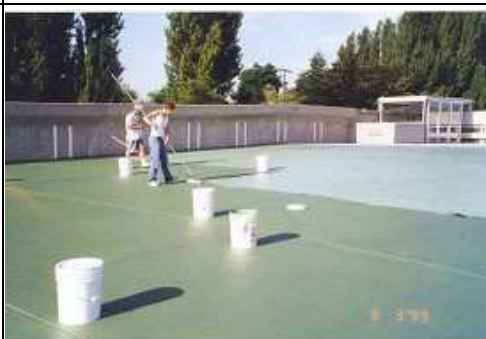
6. Followed by applying 3 coats of Miracote Membrane A.

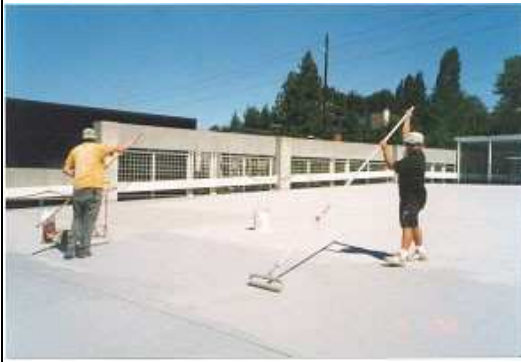
7. The membrane was then covered with three coats of Regular Miracote Protective Coating.

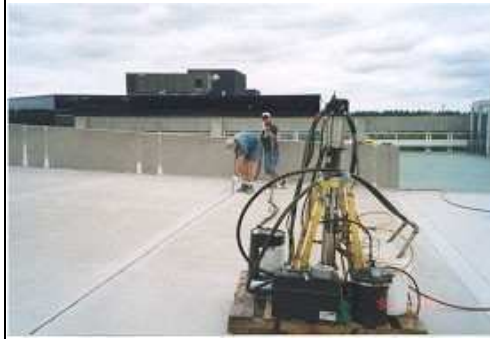
8. Then the expansion joints were filled with a two-component polyurea sealant designed to remain flexible under the vibrations of traffic loadings.

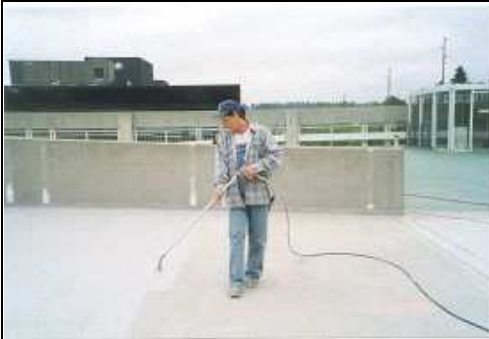
9. The final step in the system was the application of two coats of Miracote Colorbond Sealer. This can also be followed by an application of Miraseal.

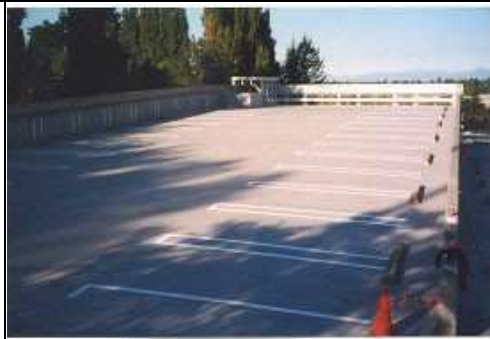
10. You can paint lines, words, etc. using any of Miracote's 15 standard. Miracote's entire system of waterproof membrane, protective coating and topcoat sealers can provide you with long-lasting protection and a readily cleanable surface.
