**Total Corrosion Management (TCM®)**  
for Reinforced Concrete

## Bringing Together the Resources for Total Corrosion Management (TCM®)

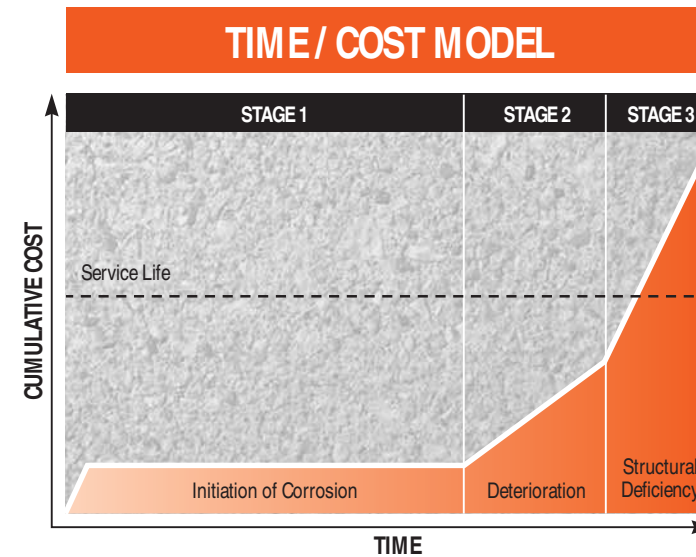
This diagram depicts the maintenance cost of a structure versus time. As time goes by the cost of repairing a structure increases at a faster rate as the steel corrodes and the concrete deteriorates.

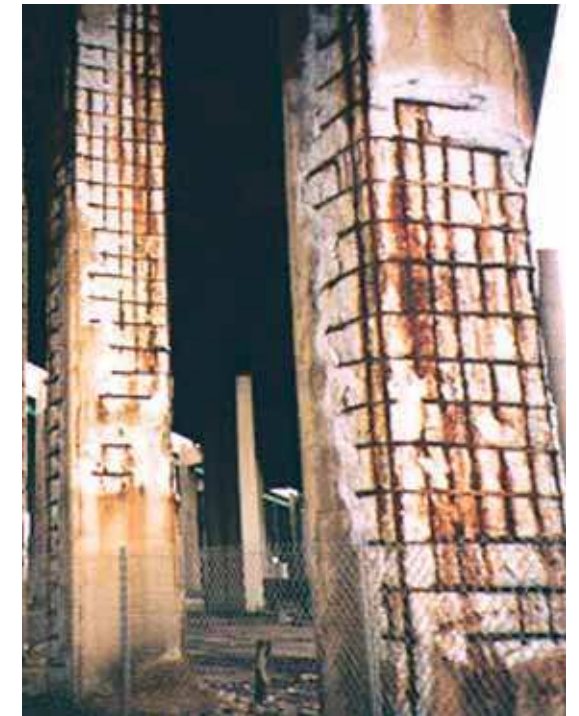
These bridge columns had to be demolished and rebuilt because the corrosion was too far advanced.

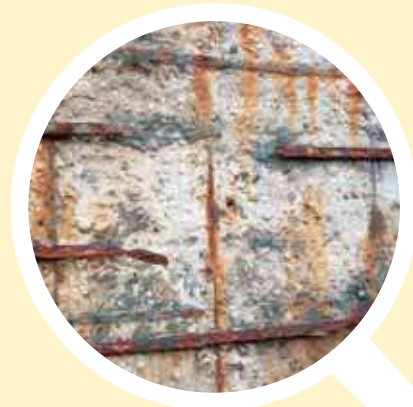
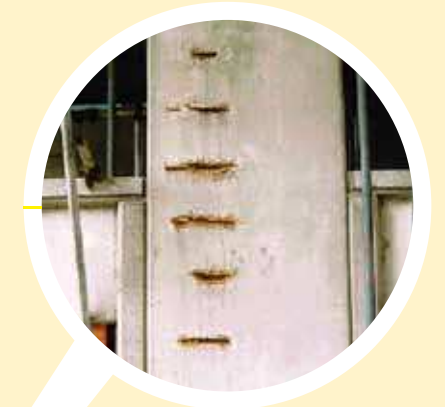
Half-cell testing

- ▲ Spall and delamination survey
- ▲ Chloride and carbonation testing
- ▲ Reinforcement mapping and cover measurements
- ▲ Half-cell potential contour mapping
- ▲ Corrosion rate assessment

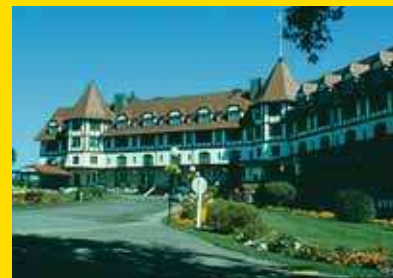
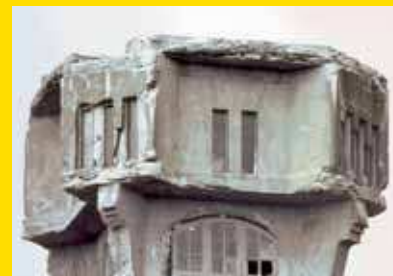
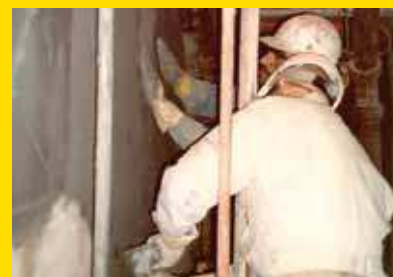
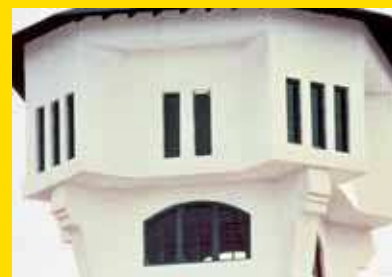
**Project**  
Algonquin Hotel, New Brunswick, Canada

**Problem**  
Beach sand and sea water were used in the concrete mix. Shallow rebar and a very aggressive salt water sea environment all contributed to accelerated corrosion of the reinforcing steel. Freezing and thawing was also a major contributor to the problems which required annual maintenance to the façade. Eventually, structural components of the building were damaged.

**Solution**  
Repairs were completed in between the busy seasons which run from May through September. SikaTop 111 and 122, polymer-modified repair mortars were used to repair the spalls. SikaTop 121 was used as a leveling coat to ensure a good surface for the coating. SikaTop 144, a cement based waterproofing coating, was used to protect all unrepaired areas of the building and to help hide the completed repairs. Finally, Sikaflex-1a, a one-part polyurethane, elastomeric sealant was used to seal joints at windows and door frames as well as control joints.

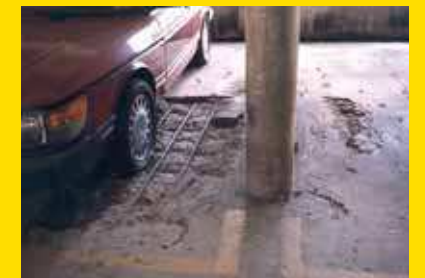
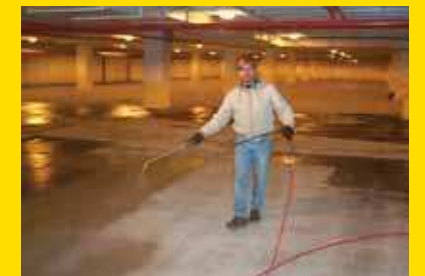
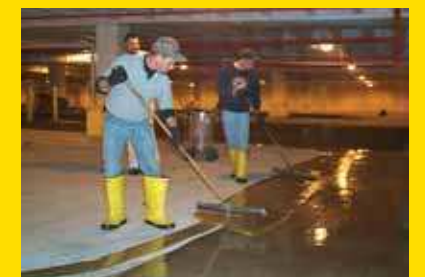
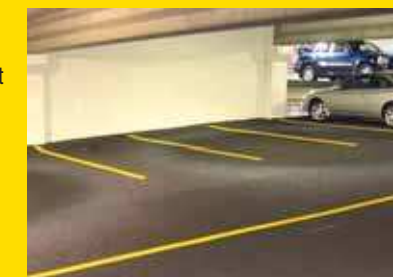
**Project**  
Cleveland Police Parking Garage, Cleveland, Ohio

**Problem**  
After years of exposure to deicing salts, the heavily reinforced slab-on-grade was contaminated with a high level of chlorides. As a result of steel corrosion, delamination of concrete was prevalent throughout.

**Solution**  
The delaminated concrete, which was approximately 50% of the 50,000 sf slab-on-grade, was removed to sound concrete. Embedded corrosion rate monitoring was installed in order to monitor both the immediate and long-term effectiveness of the repairs. The exposed reinforcing steel was cleaned. Sika Armatec 110 EpoCem, a three component, epoxy-modified rebar coating and bonding agent was applied to the exposed steel to provide added protection and to the substrate to assist in bonding. Ready mix concrete was used given the easy access and volume of repairs. Sika FerroGard 903, a surface-applied, penetrating corrosion inhibitor was applied, in particular, to mitigate active corrosion in the unrepaired areas of sound concrete which was also contaminated with chlorides. Sikadur 22, Lo Mod, a low modulus, medium viscosity, 100% solids, epoxy resin binder was squeegeed out over the entire surface to a thickness of approximately 3/16" to provide an excellent surface barrier to prevent infiltration of future water and chlorides. Black beauty aggregate was broad-cast into the wet epoxy for skid-resistance and aesthetics.

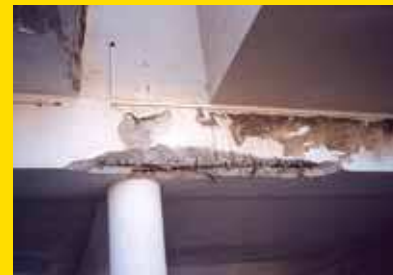
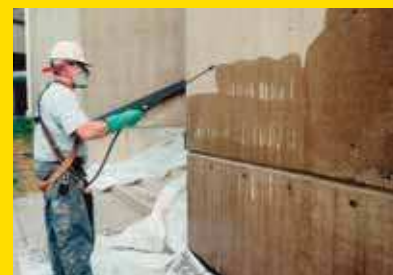
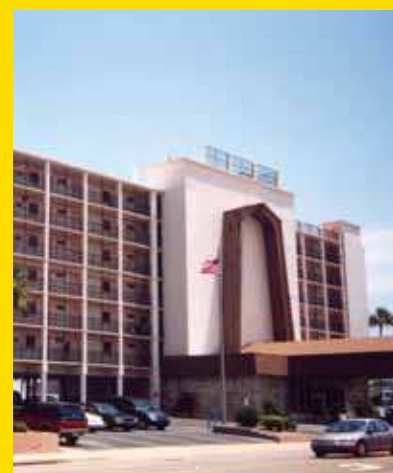
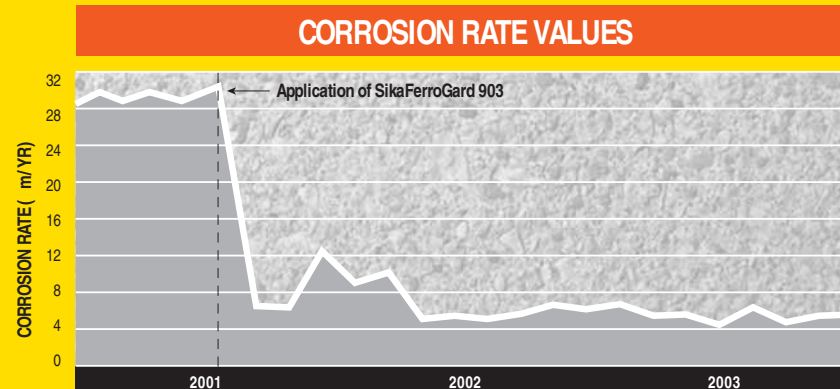
Maverick Beach Resort, Ormond Beach, Florida

The balconies had been removed and replaced in 1987. This large building; however, continued to suffer from corrosion accelerated by chlorides. The source of the chlorides was salt spray from the sea water.

Delaminated concrete primarily along the edges of the elevated walkways and the columns was removed and repaired. Sika MonoTop 611, a one-component, polymer-modified, silica fume enhanced pumpable, pourable repair mortar was used along the walkways and SikaTop 123, a two-component, polymer-modified, non sag mortar containing Sika FerroGard was used for the column repairs. Achilles IES remote monitoring probes provided by C-Probe Technologies were installed to monitor the performance of the repair system. Sika FerroGard 903, a surface-applied, penetrating corrosion inhibitor was applied, primarily, to mitigate active corrosion in the unrepaired, chloride-contaminated areas of otherwise sound concrete. A waterproofing coating was also applied to prevent future ingress of moisture and chlorides and to prevent the steel's environment from getting increasingly worse.

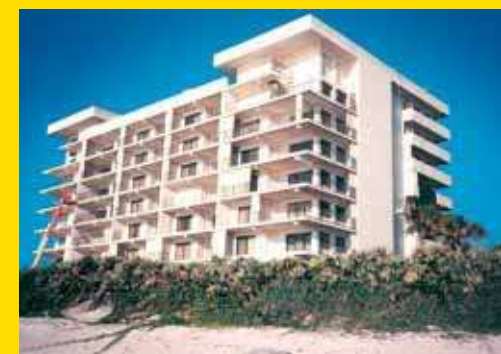
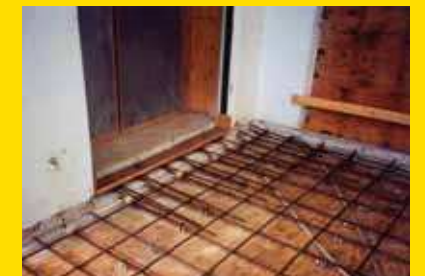
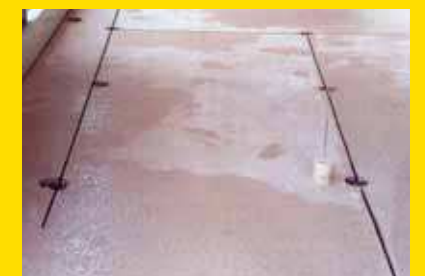
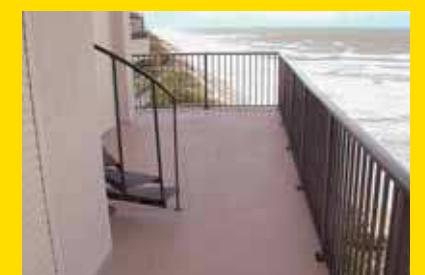
Seaside Condominium, Melbourne, Florida

Elevated chloride levels combined with hot and humid conditions caused aggressive patch accelerated corrosion of this structure on the east coast of Florida. Concrete spalling and delaminations were evident only a few years after concrete repairs were completed.

For the second repair program, Galvashield XP anodes were installed around the perimeter of the concrete repairs to prevent new corrosion activity from occurring in the adjacent contaminated concrete. After the repairs were complete, Sika Galvashield CC anodes were installed on a grid pattern in the remaining unrepaired areas of the balconies and walkways to provide an active corrosion control system.

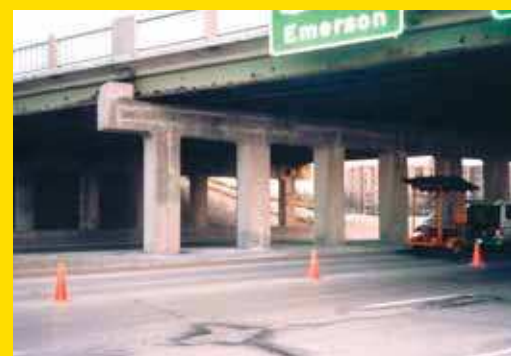
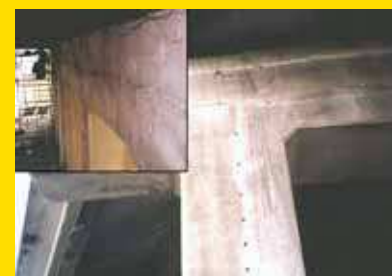
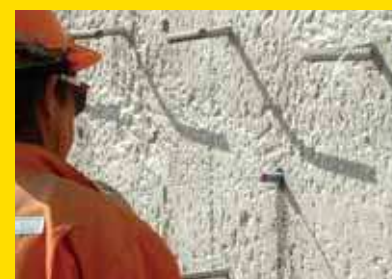
Pembina Highway Overpass, Winnipeg, MB, Canada

The piers and columns on this structure owned by the Manitoba Department of Highways and Transportation was highly contaminated with chloride de-icing salts but were still in good structural condition.

Impressed current cathodic protection (ICCP) was cost-effectively provided using Sika Ebonex® discrete ceramic anodes. The built-in ventilation system with Sika Ebonex anodes allowed them to be installed into holes drilled to the center of the contaminated columns and piers. This approach eliminated the need to have anodes installed over the entire surface area of the structure as is required with alternate ICCP systems. After the system is energized, the anodes provide long-term ICCP to the surrounding reinforcing steel.

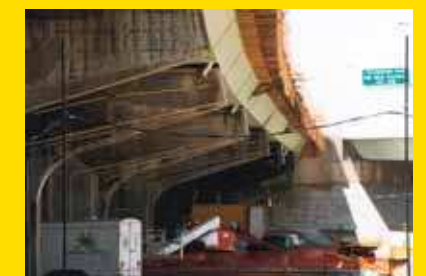
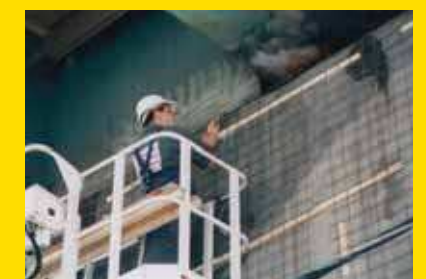
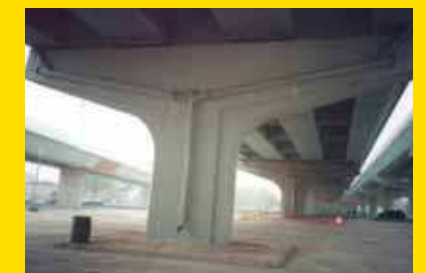
I-480 bridge substructure, Omaha, Nebraska

The Nebraska Department of Roads was planning a major structure rehabilitation of the I-480 overpass in downtown Omaha. The scope of the work included a deck replacement with a 40+ year design life; however, the concrete substructure was showing signs of distress. Faced with the potential on-going substructure repairs after the completion of the major deck reconstruction, the Department designed a substructure rehabilitation program with a similar life expectancy as the new deck. Evaluation of the concrete piers indicated the presence of active rebar corrosion. However, the piers were in generally good condition (a significant portion of the concrete was not spalled or delaminated).

Norcure ECE was used to significantly reduce the amount of chloride ions in the structure and to passivate the active corrosion. After the treatment process was complete, the system was removed and Sikagard Elastocolor, an elastic, crack-bridging, waterproofing acrylic protective coating was applied to provide protection from future chloride contamination and to enhance the aesthetics of the entire structure. In addition to providing long-term corrosion mitigation, the Norcure ECE system allowed the project to be completed two years earlier when compared to removing and replacing the contaminated piers.
