COREFLEX PRODUCT LINE UPDATE

MODIFIED REINFORCEMENT FABRIC PATTERN & PVC COLOR

FORM: PA_COREFLEX PRODUCT UPDATE_202502

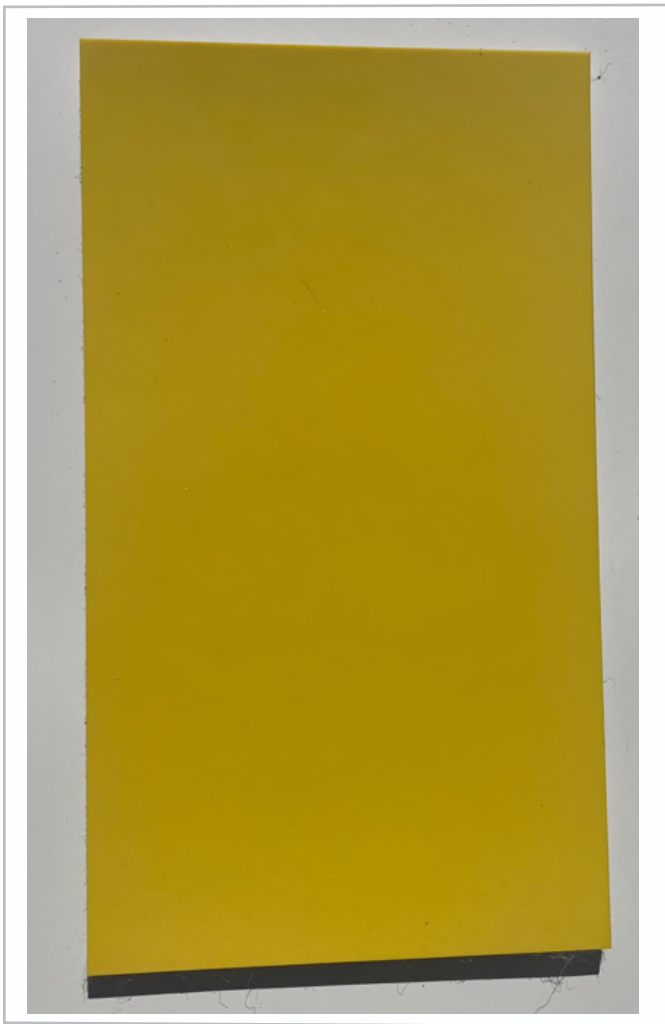
Figure 1: Old COREFLEX/COREFLASH. Lighter yellow appearance. Reinforcement fabric barely visible through PVC layers.

The PVC-KEE membrane formulation remains the same, however the COREFLEX membrane now has a slightly darker yellow appearance (See Figure 1 & 2 below). The product material properties stated on the current published technical data sheet remain the same.

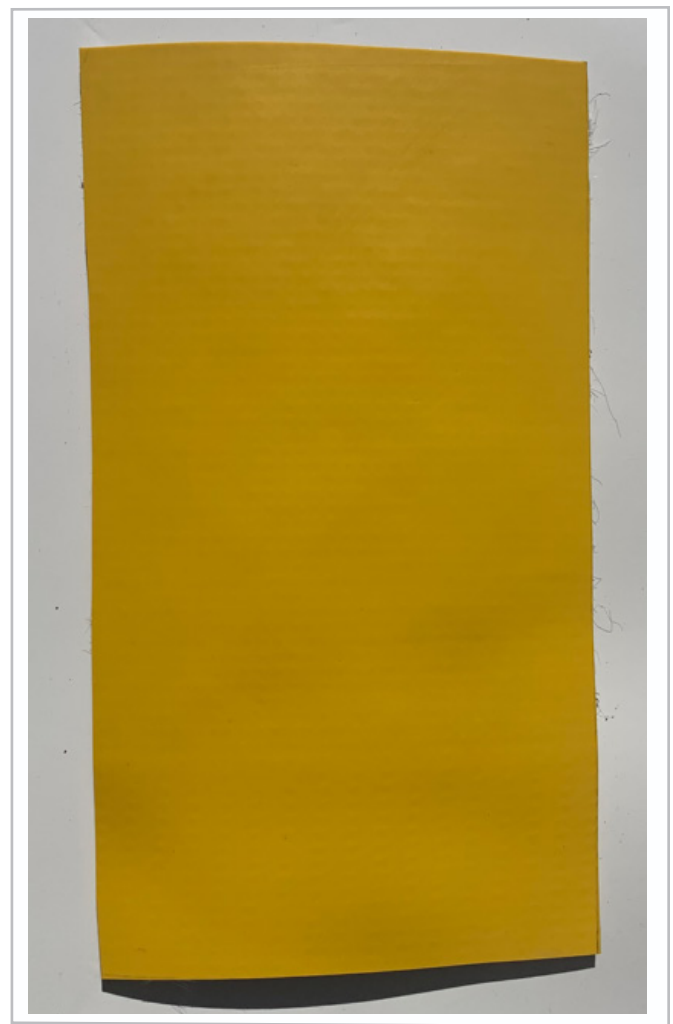
Figure 2: Updated COREFLEX/COREFLASH. Slightly darker yellow appearance with reinforcement scrim pattern visible through PVC layers.

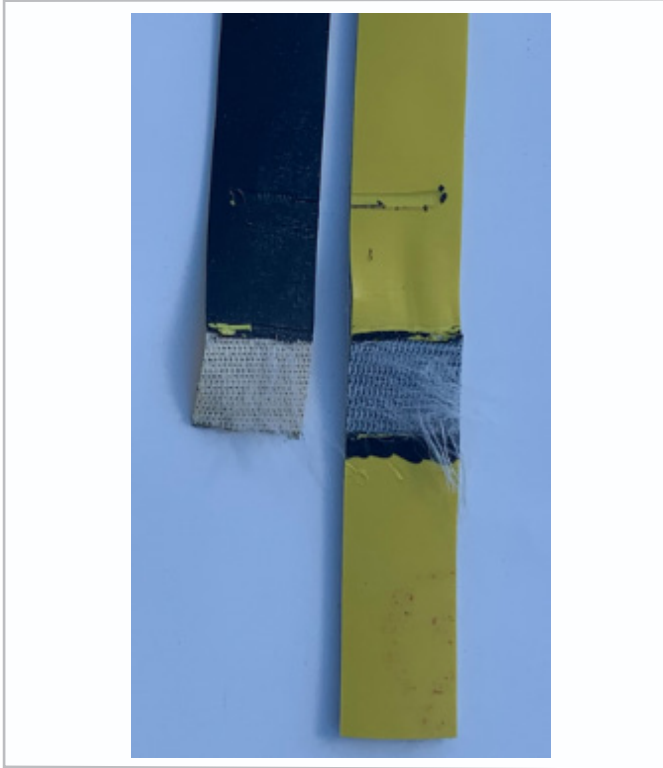
Figure 3: Old COREFLEX/COREFLASH reinforcement scrim.

The reinforcement fabric for COREFLEX 60 and COREFLASH 60 membranes now features wider scrim pattern (See figures 3 & 4), making welding easier and more efficient. During thermoplastic welding, the heat better transfers through the new reinforcement fabric scrim providing ease of welding for creating a monolithic welds to the underlying membrane.

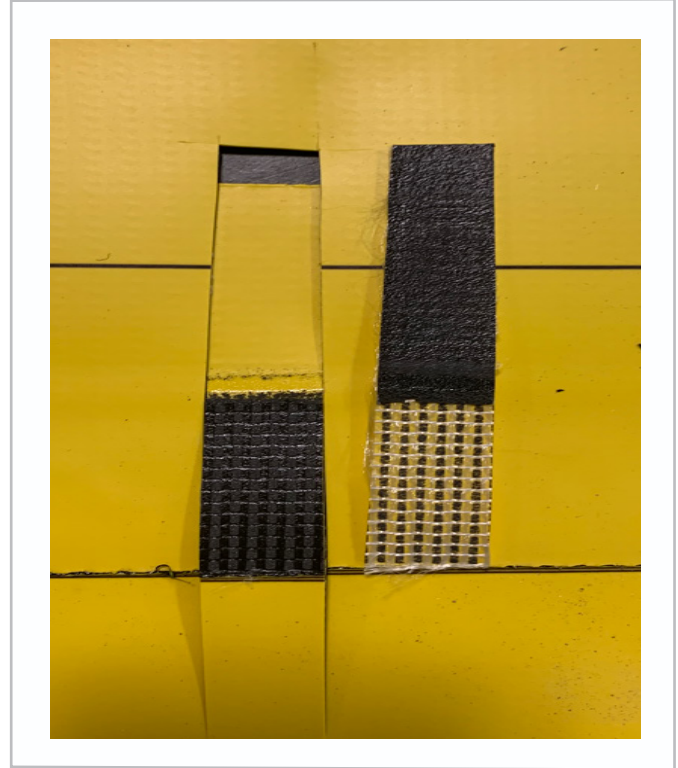
Figure 4: Updated COREFLEX/CORFLASH reinforcement scrim.

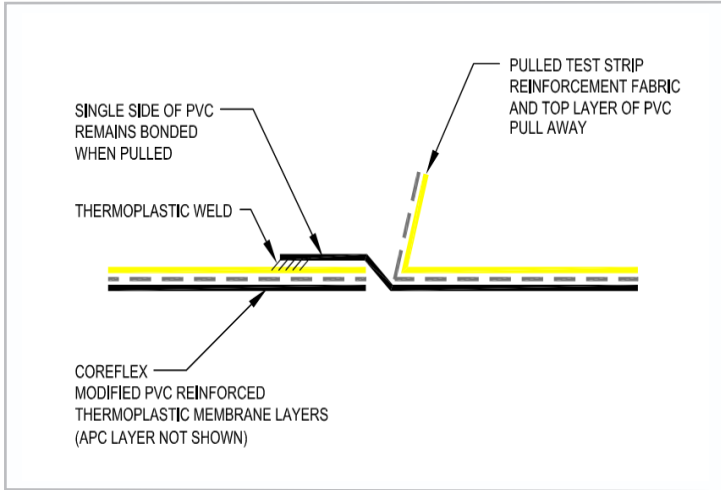
Figure 5: Example 1 of successful weld.

Verification by test pull strips now have a different appearance. See on the following page figures 5 through 8. Figures 5,6, & 7 illustrate examples of successful welds. In all of these examples, when the test pull strip is pulled, the overlapping PVC membrane remains bonded to the underlying membrane. The weld width should still be a minimum of a 1/2" wide.

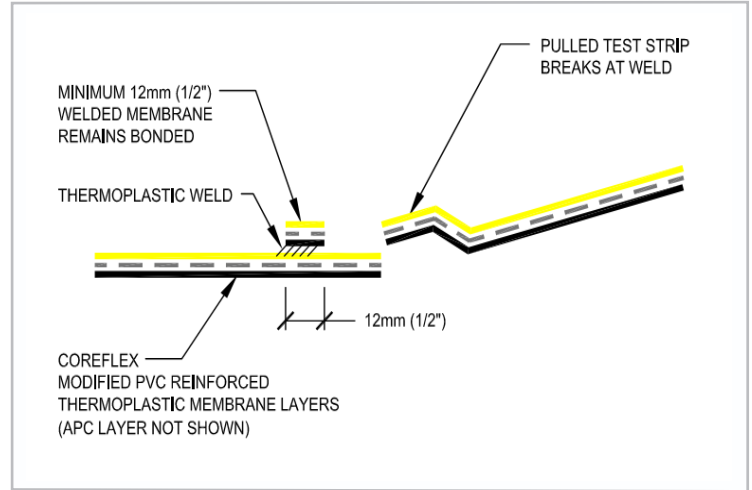
Figure 7: Example 3 of successful weld.

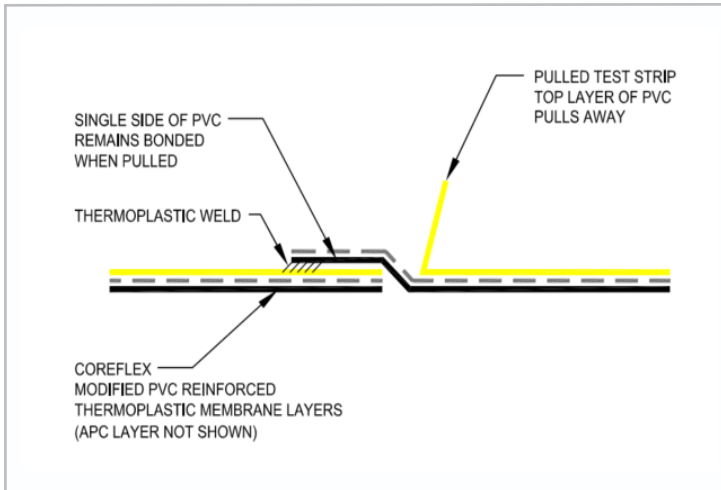
Figure 6: Example 2 of successful weld.

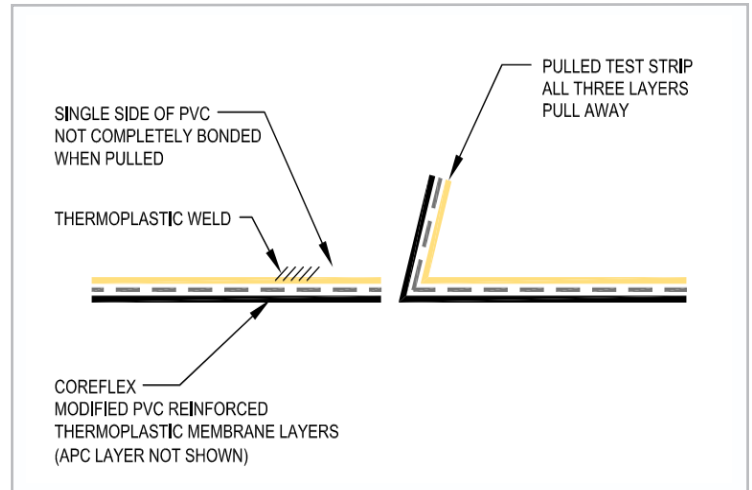
Figure 8: Example of a failed weld.

In figure 8, an example of a failed test strip, the overlapping PVC membrane completely separates from the underlying PVC membrane. This illustrates that in failed welds, the materials were not fully welded together and were able to be separated.
