TECHNICAL BULLETIN CP-03

COATING DEFECTS CAUSED BY CONCRETE OUTGASSING

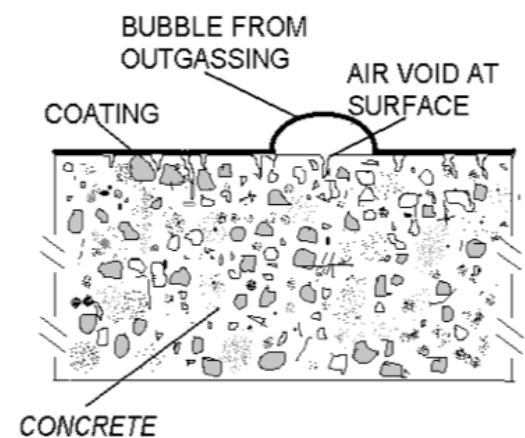
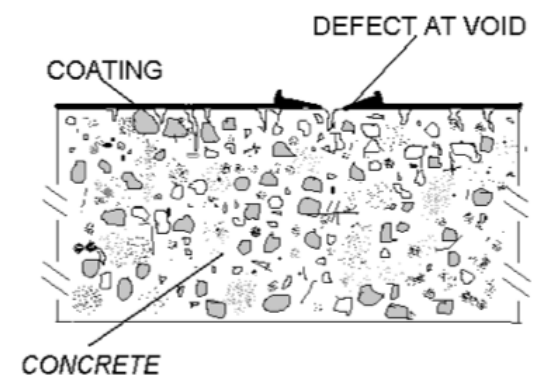
Air moves in and out of concrete with changes in temperature and barometric pressure. The phenomenon of air expanding and releasing itself through the concrete pores is called "outgassing". When barrier coatings or polymeric flooring systems are applied to a concrete surface that is outgassing, a blister can form in the coating at the pore location. This will result in a defect or void in the coating.

After the coating has cured, the defect will appear as a small bubble on the surface or a crater-like impression. This type of defect can also occur when a concrete surface is contaminated with a substance not compatible with the coating (ie. oil, soap, wax, dust) and is not properly cleaned before coating application.

There are methods to reduce the impact of concrete outgassing. The primary method is based on monitoring the surface temperature of the concrete substrate to which the coating is to be applied. An increasing surface temperature is a strong indication that outgassing will occur. Application of the coating in the afternoon or evening when the temperature is decreasing will likely reduce the possibility of outgassing. Also, the use of low viscosity primers, such as Dural Epoxy Primer or Duraprime WB, have been found effective in sealing the concrete surface prior to coating and will reduce the tendency for outgassing.

The repair of barrier coatings or polymeric flooring systems can be quite costly and time consuming. Often after repairing outgassing defects, the floor is functional but has reduced aesthetic appeal. As such it is imperative to monitor and be aware of the environmental conditions before, during and after the application of concrete coatings and flooring systems.
