**10826.000**  
**ROCKWOOL -**  
**Summary Report of Air**  
**Permeance and Wind Washing**  
DATE April 11, 2018

# Literature Review, and Research Summary on Wind Washing of Air Permeable Insulation

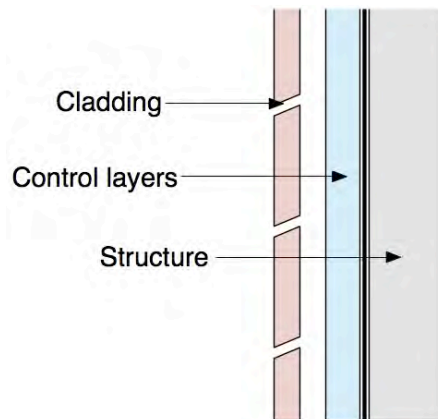
Figure 1: The “perfect wall” concept (Lstiburek 2007)

Modern enclosure design favors the use of exterior continuous insulation (ci) over the supporting structure. This approach has long been favored by building science research because of its excellent thermal performance, condensation resistance, and enhanced durability provided to the materials installed inside of the insulation (Hutcheon 1964). More recently, this design concept has been championed as the “perfect wall” (Lstiburek 2007) shown in Figure 1.

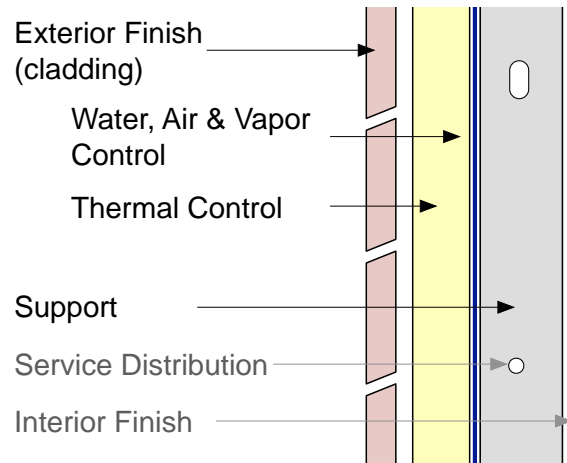
*Figure 2: Modern enclosure wall with continuous insulation and exterior air and water barrier*

In a typical well-designed ci assembly, the air and water control (air barrier and water-resistant barrier) is a single membrane placed over the support structure and protected by a layer of continuous exterior insulation (Figure 2). In many enclosure walls, well-vented and even open-jointed cladding is installed over an air gap of  $\frac{1}{2}$ " to 2" (12 to 50 mm) depth to provide a ventilated space behind the cladding and outside the continuous insulation. The flow of outside air through the gaps into the space behind the cladding – i.e., ventilation – is beneficial for encouraging drying of the back of the cladding and any undrained rainwater or condensation retained on or within the cavity.

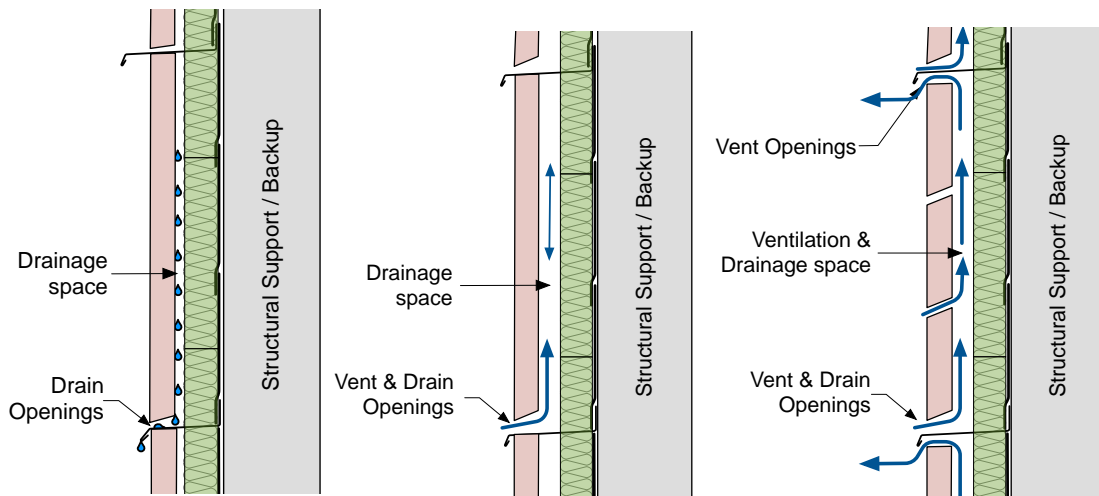
Figure 3: Drained (left), vented (middle), and ventilated (right) cladding systems

A **drained cladding system** employs a specific rain control strategy: the cladding is assumed to allow water to pass, and a drainage layer (water-resistant barrier) and drainage gap (as small as a fraction of a millimeter) collect and drain the water back to the outside.

A **vented cladding system** is one which has openings that allow some degree of connection between the outdoors and the gap behind the cladding, but whose vent area and distribution is such that little to no airflow occurs, although diffusion is encouraged.

A **ventilated cladding system** uses relatively large vent openings to connect the outdoors to an unobstructed air gap behind the cladding in such a manner that air flows in one vent and out another via the air gap.

Figure 3 illustrates the differences between these three systems.

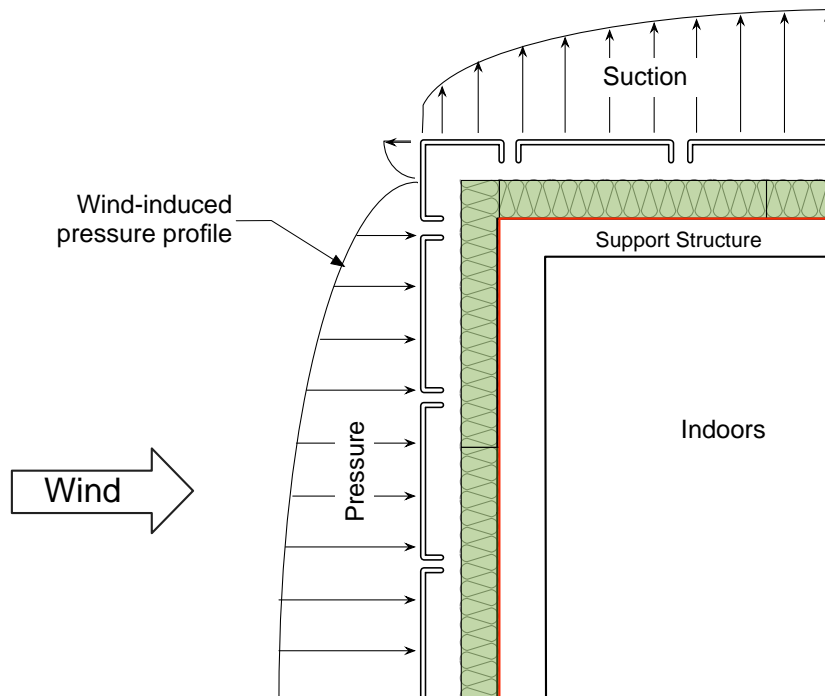
Figure 4: Typical pressure profile by wind action at a building's exterior corner

Wind washing airflows are driven by wind-induced air pressure differences which form over the face of a building (pressure gradients). Tall buildings and exposed sites experience the highest wind speeds. Wind pressures and gradients increase with the square of wind speed. The wind pressure gradients that drive wind washing are largest near building corners and parapets. Hence, wind washing is a serious concern at the corners of a building, where wind pressure gradients are large, although it can be a problem in the field of the wall as well. Figure 4 presents the typical shape of the pressure profile that forms around the corner of a building when the wind blows on one face.

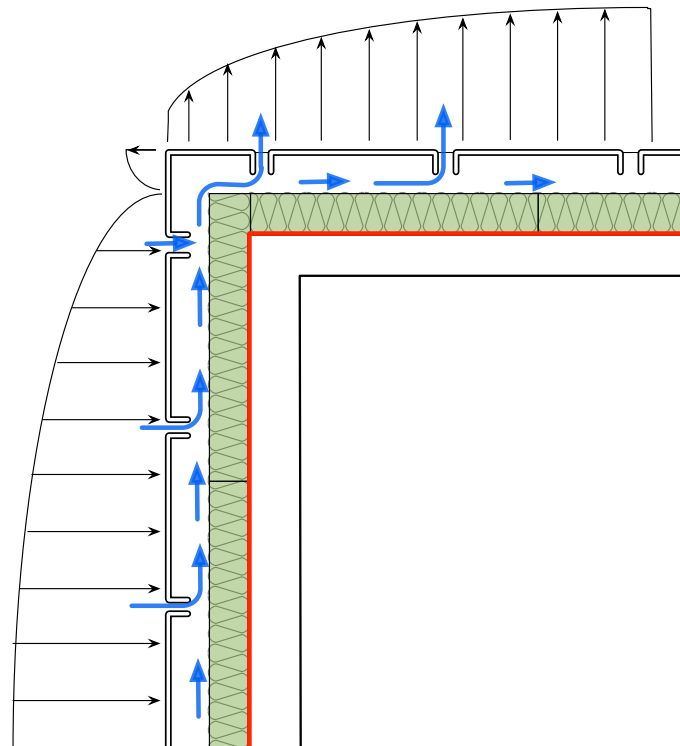
Figure 5: Airflow path through vented cladding and air gap

In walls with vented cladding over air gaps, airflow will occur behind the cladding through the air gaps (Figure 5). This is desirable as it supports the drying objective of the air gap. However, if the airflow velocity rises too high, or if the material properties or assembly are improper, the airflow can pass through or behind the insulation and result in much more heat loss than assumed in design.

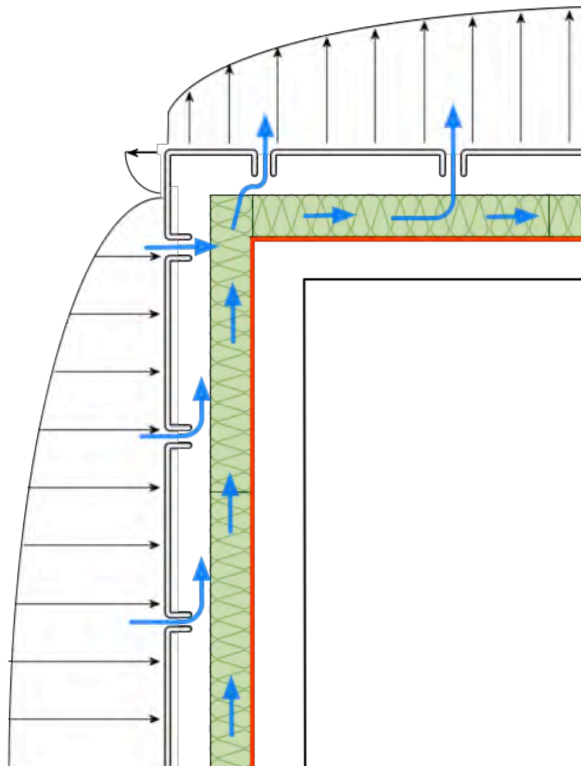
Figure 6: Wind washing - airflow passing through air permeable insulation

Two very different types of wind washing can occur: wind-driven airflow over and through air permeable (fibrous) insulation (Figure 6) and airflow behind insulation of all types (Figure 7). For air to flow behind the insulation, gaps must exist both behind the board and between joints to form a complete flow path.

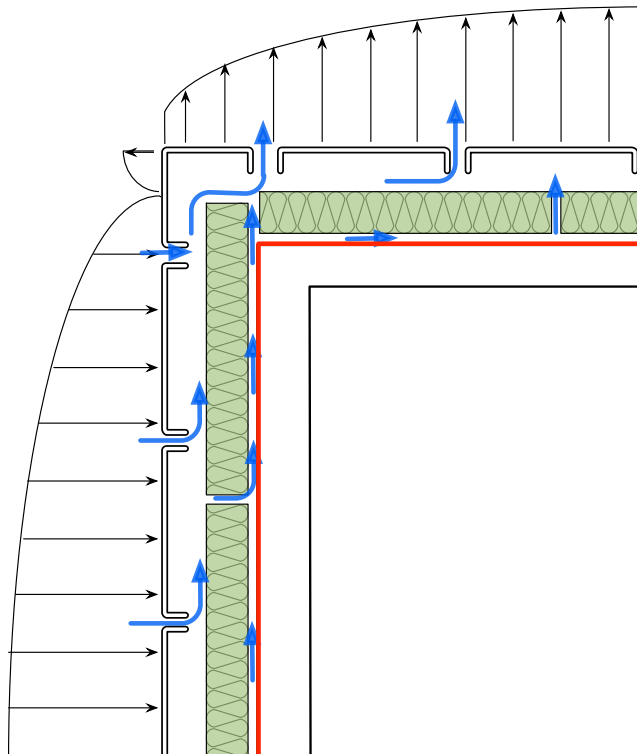
Figure 7: Wind washing - airflow passing behind and around insulation

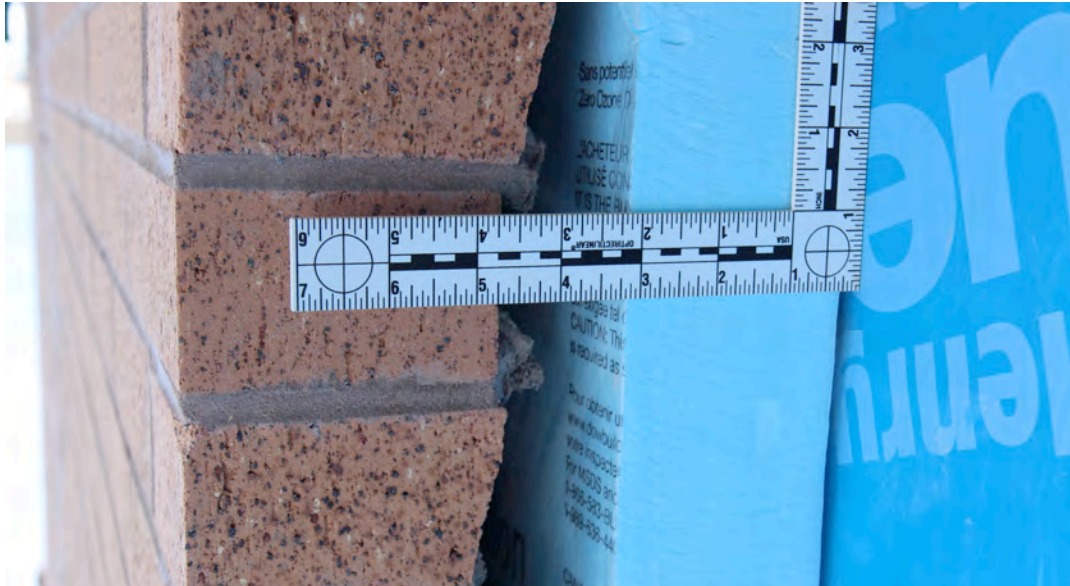
Figure 8: Actual air gap (1/4" or 6 mm) measured behind insulation on a school enclosure

The most common problem experienced in the field is airflow passing behind or around layers of insulation. Rarely is this a problem with materials or design: the insulation boards must be butted tight together and be pressed tight to the air barrier behind them on the warm side. Figure 8 is a photograph of a school under construction which was built with a ¼" (6 mm) gap behind the insulation for a significant proportion of the enclosure. This building did not experience in-service problems because the joints were butted tight and the cladding was vented sparingly (it was a vented and drained system).

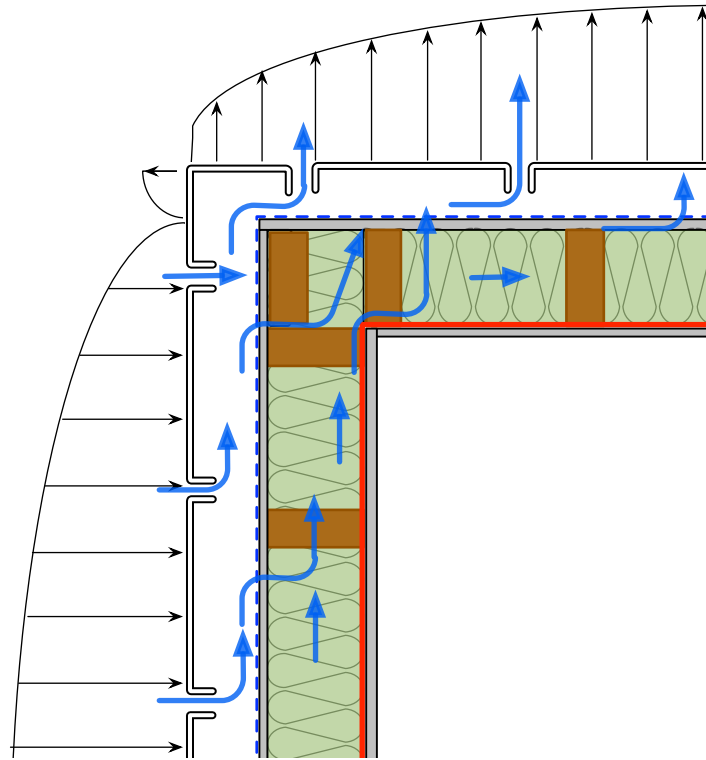
*Figure 9: Wind washing flows through insulation within framed wall*

More than a decade after this work, Uvslokk (1996) presented further detailed field measurements of wind washing for similar wall construction: ventilated cladding, wood framing, interior air barrier and leaky or non-existent exterior sheathing. The research quantified the amount of airtightness required to protect cavity insulation, and reported on extensive field pressure measurements within ventilated gaps behind claddings. Hotbox testing replicated the field pressures and measured heat flow through walls insulated with 150 mm (6") thick batts made of 31.9 kg/m<sup>3</sup> (2 pcf) stonewool or 21 kg/m<sup>3</sup> (1.3 pcf) glass fiber. The results showed that some resistance to airflow was required exterior to the sheathing to protect insulation inside the stud cavity, and Scandinavia adopted exterior wind barrier performance requirements in wood-framed house construction.

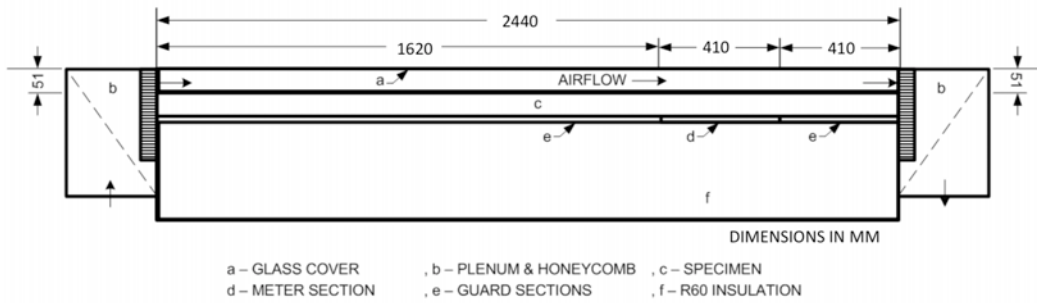
Figure 10: Schematic section of wind washing test apparatus

The measurement concept is simple: air is drawn over a 1625 mm (64") length and 48" (1.2 m) width of guard heater before reaching a 406 x 406 mm (16"x16") square meter section, d, where the heat flow is measured. A uniform temperature is imposed across the sample and the heat flow measured at the meter section for a wide range of velocities. Van Straaten et al. (2016) outlines more details.

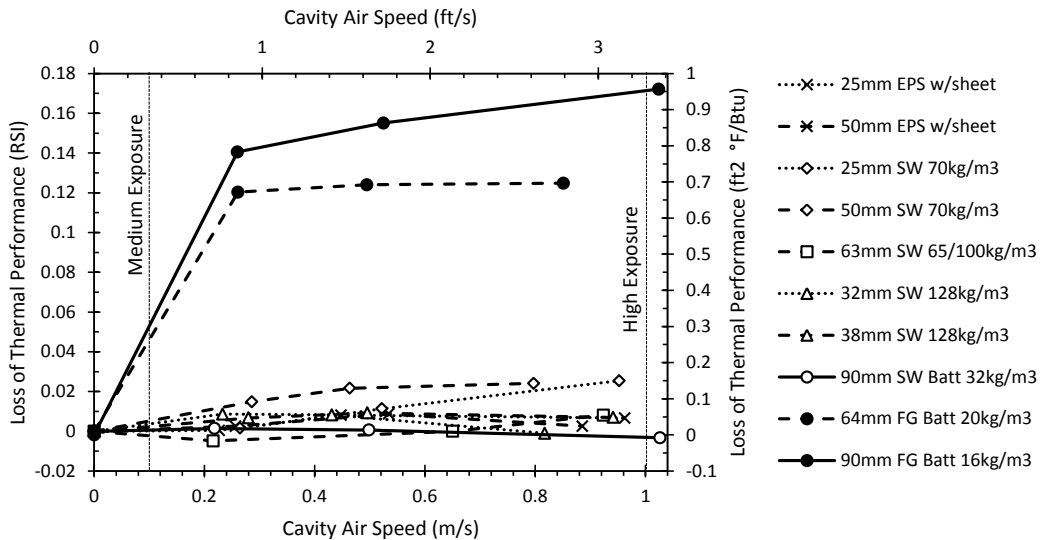
Figure 11: Measured impact of wind washing from laboratory measurements (R-value=RSI\*5.678)

A number of different mineral fiber insulations (both glass fiber and stone wool) with densities from 16 kg/m<sup>3</sup> (1 pcf) to 128 kg/m<sup>3</sup> (8 pcf) were tested. As a comparison an expanded polystyrene (EPS) foam board with an airtight laminated plastic film was tested.

The loss in thermal resistance (in RSI) is plotted for each sample in Figure 11 as a function of air gap air speed between zero and 1 m/s (near the top of the likely range of velocities expected based on the literature review). It can be seen that only the low-density fiberglass batt (FG) products exhibit a measurable impact: about a 5-8% reduction in thermal resistance. The impact on the other stone wool (SW) products is small, close to the range of error of the equipment. Regardless, the reduction is at most RSI0.03 (R-0.2).

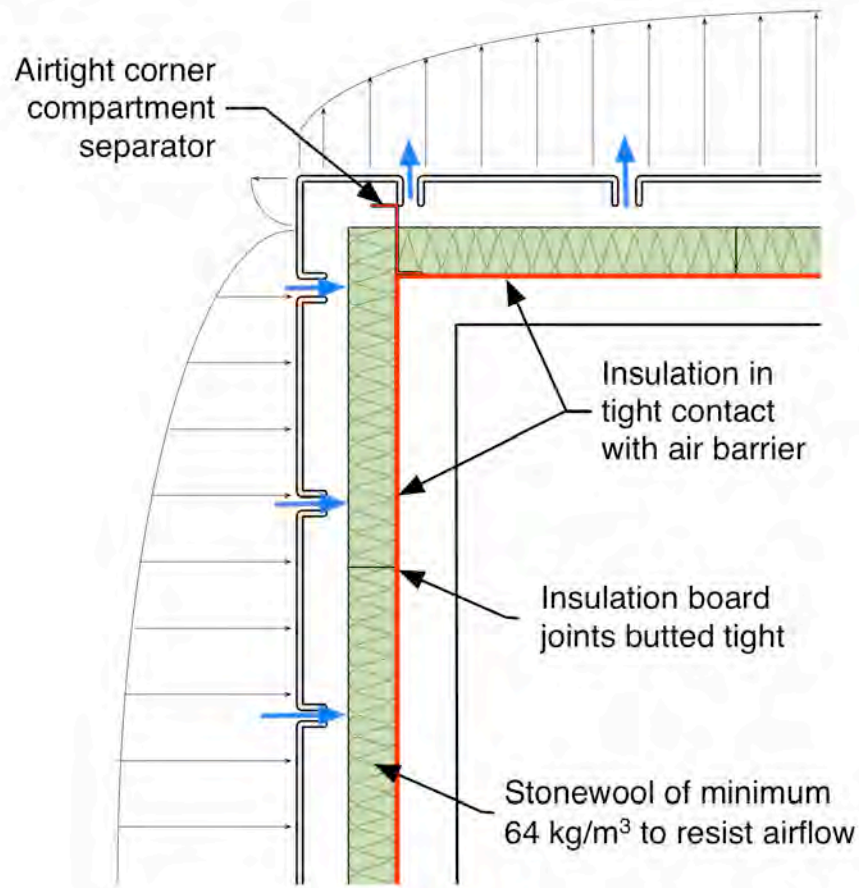
Figure 12: Several strategies to minimize the risk of wind washing are available

The extensive research, spanning many decades, presented above indicates that wind washing can occur, but can also easily be avoided. Poor design choices, inappropriate materials, and bad workmanship can result in poor performance in some situations. Several strategies that can reduce wind washing risk are shown in Figure 12.
