TEST REPORT

Report No.: D8867.01-501-47

TREMCO®, INCORPORATED
Beachwood, Ohio

PRODUCT TYPE: Wall Panel System
SERIES/MODEL: ExoAir® 220, Spectrem® 1, Dymonic® 100

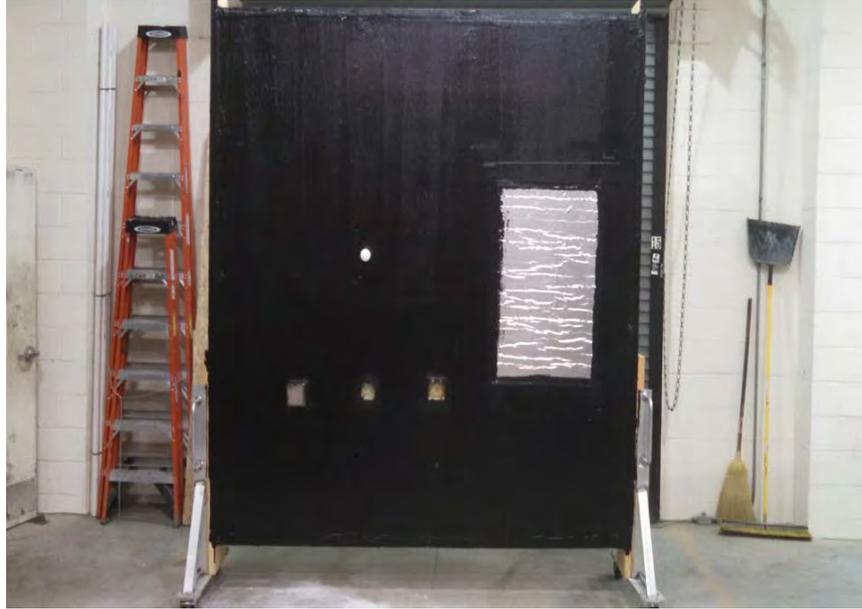
Photo No. 1

Exterior of test specimen

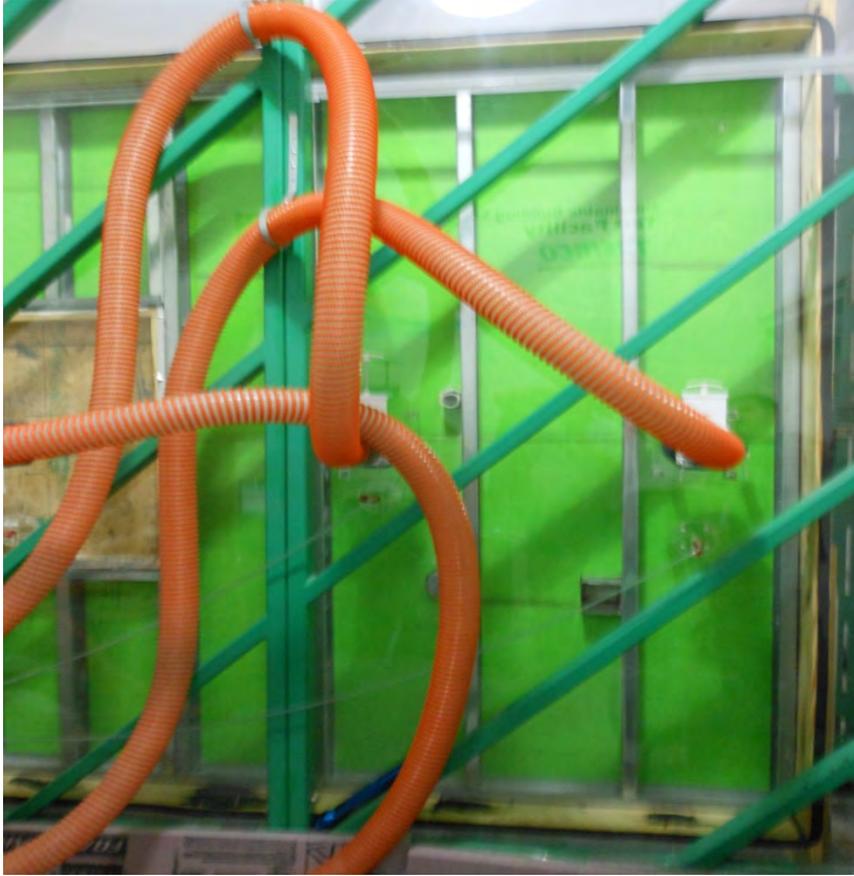
Photo No. 2

Interior of test specimen
