# Troubleshooting Guide

Causes, Repair & Prevention

March 2020

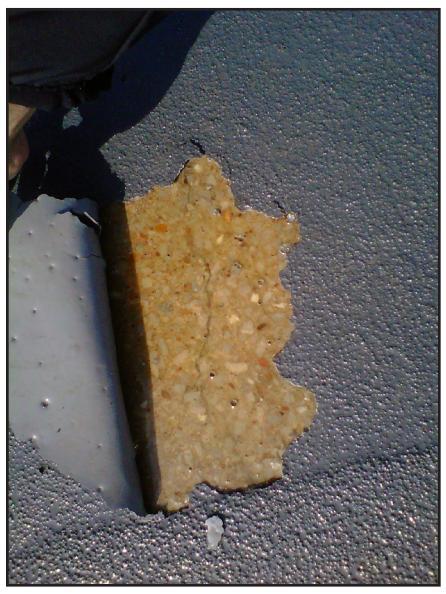
Coating may peel off in places and show signs of concrete laitance or other contaminants on the backside.

- Improper Surface Profile: Surface was not shot-blasted or abraded prior to applying membrane, or the base coat was applied over epoxy primer after the 24-hour window.
- Contamination from Moisture: There was dew or other moisture on the surface that was coated.
- Contamination from Dust, Dirt, Etc.: Coating over contaminated surfaces will lead to coating failures such as loss of bond.
- Incompatible Materials: Materials that are incompatible with the coating will cause many issues including delamination.
- Thin Topcoat Application: A final topcoat applied too thin may delaminate and peel from the coating system.

- 1. Remove all loosely bonded material.
- 2. If substrate is exposed, abrasion may be necessary.
- 3. Clean repair area.
- 4. Re-apply material as specified and per Neogard recommendations.

- Improper Surface Profile: Substrate should be shot-blasted or abraded and cleaned prior to application
  of primer. Shot-blast surface ICRI CSP3 to CSP4 to remove contamination or laitance, and for optimal
  bonding. Base coat must be applied within 24 hours of primer application. If base coat cannot be
  applied within 24 hours, clean and re-apply primer.
- Contamination: Ensure deck is clean and dry prior to application of material.
- Incompatible Materials: Perform field adhesion test prior to application of the coating when installing coating over existing coating system. See the Field Adhesion Testing section of this guide.
- Apply coating at specified rates and per Neogard recommendations.

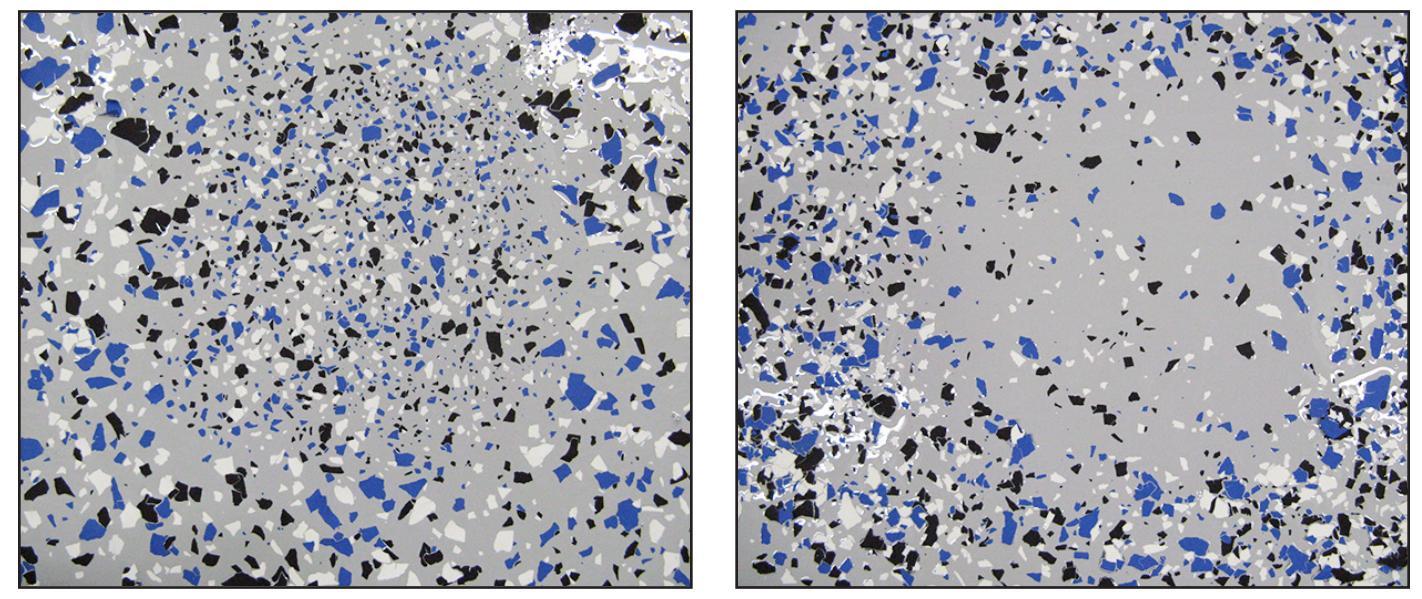
Even flake disbursement is a key factor in the aesthetics of a random flake flooring system. Having the same size and coverage of flakes is key to a uniform appearance.

- Flakes Broadcast Too Quickly: This leaves an uneven disbursement in the base coat. To ensure uniform coverage, make certain the broadcaster takes their time.
- Flakes Crushed During Broadcast: This causes variations in the size of flakes. Size variation of flakes in the floor is caused by crushing the flakes in hand as they are broadcast. Also, reaching for the flakes in the bucket, they are inadvertently crushed.
- Clumped Flakes: If clumped flakes are introduced into the wet base coat, they will dry in a clumped formation.

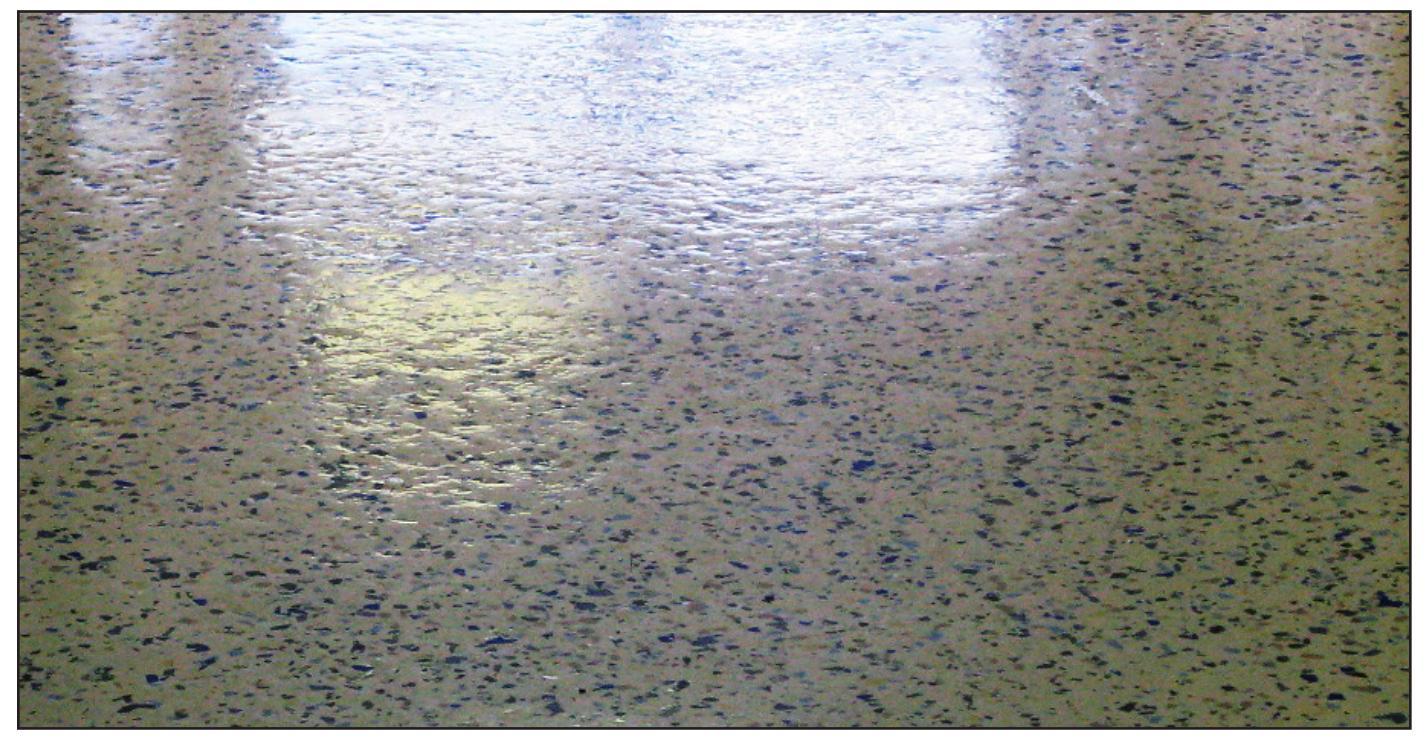
Orange peel is a stipple finish appearance in the final topcoat of epoxy or urethane flooring system. Some flooring manufacturers offer this finish; however, it is not always desirable to the customer.

- Cold Substrate/Materials: If the substrate temperature is below 50°F/10°C, the epoxy or urethane will
  not flow and level out, and can produce the orange peel finish. This will be more prevalent if the topcoat
  is applied in a thin layer, somewhere between 3–6 wet mils. The combination of a cold substrate and
  cold materials can readily produce this type of finish.
- Hot Substrate/Materials: Hot temperatures can also result in an orange peel finish. If the substrate is above 90°F/32°C, the topcoat may cure too quickly. This rapid curing will cause the material not to flow and level out. Just as in cold temperatures, thin topcoat layers, hot substrate temperatures and hot material can produce an orange peel finish.

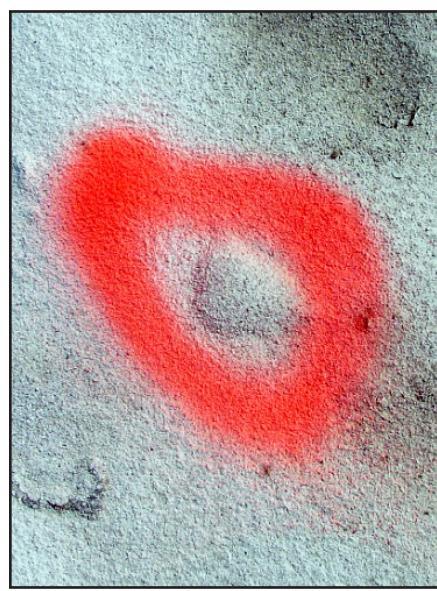
Small to medium bubbles in the coating surface They can be randomly dispersed or centralized in one location. Open blisters will typically be a single smooth bubble with no pinholes or multi-chambered cells.

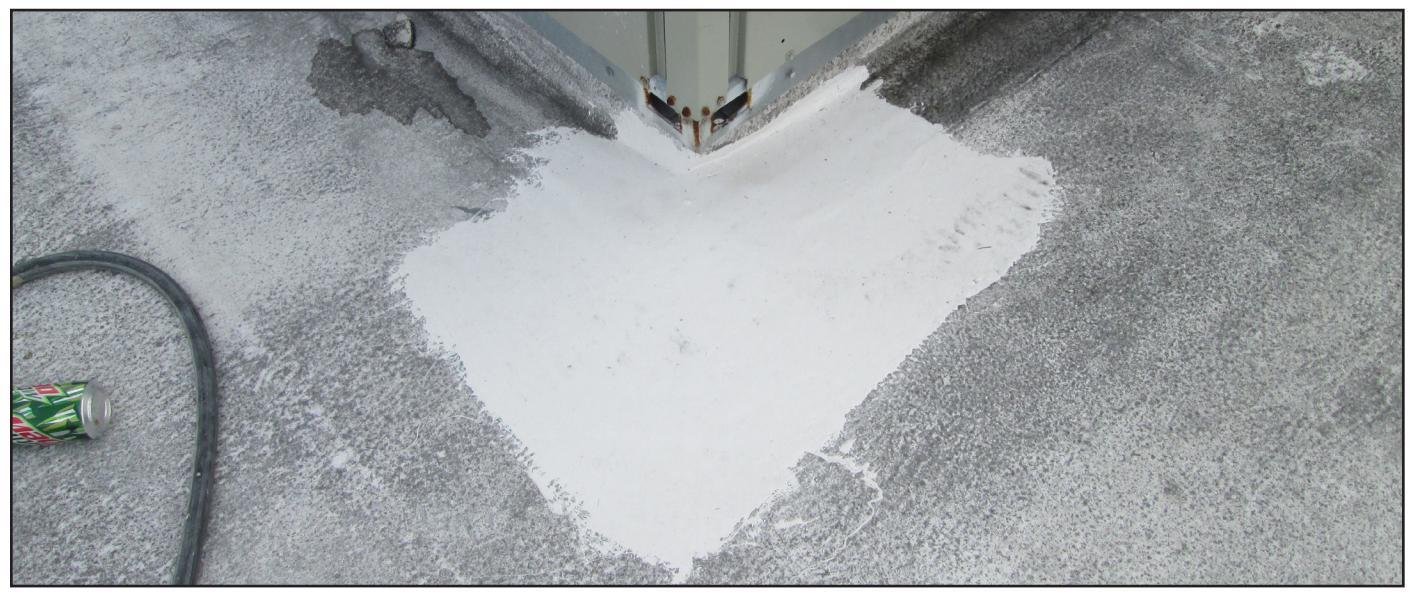
Surface not cleaned properly and does not extend 6"-8" beyond the affected area.
