# Troubleshooting Guide

Causes, Repair  
& Prevention

December 2023

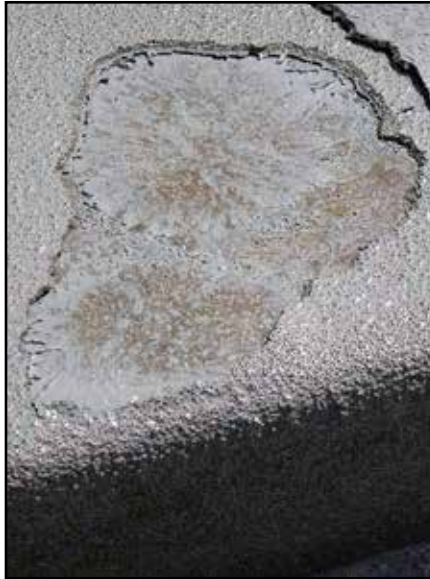
**Area underneath removed blister**

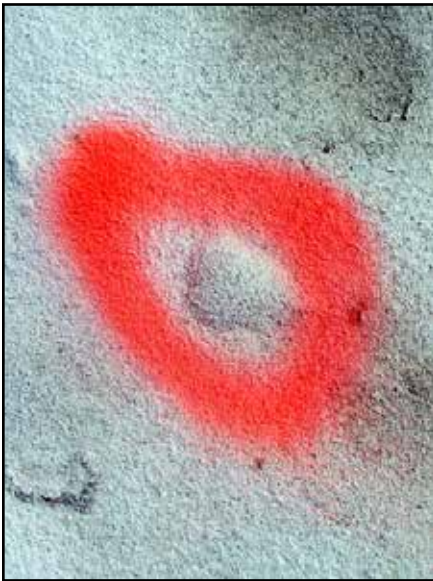
**Blister due to contamination**

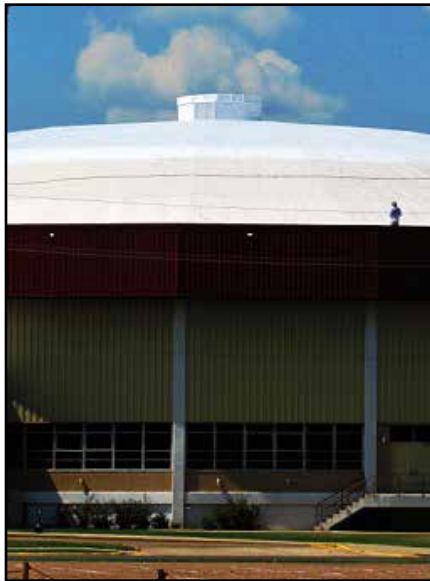
**Roof with moisture contamination**
