TECHNICAL GUIDE **TROUBLESHOOTING**

Prepared by NEOGARD® Technical Service • November, 2014

WATERPROOFING, FLOORING & ROOFING
CAUSE, REPAIR, & PREVENTION

November 2015 Edition

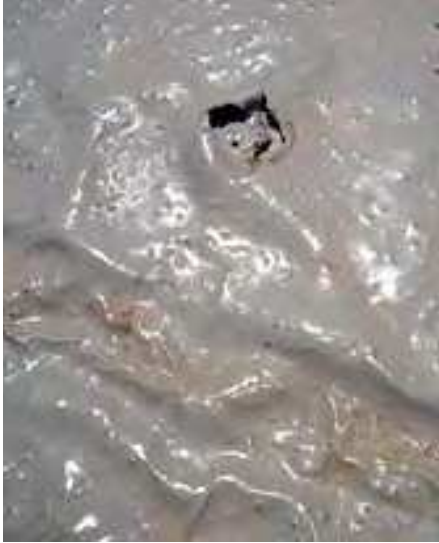
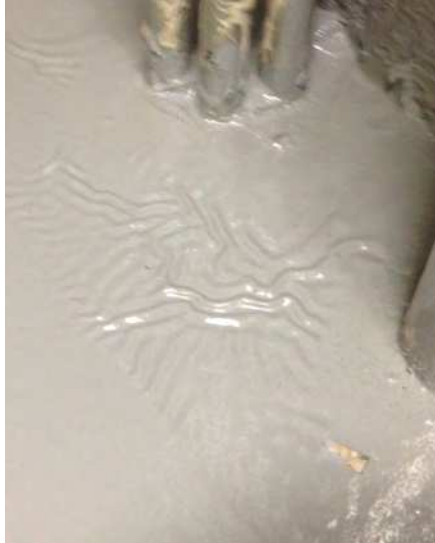
Coating is wrinkled in appearance. Multiple lines of parallel wrinkling may occur.

- **UNCURED/OFF-RATIO COATING:** Material applied over uncured or off-ratio coating, causing stress on topcoat.
- **COATING TOO THICK:** Coating applied at a thickness that exceeds application instructions.

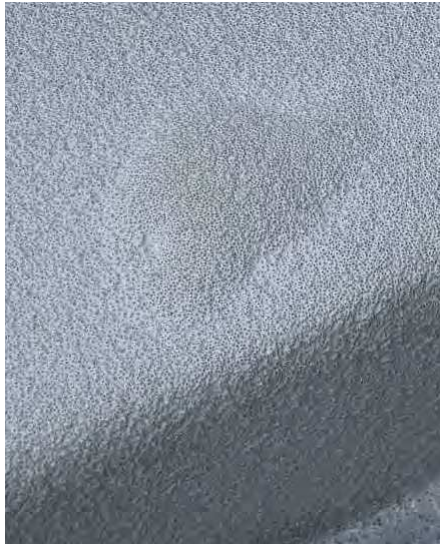
Coating is soft and may transfer when touched. Coating may also delaminate.

Typical blister

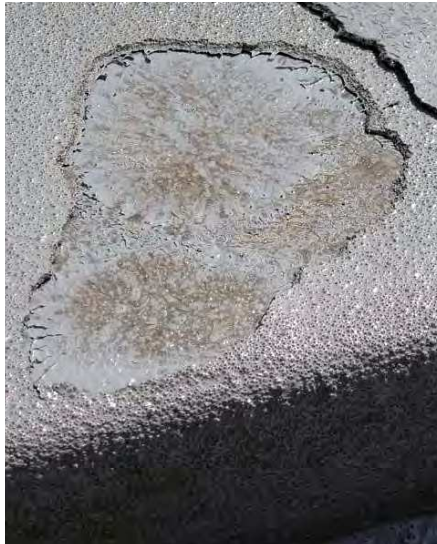
Area underneath removed blister

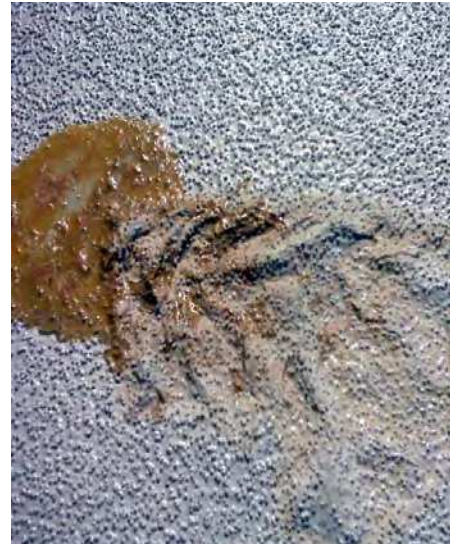
Off-ratio

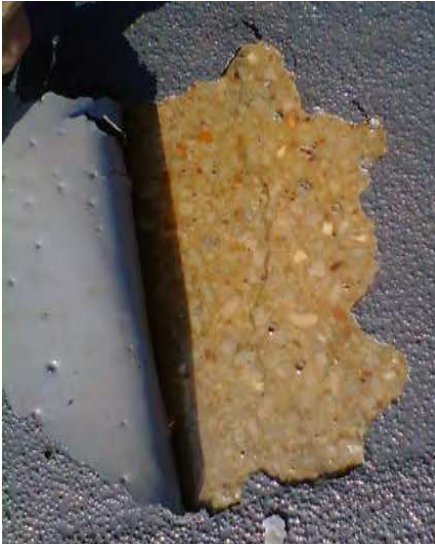
Premature failure of coating can occur through delamination. Coating may peel off in places and show signs of concrete laitance or other contaminants on the backside.

Delamination due to moisture

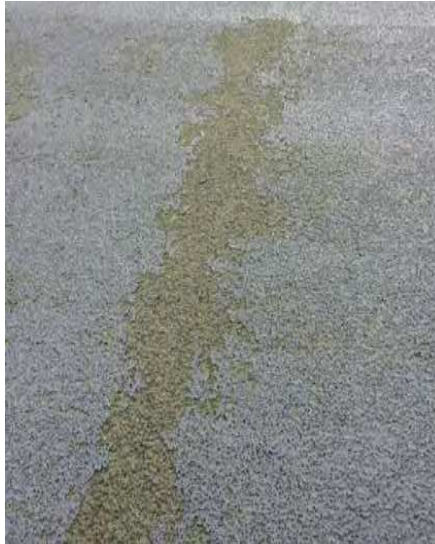
Delamination due to incompatible materials

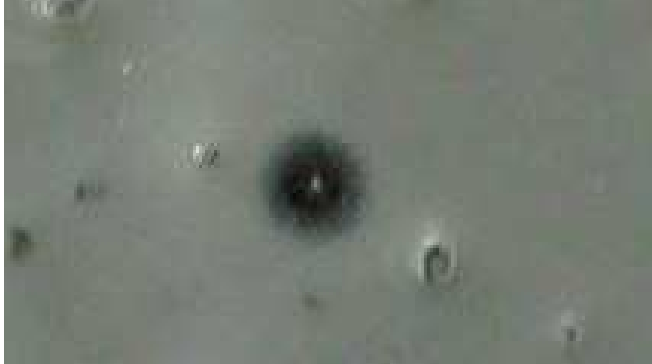
Fish eyes are round indentations or separation in the coating finish. Upon closer examination, they look like a crater with a rim around the perimeter of the defect along with a very small dot in the center – hence the name “fish eye”.

- **SILICONE CONTAMINANTS:** Certain manufacturing processes such as welding or spraying can deposit silicones on the floor causing fish eyes to appear.
- **OIL/GREASE CONTAMINANTS:** Oil or grease contaminants can cause the coating to function improperly and fish eyes to appear.

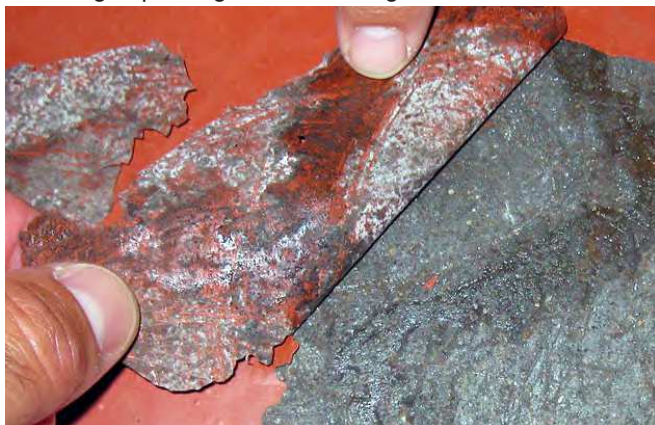
Coating is peeling or de-bonding from either the substrate or between layers of coating.

Delamination—substrate

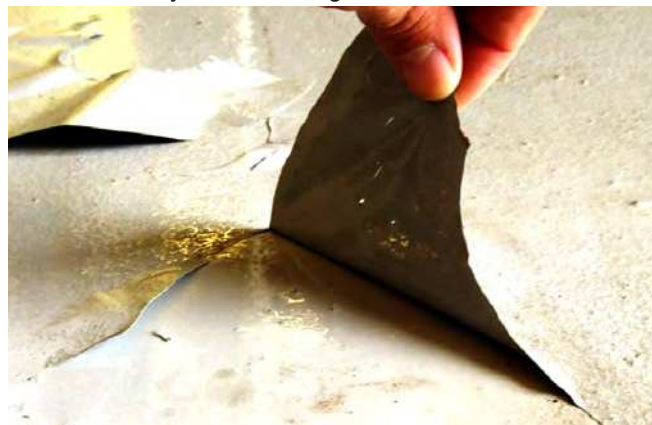
Delamination—between coats

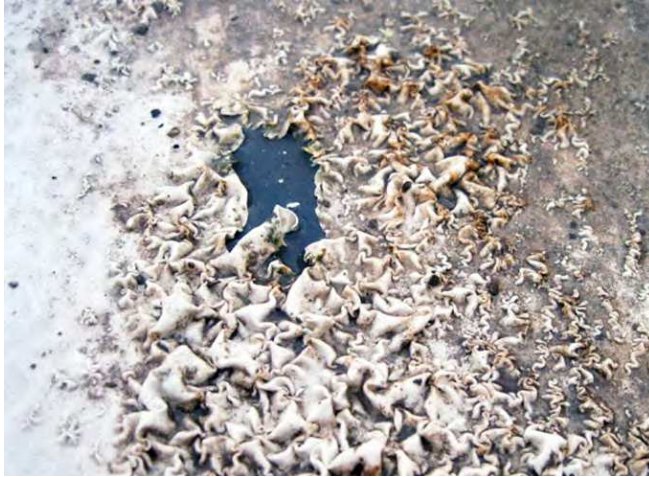
There is loss of bond between coats or between the coating and the substrate.

Delamination due to thin topcoat and ponding

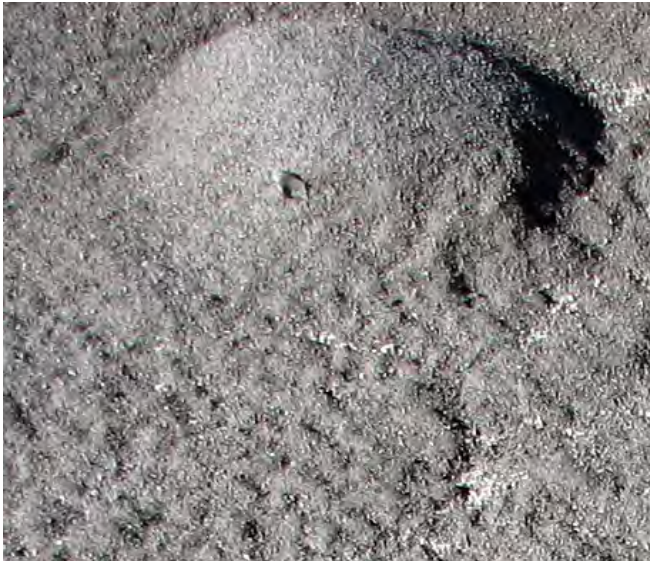
Foam blisters are medium to large bubbles on the surface of the foam. They are typically randomly dispersed.

Typical unopened foam blister

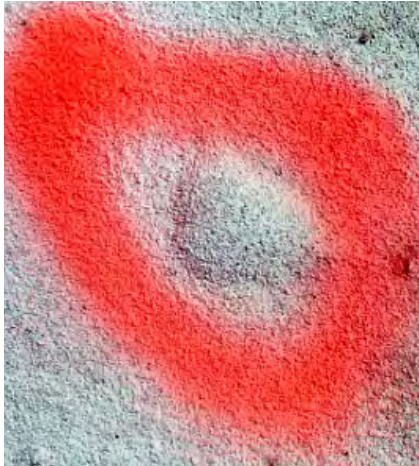
Coating blisters look like small to medium bubbles in the coating surface and can either be randomly dispersed or centralized in one location. The open blister will typically be a single bubble and will be smooth with no presence of a pinhole or multi-chambered cells.

Blister due to contamination

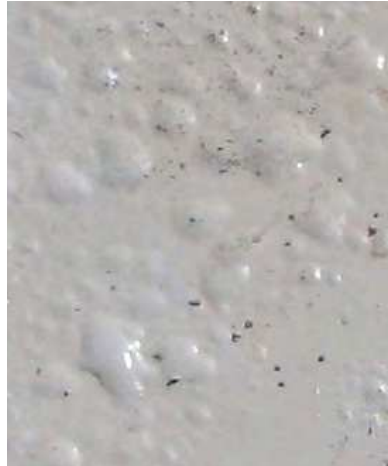
Blisters due to trapped solvent

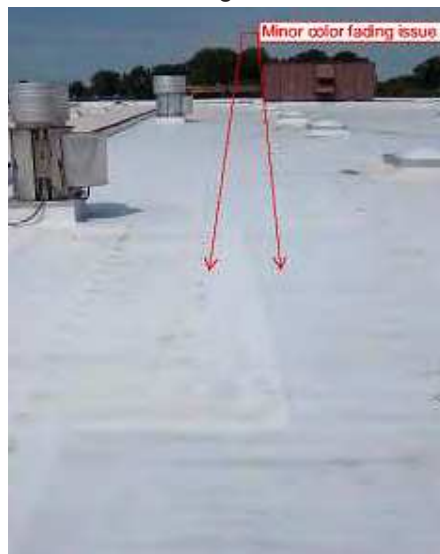
Surface of coating does not cure to a glossy finish and reflect light as is ideal for a roofing topcoat.

Roof with shade variation

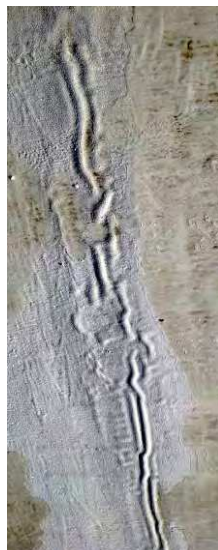
Coating appears wrinkled in places.

- Coating was applied before previous coats were allowed to cure. The topcoat application will appear smooth but is floating over a solvent rich base coat. Once the base coat material releases solvents, the film shrinks and it is 10%–20% smaller. The base coat pulls the topcoat material into wrinkles to alleviate the stress of the oversized surface.
