Joint Filler Profile is Important

The primary function of MM-80 is to restore the floor surface to an interruption-free, continuous plane. This is accomplished by filling the joints flush while protecting joint edges from damage caused by hard wheels.

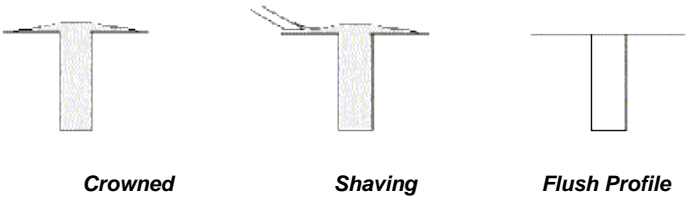
OVERFILL AND SHAVE

Install MM-80 as previously described, slightly over filling. Allow MM-80 to go past the gummy state until it sets into a solid (usually 6-8 hours). If possible at this time, shave off the excess, since it has not reached its full hardness and shaving is relatively easy. Possible shaving tools include well-honed spud hoes, ice scrapers, tile floor

stripping tools, wallpaper scrapers, putty knives, etc. Having a long-handled tool adds leverage and is easier on the back.

If you cannot shave on the day of installation, return as soon as possible afterward. Apply heat to the **MM-80** using a hot air gun or torch, then promptly shave. Do not burn or char the **MM-80**. (Note: Using an overfill procedure will leave a slight film on the top of the concrete, most of which will eventually wear off with traffic).
