FIELD DAMAGE REPAIR TECHNICAL DATA SHEET

PATCHING AND REPAIR PROCEDURES FOR LP® FLAMEBLOCK® PANELS

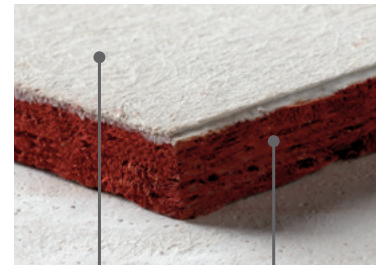
LOOK BENEATH THE PYROTITE® COATING AND YOU'LL FIND THE STRENGTH OF LP® OSB.

LP® FLAMEBLOCK® FIRE-RATED SHEATHING FEATURES A PROPRIETARY NON-COMBUSTIBLE, FIBERGLASS-REINFORCED PYROTITE® COATING.
