# PNA JOINT STABILIZERS IMPROVE WAREHOUSE OPERATIONS

A national auto parts supplier has a 400,000-square-foot facility in New York that services the company's East Coast stores. It loads and unloads about 30 trailers per day.

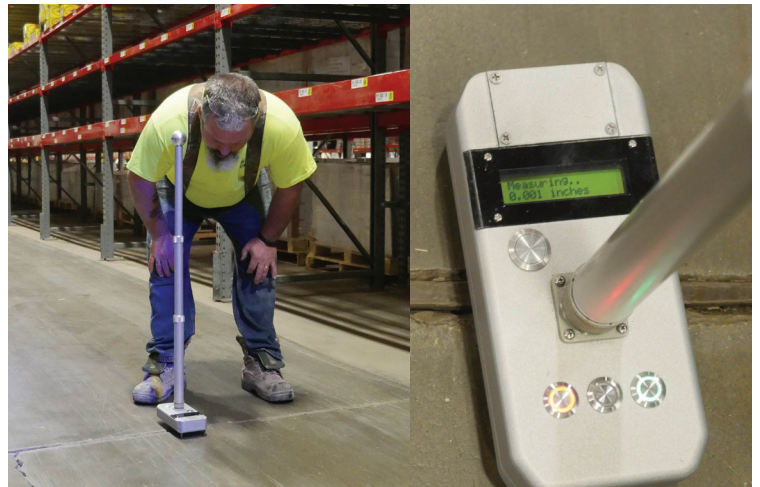
In 2008, an additional 1,542 stabilizers were installed. The plant remained operational while the work was completed, with minimal interruptions. Deflection readings after the floor was stabilized matched those obtained during the trial.

Ten years later, in 2018, a team returned to the facility to see how the Joint Stabilizers were performing. A forklift truck carrying a 5,000-pound load was driven over the joints that had been stabilized a decade earlier and new deflection readings were taken. The readings showed deflection values between 0.001 and 0.003 inches – virtually unchanged from when the stabilizers were first installed, and still well below the 0.010-inch threshold for differential deflection specified by ACI for small, hard-wheeled truck traffic.
