## **Technical Bulletin**

Re: Technical Bulletin – Steel & Ice Ball Impacting of PVC & TPO with ROCKWOOL Stone Wool

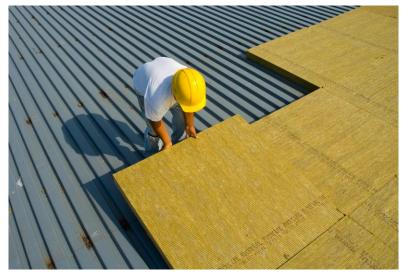
The roof assemblies were impacted by 2" diameter molded ice spheres, target weight 0.1385 lb, propelled at free-fall speeds of the same size hail, 111.6 ft/sec (76.1 mph), to develop 26.8 ft-lb kinetic energy, Class 4. Projectiles were launched perpendicularly against the assembly with double impacts at two target locations within ½" of one another. The thermoplastic membranes were found to be intact after impacts by the 2" ice balls.
