CASE STUDY MAYO CLINIC HOSPITAL, PHOENIX

Drainage Channel Stabilization Phoenix, AZ

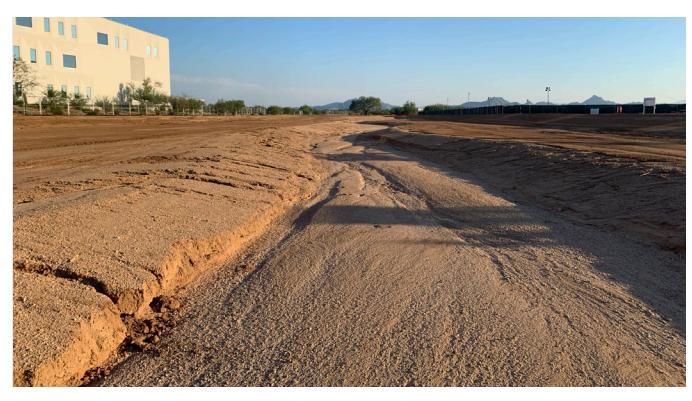
The channel section is designed to have a meandering, lowflow channel section to match the existing wash bank's full capacity. The 100-year design worst-case flow of 2,338 cfs would overtop the low flow banks and be contained in the flood flow channel.

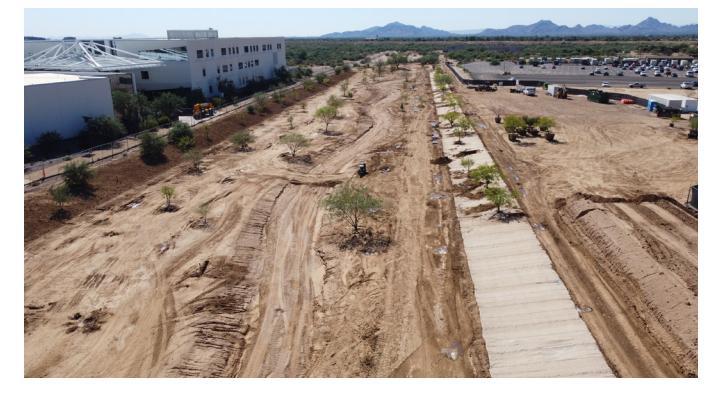
A vegetated solution was required for erosion protection the slopes of a drainage channel at the Mayo Clinic Hospital.

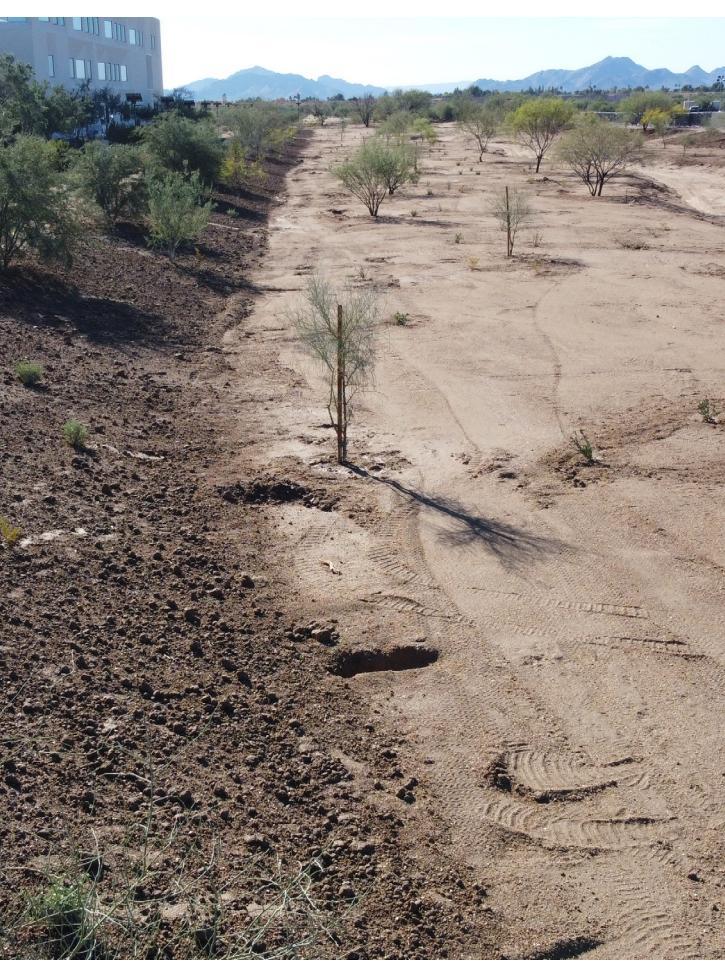
After PYRAMAT was installed, it was soil filled and hydroseeded with native seed mix. The installed naturebased solution meets the USACE permit requirements and required no revisions to the FEMA Flood Insurance Rate Map (FIRM).

- Promotes infiltration of surface water
- Lightweight and easily transported into areas with access challenges
- Ease of installation reduces time and labor costs
- Trees and shrubs can be planted directly into the HPTRM to promote vegetation
