Inland products solve KCI Compressor's 20 year roof problem

Project: KCI Compressor, Tulsa, Oklahoma

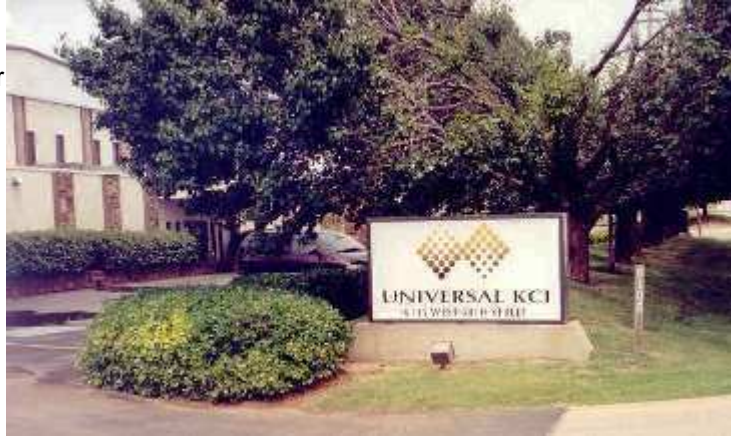
The Tulsa facility is a thirty foot eave, 100,000 square foot steel building of relatively low slope with 292 fiber glass sky lights. Attached is an additional 15,000 square foot office area of conventional construction with a BUR gravel ballasted roof.

All metal surfaces and sky lights were thoroughly power washed and mechanically cleaned as necessary. All seams, fasteners, penetrations and sky light terminations were addressed with Inland's RC2200 and Inland's RPM mesh as needed. At this point the integrity of the roof was secure.

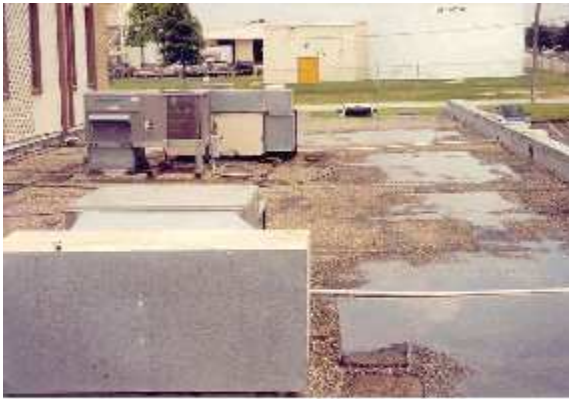
Leaks and standing water on the KCI roof were just a few of the many problems to be solved by Inland products

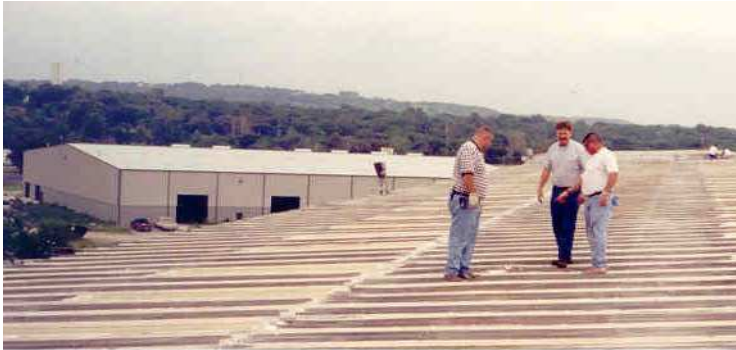
David Kummers, John Suskey, and Alan Lewis check over the prep work on the skylights and metal roof before the application of Inland Rubber Roof Coatings

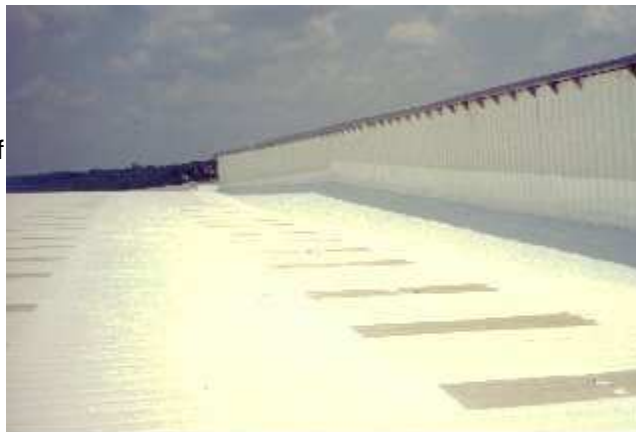
A total of 292 fiberglass skylights were protected with Inland's CR-2100 Skylight Coating

All skylights were coated with two coats of Inland's CR2100 sky light coating.
