ACO StormBrixx®

## Inspection and Maintenance Guide

StormBrixx 300

StormBrixx 600

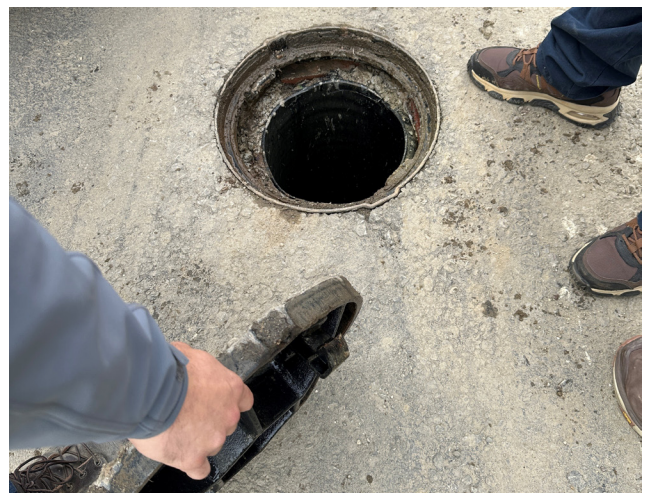
### 2.1 Locate the Access Cover

Remove the lid, and safely place it to the side.

The lid has a push-fit locking and requires a vertical pulling force to remove.

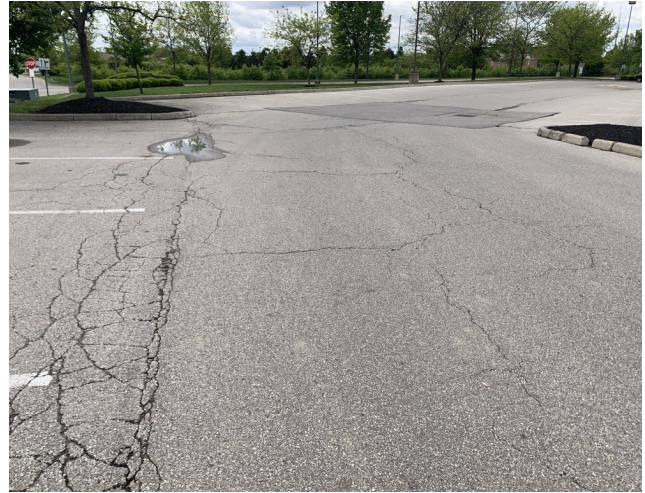
Example of pavement distress

Start the visual inspection by checking the external area above the tank as concerns here may indicate damage to the tank structure. Check the following:

- Condition of access covers
- Condition of access shafts
- Observe any unusual settlements of the surface above the tank area
- If the area above tank is paved, check for any excessive cracks in the pavement

If excessive pavement settling and/or cracks are noted during external inspection, ensure a thorough inspection of the internal area for cracks and/or damage.

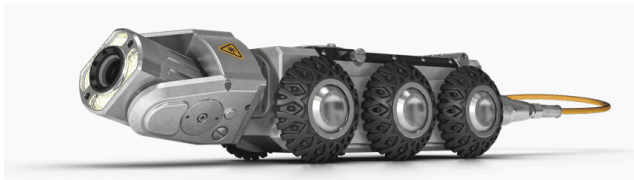
Example of a small-diameter crawler for tight spaces

ACO recommends crawler or push camera proportioned for a 4" diameter pipe inspection. These units can have adjustable cameras and turning capabilities to assist with inspection.

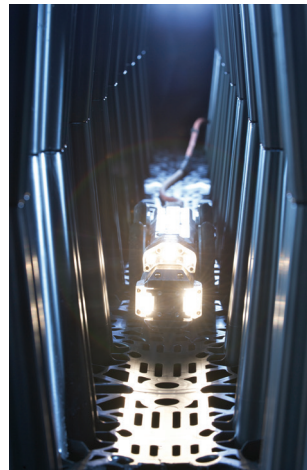
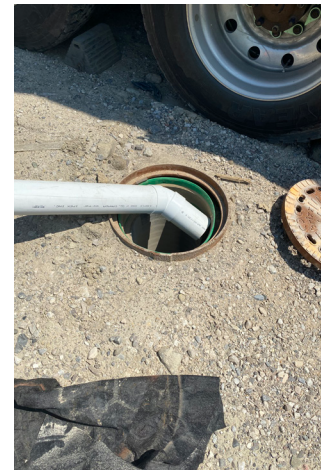
4" pipe with 45 ° elbow to guide push camera

The Remote Access Unit includes push camera guides molded into the bottom for easier camera alignment. Depending on the access point location, you may inspect the tank in up to four directions.

Best practice for use of a push camera is to use a 4" pipe with a 45° elbow at the end to help orient the camera in the direction intended for inspection. This is particularly beneficial for deeper tanks.

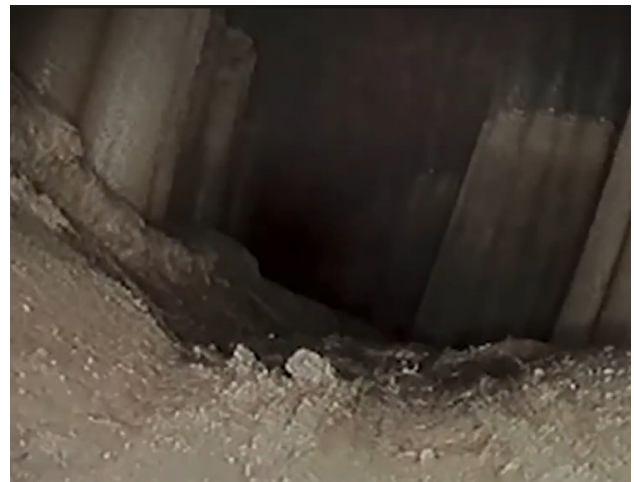
Sediment in tank

During bottom-layer inspection, cleaning is required if sediment has built up to ¼ of the tank height or 6" — whichever is shorter. See section 2.4.

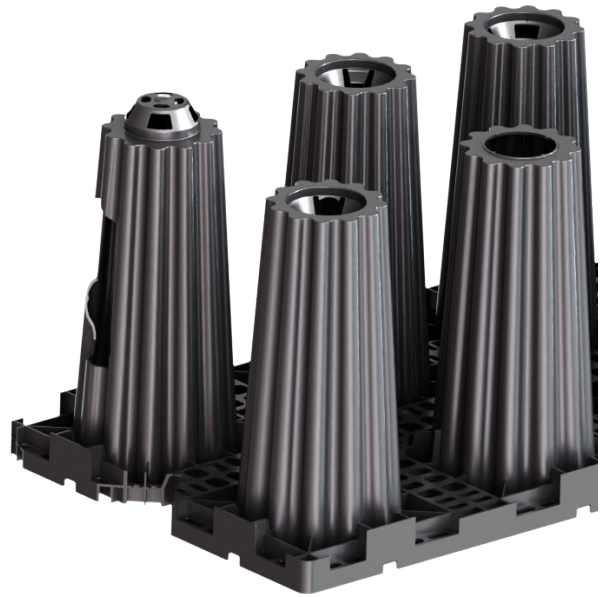
Example of damaged column and base plate

If visible cracks are noted during inspection, contact ACO for structural inspection guidance.

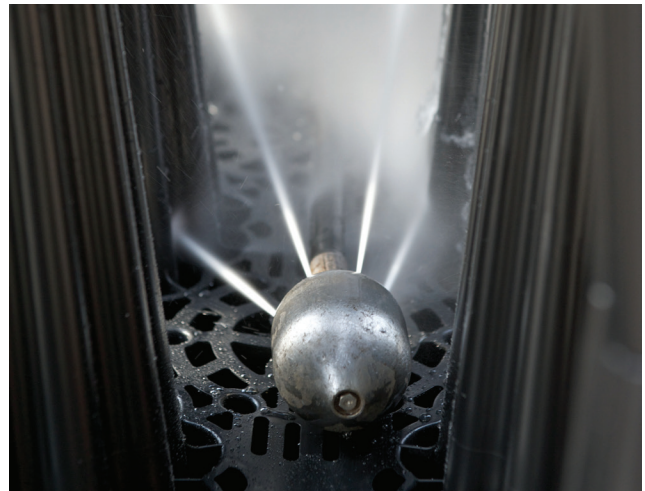
Clean the ACO StormBrixx Tank by utilizing Hydrovac equipment to loosen and suspend the debris and sediment.

ACO recommends a max jet pressure of 1,600 psi. The water level may be observed from the access point.

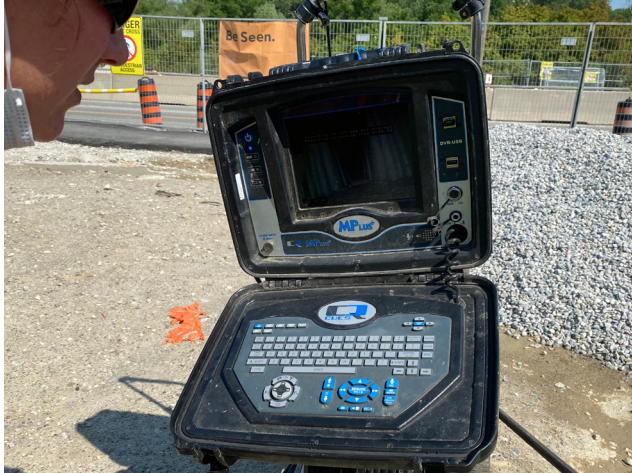
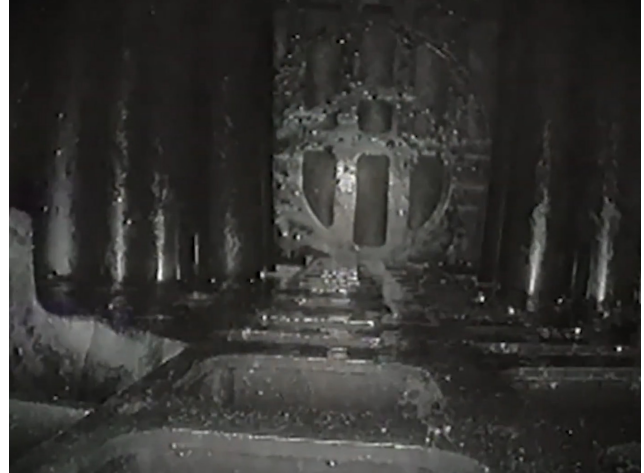
Camera view of clean tank

After completing cleaning, perform a final tank inspection in accordance with step 2.3.

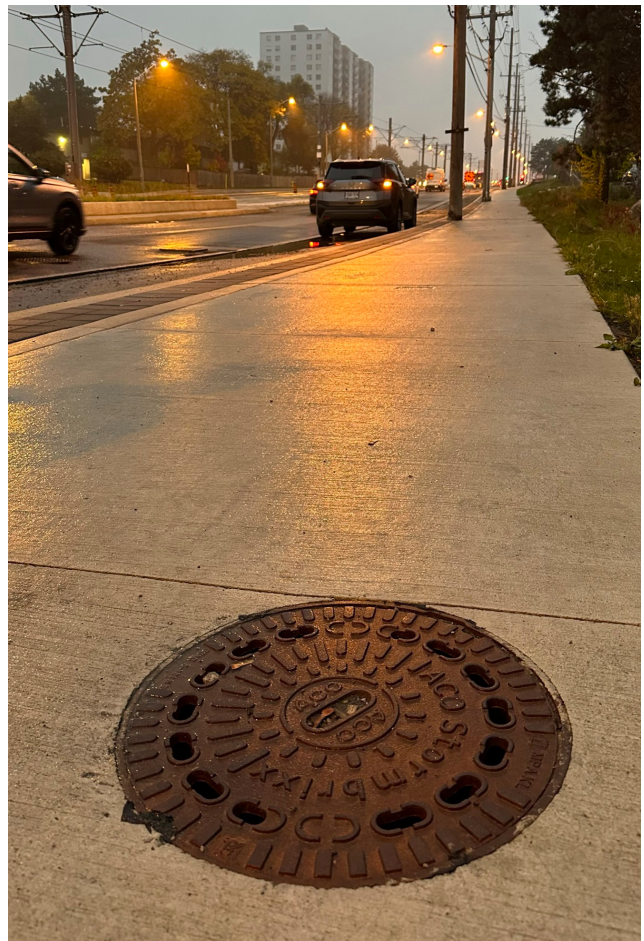
After completion of inspection and cleaning of the ACO StormBrixx system, clean access cover and frame seating areas to remove dirt that may cause it to resist replacement. Push cover securely in place.
