PROJECT PROFILE

Fidelity Investments Reflective Pool

Off the Roof and Into the Water Outside-the-box-thinking Leads to Novel EPDM Pond Liner

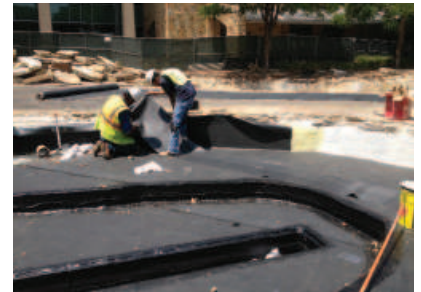
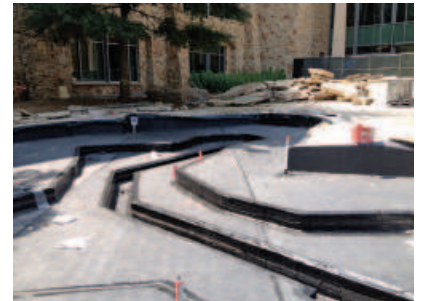
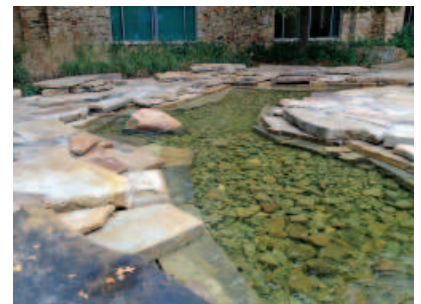
Over the next few weeks, Ostrander’s crew removed sandstone and river rock overburdens and then hydro-blasted off the existing parge coating. Once surface voids were filled, they installed sheets of Sure-Seal EPDM 60-mil Reinforced Membrane, making sure to use Sure-Seal PS Elastoform Flashing on all transitions. The final waterproofing step was to cover the Sure-Seal EPDM with CCW-300HV Protection Fabric, a tough nonwoven polypropylene protection course designed specifically for use with EPDM membranes.

With the waterproofing complete, contractors reinstalled the sandstone and river rock overburdens and then filled the pool. Would it hold water this time? Yes it would, thanks to new plumbing, outside-the-box thinking and a unique application for a traditional roofing membrane.
