capitalizing on

WATERPROOFING

As Seen in *the parking professional* Feb. 2005

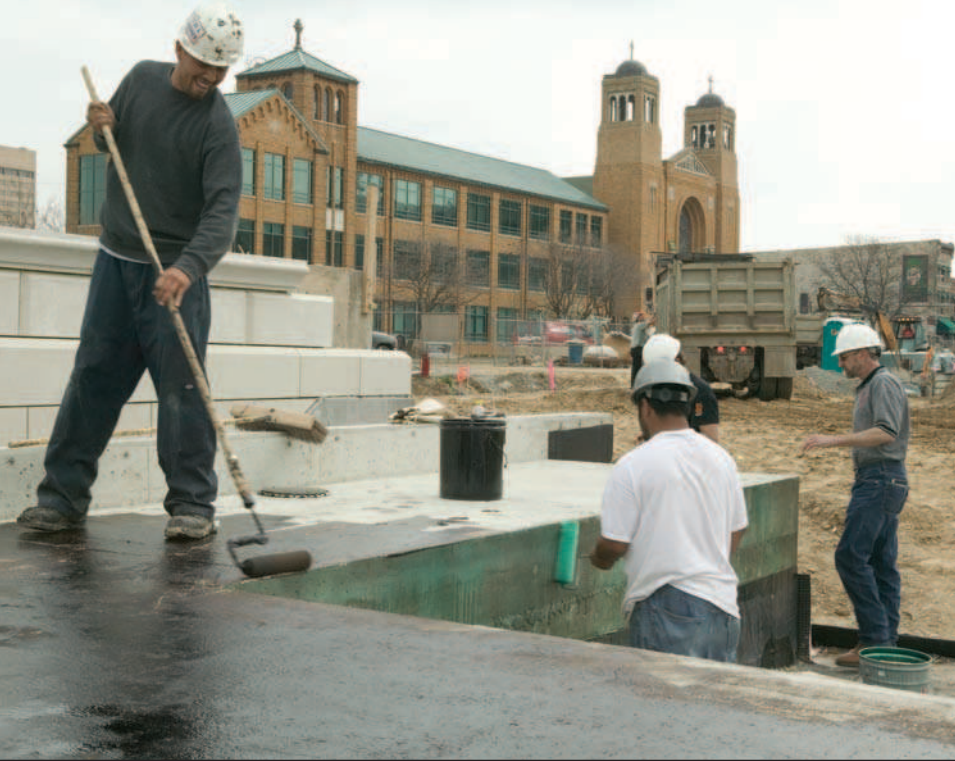
“The system was designed to manage large amounts of water. It was basically a moat that circled the building,” stated Bill Neville, project manager for Chamberlin. “We built towers to apply the membrane because the back fill could not be installed immediately, but the construction of the walls had to proceed.” From the towers, the concrete was waterproofed using CCW-500R hot applied rubber membrane and 82,357 square feet of Carlisle 860/861 membrane and then covered with 82,357 square feet of MiraDRAIN drainage board. “Both products are manufactured by Carlisle Coatings and Waterproofing and were essential to the success of the project.”

The entire parking structure was encapsulated with waterproofing. The ground layer had a moisture barrier of 155,950 square feet of Carlisle 60-mil EPDM membrane under slab, which tied into the below grade walls that transition into the grade-level roof. “By completely waterproofing the building and then installing the sheets of drainage that lead to a below ground drainage system, we were able to protect the new structure from moisture intrusion,” said Frieze.

The system consisted of 181,855 square feet of Carlisle CCW-500 hot rubber 215-mil system and 181,855 square feet of Carlisle’s MiraDRAIN 9000 drainage board. Additionally, over 26,000 square feet of Carlisle rooftop planting system was applied, not to mention the gravel and asphalt that topped the parking area.
