## **093 ZINC CONTROL JOINT**

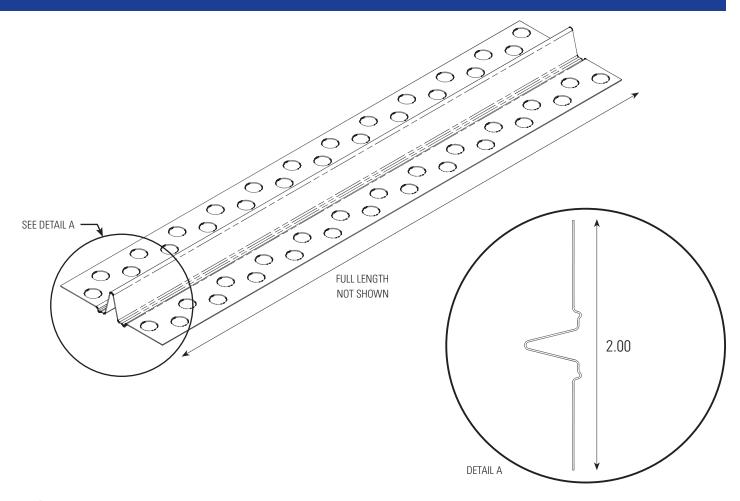
CEMCO's 093 true-zinc control joint is perfect for interior high-end plaster applications, allowing for controlled expansion of the ceiling or wall finish. Made from high quality 26 ga. zinc, and formed to exacting tolerances, the pull tape on the joint protect the expansion trough to provide for crisp and clean finishes in both plaster and veneer finishes. CEMCO's 093 control joint is manufactured by Niles Corporation and distributed by CEMCO.
