# Grout Troubleshooting Guide

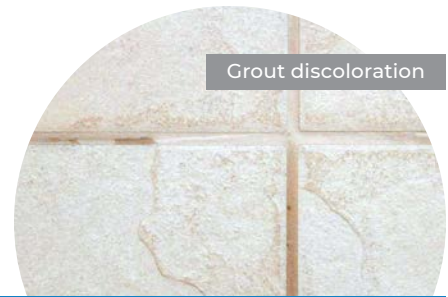
# Grout discoloration

A non-uniform, blotchy, shaded or dirty appearance of the grout joints

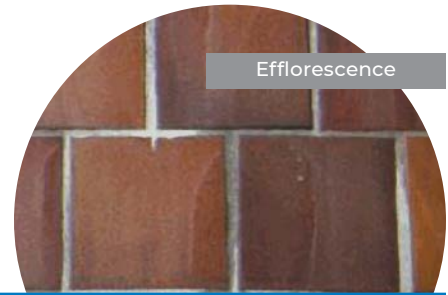
# Efflorescence

A white, powdery substance (calcium salts) in the grout joints

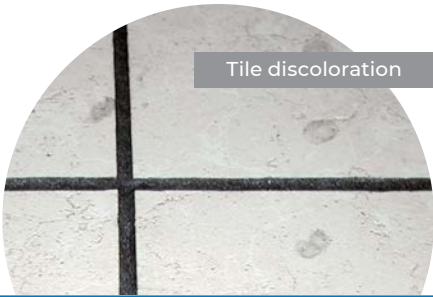
## Tile discoloration

A non-uniform haze, film, shaded or dirty appearance on the tile surface

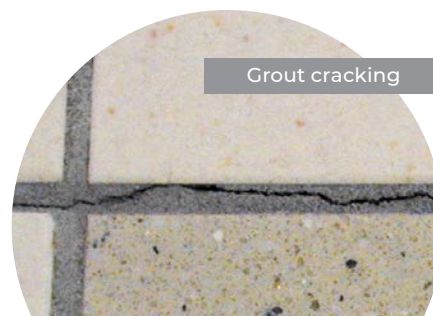
# Grout cracking

A separation or slight opening in a grout joint, usually located between the grout joint edge and the tile edge

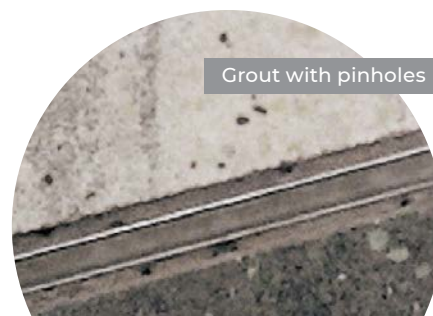
# Grout with pinholes

Very small holes – typically the size of a pinhead or less – that appear in the grout joints

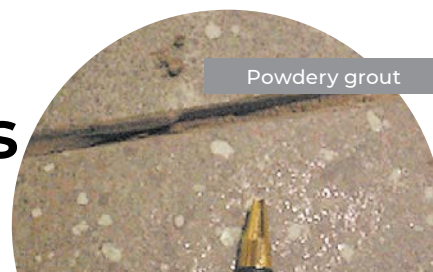
# Powdery grout in the joints

The lack of a solid, hard grout joint as exhibited by the presence of grout powder

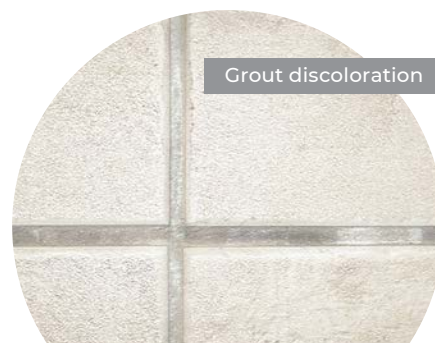
# Grout discoloration

A non-uniform, blotchy, shaded or dirty appearance of the grout joints

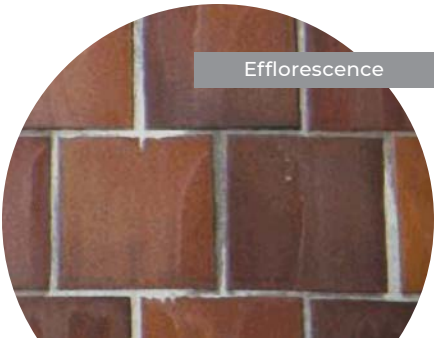
## Efflorescence

A white powdery substance (calcium salts) in the grout joints

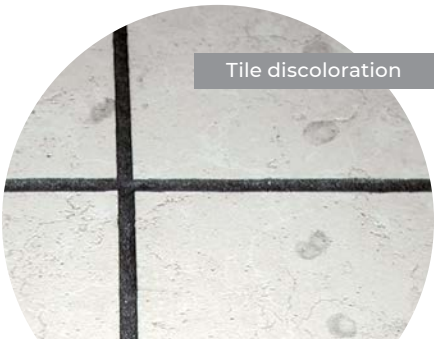
## Tile discoloration

A non-uniform hazy, filmy, shaded or dirty appearance on the tile surface

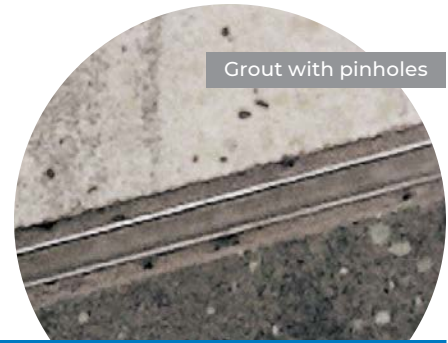
# Grout with pinholes

Very small holes – typically the size of a pinhead or less – in the grout joints

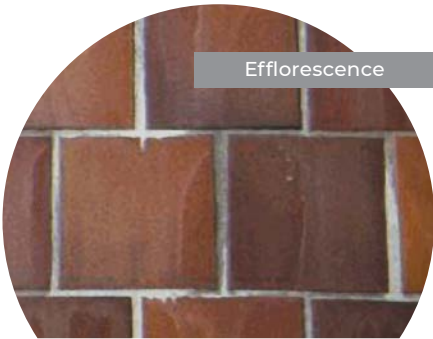
## Efflorescence

A white powdery substance (calcium salts) in the grout joints

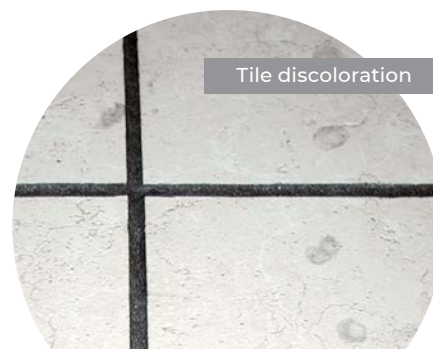
# Tile discoloration

A non-uniform haze film, or shaded or dirty appearance on the tile surface

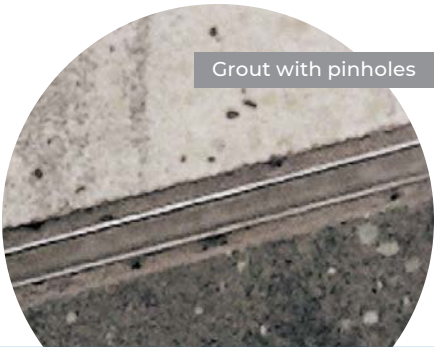
## Grout with pinholes

Very small holes – typically the size of a pinhead or less – in the grout joints
