PANGO® WRAP

OVERLAP WITH PANGO® TAPE

CONCEPTUAL FIELD ILLUSTRATION

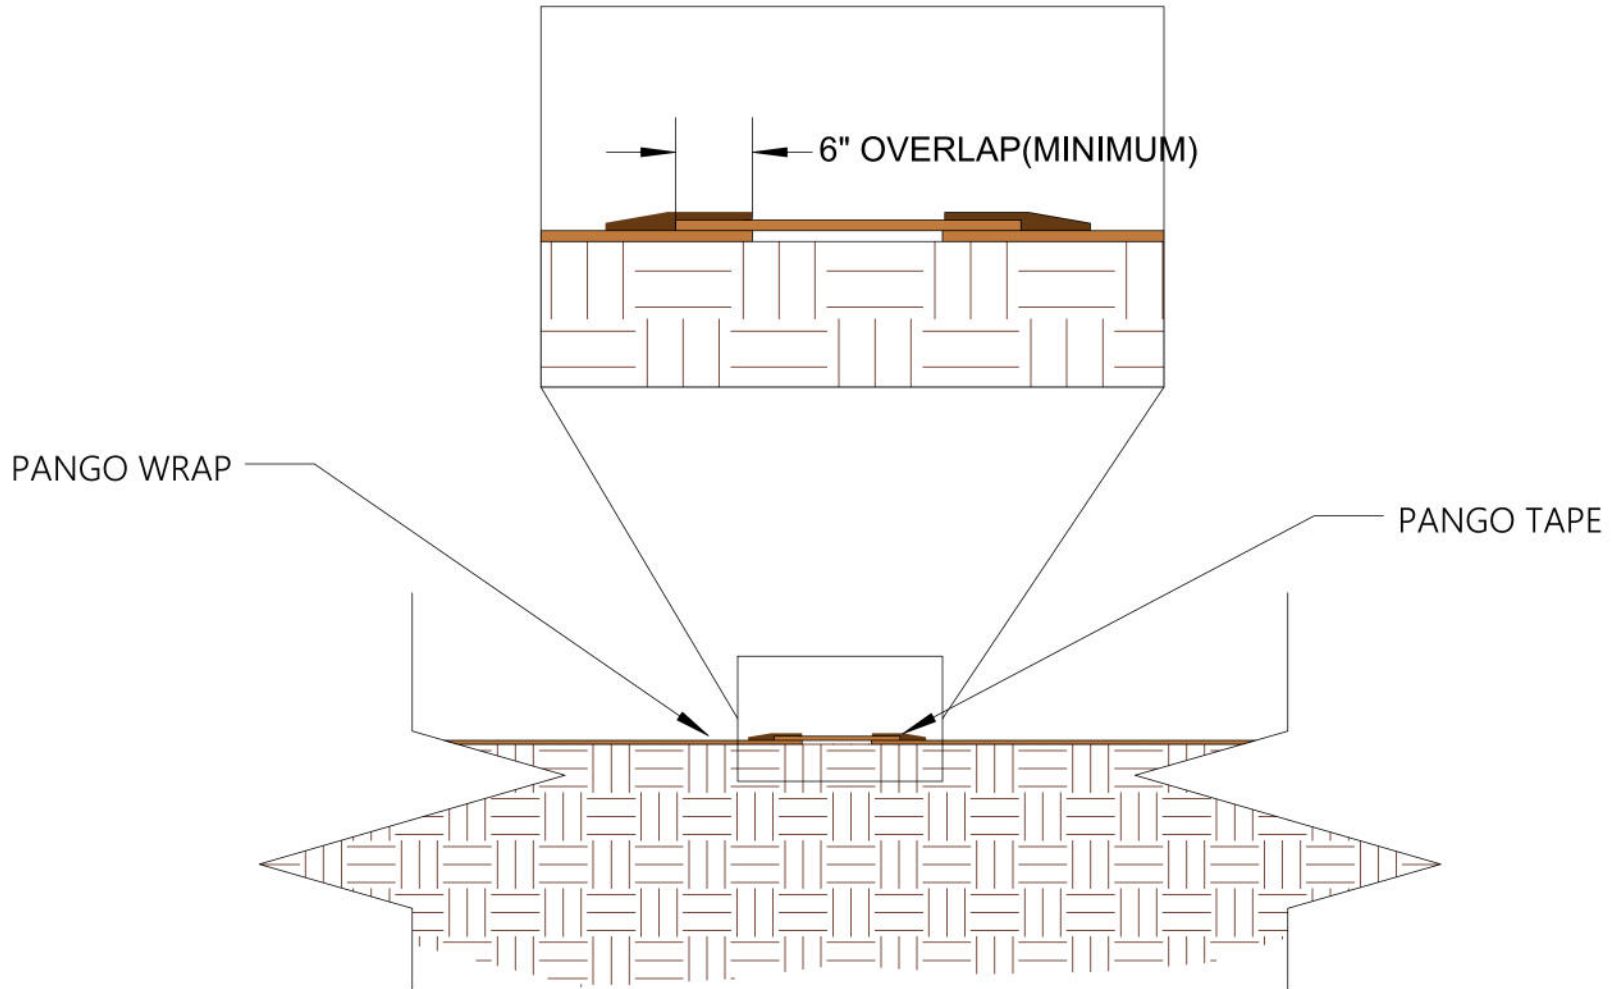
PAGE 2 OF 2

REPAIR OF DAMAGED AREA WITH PANGO® TAPE
