Sto Corp.
3800 Camp Creek Parkway
Building 1400, Suite 120
Atlanta, GA 30331
Tel: 404 346-3666
Toll Free: 800 221-2397
Fax: 404 346-3119
Web: www.stocorp.com

Stucco Repair and Maintenance

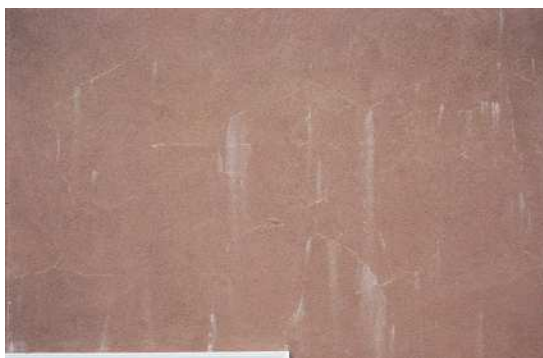
Photo 1: Cracks that are dispersed across a large area can be repaired with elastomeric coating if narrow in width (1/32" or less), Procedure A, or with glass fiber reinforcing mesh and acrylic base coat, Procedure B. Surface cleaning to remove the efflorescence and any other surface contamination must be done first.

A. Hairline Cracks (up to approximately 1/32" wide)

1. Apply two coats of color-matched smooth elastomeric coating by brush or roller and allow to dry. General application guide is 12-14 wet mil thickness per coat. Refer to Sto product bulletin 212 (Stolastic) or 222 (StoSilco Lastic) for specific information. Apply the coating up to an architectural break or to the full elevation as necessary to obtain a satisfactory aesthetic appearance.

B. Moderate Cracks (up to approximately 1/8" wide)

1. Embed glass fiber reinforcing mesh (920E Sto Mesh) in acrylic base coat (225 Sto RFP). Treat the cracks individually with a 4-6 inch wide strip of mesh centered over the crack. If cracks are spread throughout an area, treat the whole area with mesh. Overlap all mesh seams minimum 2-1/2". Resurface up to an architectural break or resurface the full elevation as necessary to obtain a satisfactory aesthetic appearance.
2. After the base coat is dry, usually within 24 hours, re-apply Sto acrylic elastomeric finish to match the color/texture of adjacent areas.

1. Fill the crack with knife-grade elastomeric crack filler (CR214 Sto Flexible Crack Filler) and follow procedure A or B above.

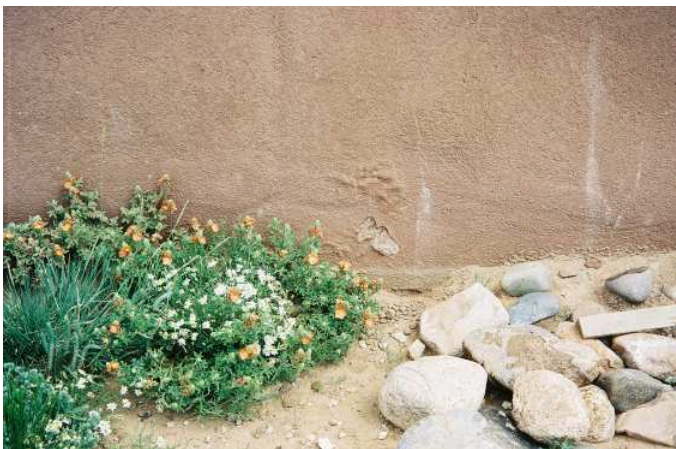
Photo 1: The blistered area at the base of this wall can be removed with a hand tool, and new color/texture matched finish applied to repair it. The likely root cause of this blister is ground water that seeps into the stem wall below and wicks up into the stucco. A canale (scupper) from the roof above drains water directly into the ground and not away from the wall. A diverter that directs water away from the wall would prevent recurrence.

1. Remove the blistered stucco finish with a scraper or other hand tool to adjacent well adhered finish.
2. If the stucco surface is chalky, clean and apply primer or surface conditioner (831 Sto Plex W) to restore the integrity of the surface.
3. If the stucco is weak, loose, or scaling, remove the weak material with a scraper or wire brush to a uniform depth and to where it is firm. Dampen the prepared surface and apply stucco base coat so it is even with the adjacent stucco. Moist cure. Proprietary stucco patch materials are also available from Sto such as 244 Sto Leveler. Follow the manufacturer's instructions for these materials.
4. Apply color/texture matched finish to the repaired stucco surface.

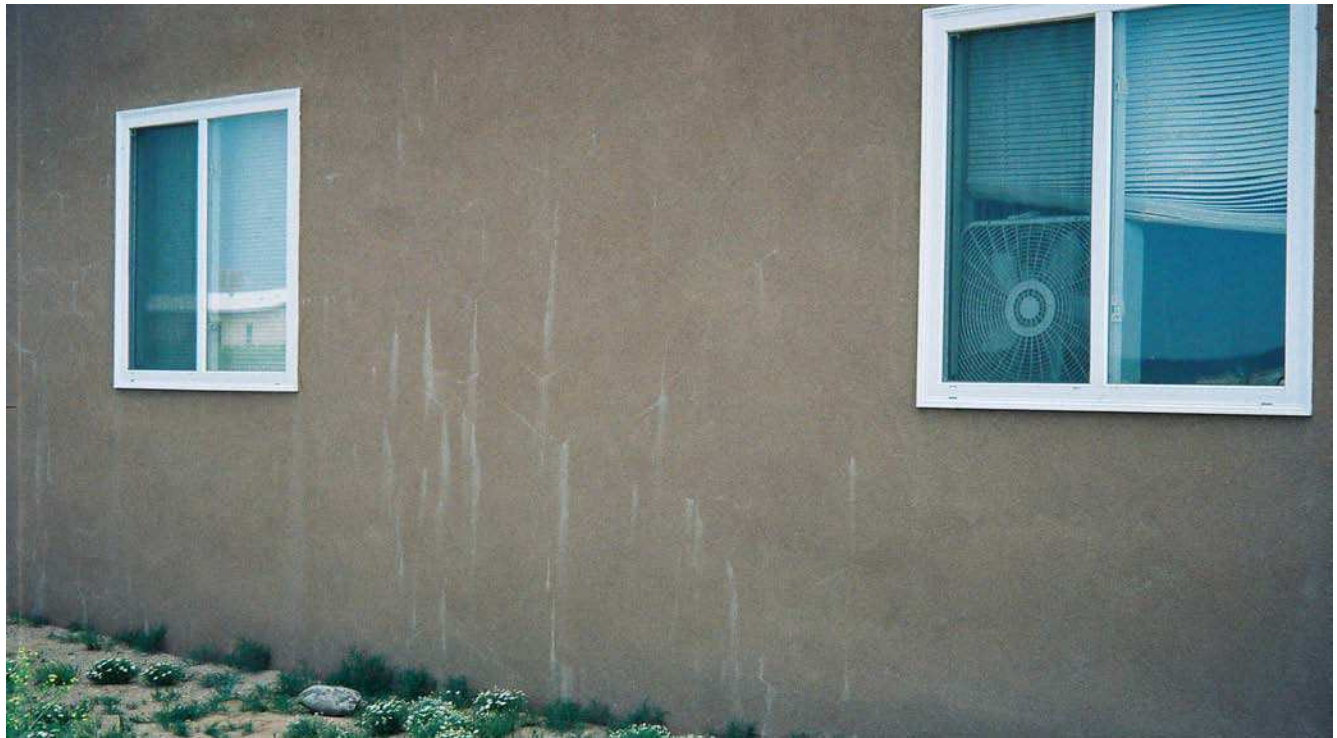
Photo 1: Efflorescence can be cleaned with a mild acid solution to remove unsightly stains on the exterior surface of the stucco.

Efflorescence can generally be removed by light washing with a cleaning agent. A common household solution is vinegar and warm water. Proprietary cleansers¹ are also available from a number of different sources (see notes below). Care should be taken to avoid heavy abrasion of the surface which could damage the integrity of the textured material. A soft bristle scrub brush should be used to scrub the affected area with the cleaning solution. Always try a small inconspicuous area first to be sure of desired results. When using proprietary cleansers follow the instructions and safety precautions on the packaging.

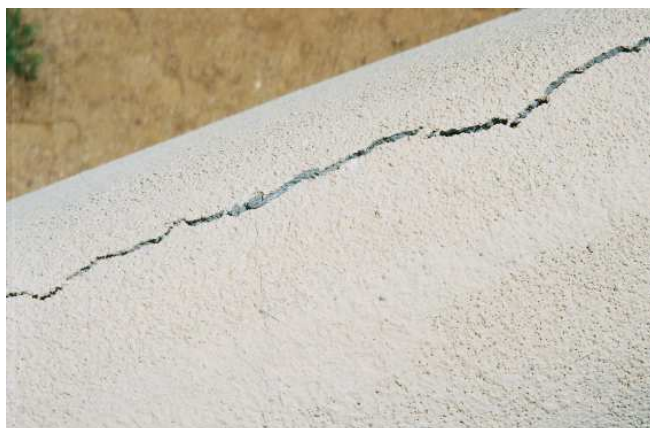
Photo 1: the large crack in the parapet requires elastomeric crack filler, followed by waterproofing with glass fiber mesh installed around the parapet and a minimum of 6" down each side.

- B. Highly exposed surfaces such as parapets and sill returns require membrane protection to effectively waterproof these surfaces (Photos 1 and 2).
 - 1. Fill cracks with flexible crack filler (CR214 Sto Flexible Crack Filler).

- 2. Embed glass fiber reinforcing mesh (920E Sto Mesh) in waterproof base coat material (235 Sto Flexyl). Extend this application around parapets minimum 6" down each side. Extend minimum 4" down sills and up jambs at window sill returns. At three way intersections, for example, outside corners of sill returns, add another mesh strip application to cover all exposed areas (dotted line, photo 2).
