# Tech Hotline

**No. 0894-E**  
**Rev: October 2014**

## Wind Load and Adhesively Attached StoTherm® ci Systems

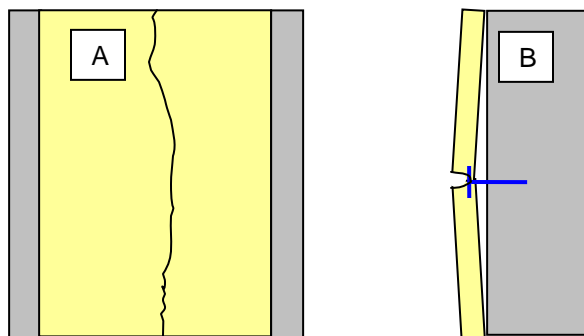
Figure 1. Typical failure modes of gypsum-based sheathings attached to frame construction

A. On the left the back of a test panel and the effect of positive loading are shown – failure of the sheathing with cracks roughly parallel to and centered between studs. B. On the right a side view of a test panel and the effect of negative loading are shown – failure of the sheathing at a fastener penetration.

Wind pressure is one of many environmental loads that StoTherm® ci systems resist. Resistance to wind pressure is measured by performing standard tests<sup>1,2</sup> with loads applied perpendicular to the system. The support construction is often sheathing over wood or metal frame assemblies. Frame construction represents a worst case scenario for stiffness as compared to concrete or CMU wall construction. Sto Corp. has tested numerous frame assemblies with StoTherm® ci adhesively attached to gypsum-based sheathings. In general we have established that the limiting factor in the assembly is not the adhesive attachment of StoTherm® ci, but is the sheathing or its attachment.
