BIO-SAN[®] C500

Antimicrobial Crystalline Technology

*For protection of
concrete in severe
sewage conditions*

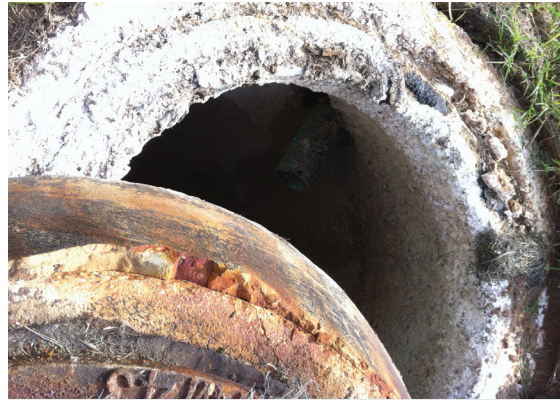
Microbial induced corrosion can seriously reduce the service life of concrete sewer structures and wastewater treatment plants.

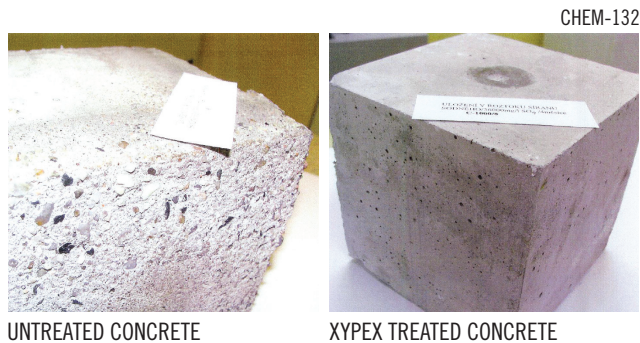
6 Protects concrete in sulphate environments

Samples of both Xypex treated and untreated concrete were placed in a highly concentrated sulphate solution. After 4 months the untreated samples experienced a weight loss of 4,800 g/m² whereas the Xypex treated samples only lost between 5 g/m² and 50 g/m², showing no visible signs of surface deterioration.
