# Troubleshooting Guide

Causes, Repair  
& Prevention

December 2023

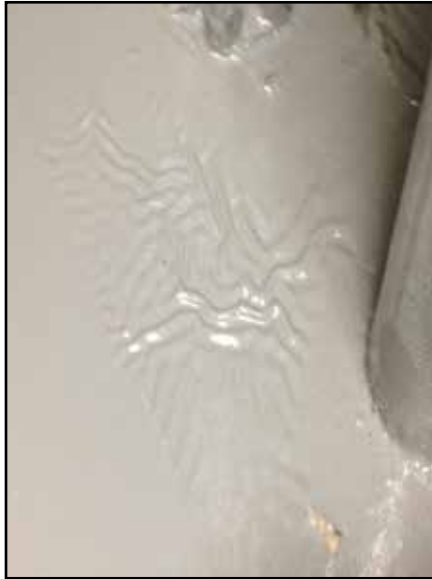
Coating is wrinkled in appearance. Multiple lines of parallel wrinkling may occur.

- Previous Coat is Uncured or Off-Ratio: Material applied over uncured or off-ratio coating, causing stress on topcoat.
- Coating Too Thick: Coating applied at a thickness that exceeds application instructions.

- Previous Coat is Uncured: Ensure that coatings are completely cured before applying additional coats.
- Previous Coat is Off-Ratio: Mix all materials thoroughly, following mix ratios printed on product labels or the Product Data Sheet. See Product Mixing Instructions in the Support Information section of this guide.
- Coating Too Thick: Apply coatings at recommended coverage rates.

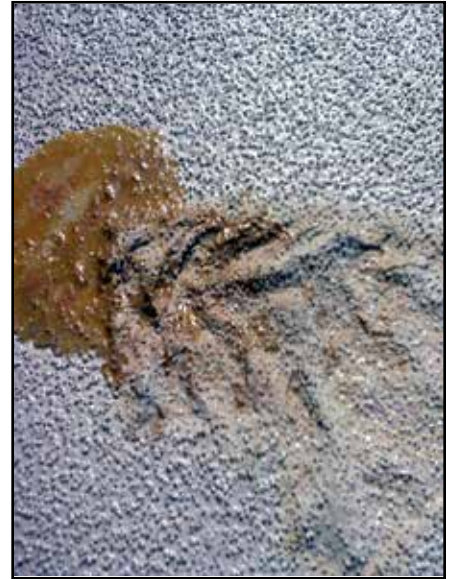
Coating is soft and may transfer when touched. Coating may also delaminate.

**Off-ratio coating**

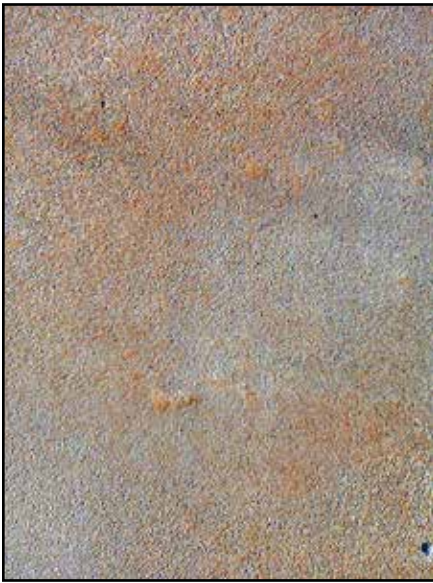
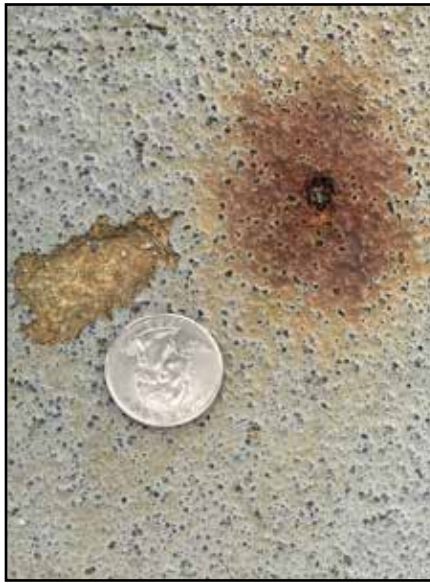
There are rusty, reddish-brown stains in the coating. The presence of rust can be purely aesthetic, or it may indicate a condition which affects the integrity of the coating system.

- Shotblast Beads: Rust stains develop when shot-blast beads utilized during surface preparation are not properly removed. Rust stains will bleed through the entire system if metal is not removed prior to applying the coating system.
- Metal in Aggregate: Rust may also develop from metal fines contained in the aggregate.
- Rebar or Mesh: Rust from rebar or mesh too close to the surface can also appear.

If the contamination source is from the surface, power washing along with the use of a rust neutralizer may remove stained area.

1. If the contamination source is located in the substrate, remove the coating down to the substrate and abrade the surface to remove all rust.
2. Apply Ureprime HS2 or HS4 at a rate of 300 sf/gal to properly prepared area and allow to cure.
3. Apply 70714/70715 Series epoxy at a rate of 100 sf/gal (16 WFT/16 DFT).
4. Re-apply coating per specifications and Neogard recommendations in the Waterproofing Application Manual.

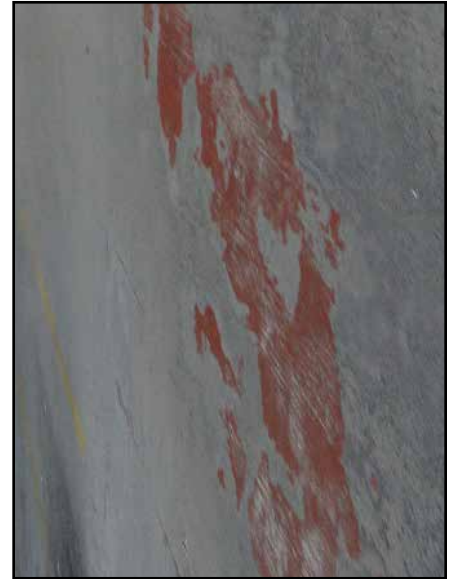
Coating is worn, exposing primer and bare concrete.

- Inappropriate Application: Excess aggregate in wear coat and insufficient topcoat material led to premature wear.
- Wrong System Specified: Applied system not designed for heavy duty areas such as drive lanes, turns, ticket splitters, etc.
- Moisture Contamination: Premature wear due to moisture contamination during application.
- Improper Mixing: Failure to mix components properly prior to installation, scraping unmixed material from walls of buckets, insufficient mixing time for proper dispersion, or a contaminated mixing paddle, resulting in off-ratio components and poor physical properties.

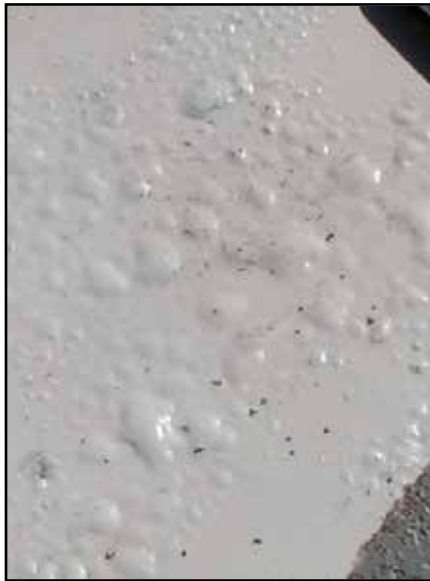
**Trapped solvent blisters**

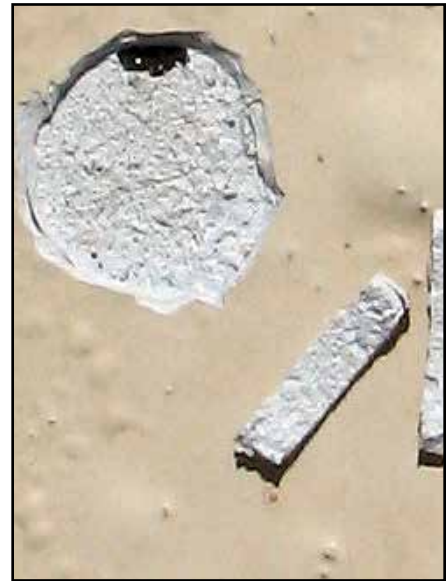
**Removed blister**

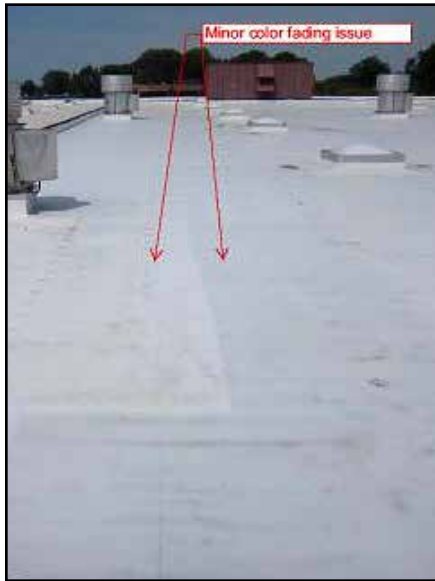
Surface of coating does not cure to a glossy finish and reflect light, which is ideal for a roofing topcoat.

**Roof with shade variation**

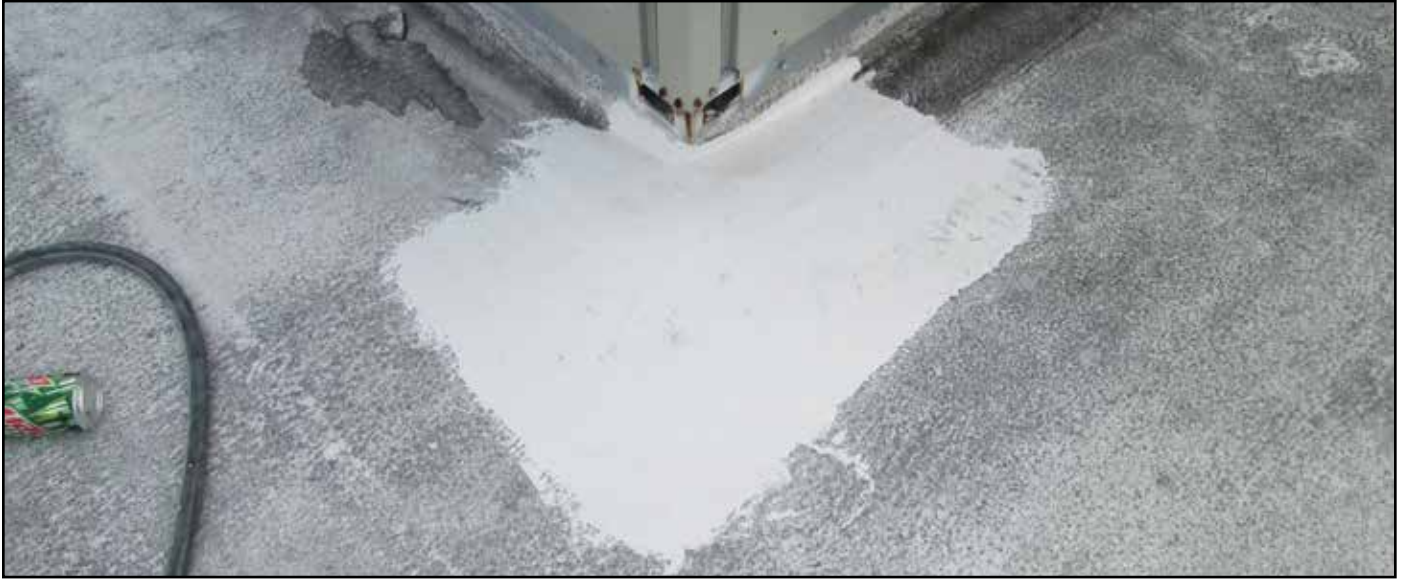
Surface not cleaned properly and does not extend 6"–8" beyond the affected area.
